COUNCIL BILL NO.  2016- 063

AN ORDINANCE

This Blight Report for 616 South Market Ave., Springfield, Missouri 65806 (the “Property”) is being submitted by WPV, LLC, a Missouri limited liability company (the “Developer”), for the purpose of demonstrating that the Property should be declared blighted pursuant to the LCRA Law. This Blight Report will demonstrate that the Property is a “blighted area” under the LCRA Law due to the predominance of (1) deterioration of site improvements; (2) insanitary and unsafe conditions; and (3) the existence of conditions which endanger life and property by fire or other causes. Because of the aforementioned conditions, the Property constitutes an economic and social liability and a menace to the public health, safety, morals, and welfare in its present condition and use.

## Property Inspection Report

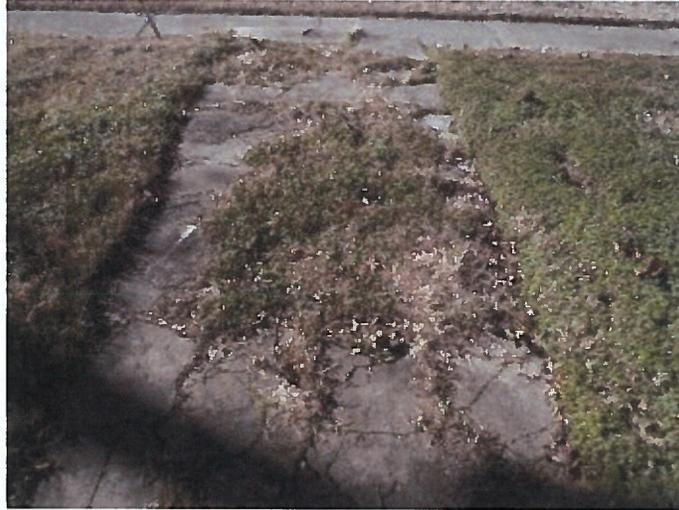
- Sidewalk is badly damaged & deteriorated. Needs complete replacement.

Sidewalk is badly damaged & deteriorated

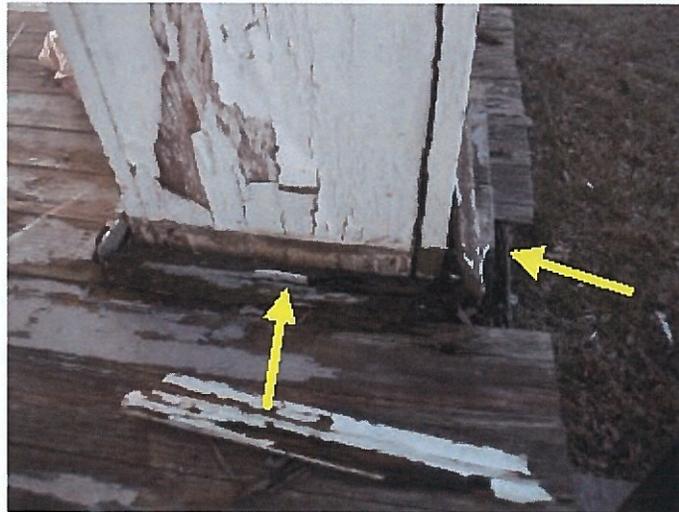
- **Moisture damage found around base of several posts. Needs attention/repair.**

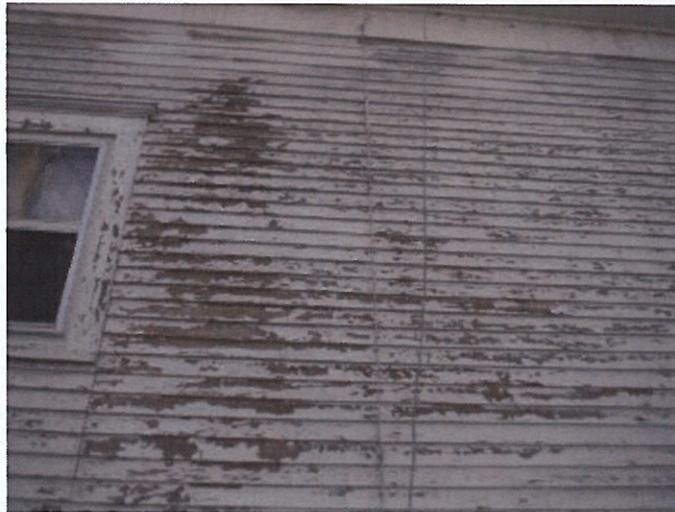
- Areas of damaged and poorly patched siding at NE corner.
- Heavy peeling paint on most all of exterior siding. Paint may be lead. Needs remediation by a qualified contractor.

Heavy peeling paint on all sides of exterior

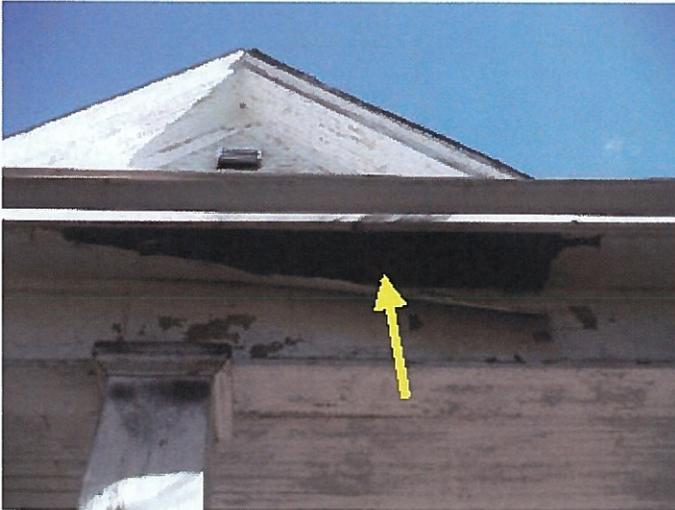
- Holes and many moisture damaged areas of soffit and trim need repair by a professional.
- Heavy peeling areas of suspected lead based paint on all areas of soffit and trim need remediation by a licensed contractor.

Moisture damaged soffit at front porch

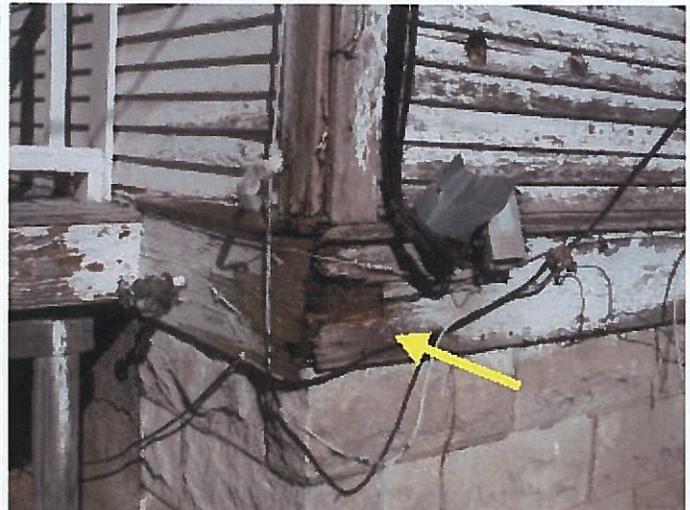
Moisture damage at lower SW corner

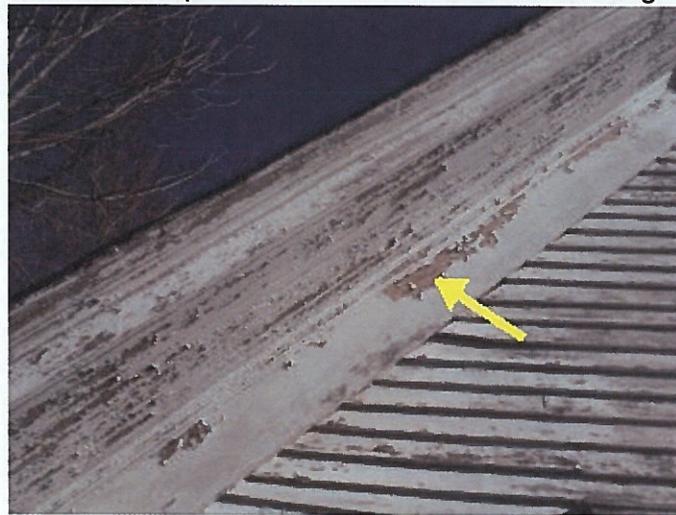
Suspected lead based peeling paint on all soffit, fascia, and trim

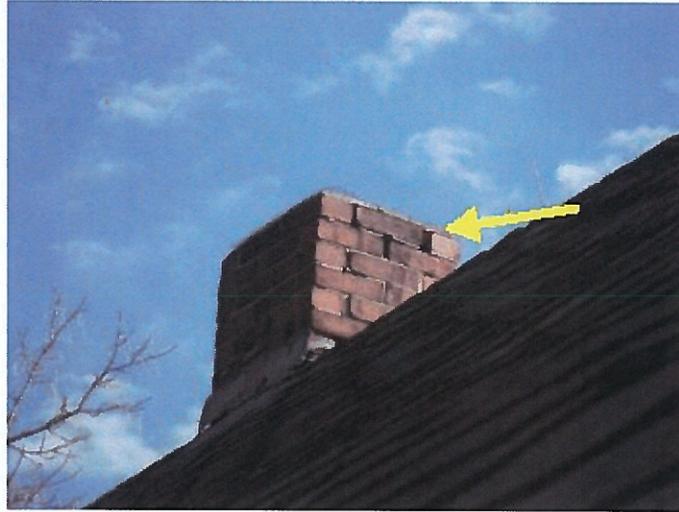
- Rain cap/spark screen recommended
- FYI: Chimney is the flue for the water heater and furnace.
- Areas of missing mortar observed at top of chimney. Needs tuck pointing by mason.

Areas of missing mortar observed at top of chimney

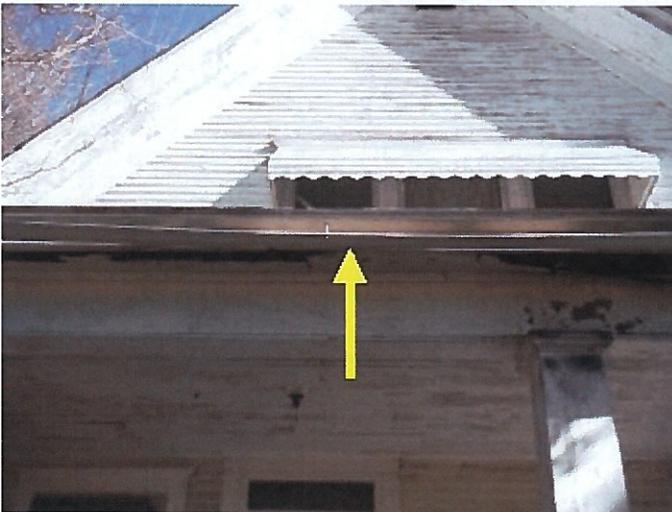
- **Guttering is in poor condition. Several areas are loose & missing. Needs repair/replacement for proper drainage and control of roof water.**

Guttering at front porch is loose/displaced

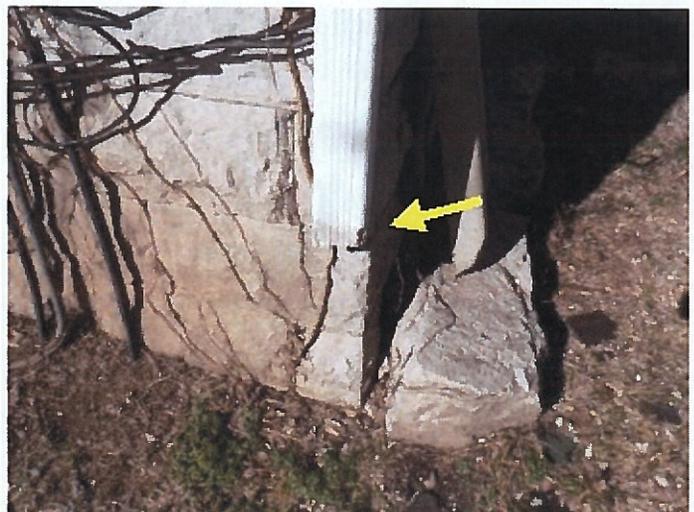
Missing downspout elbow at SE corner

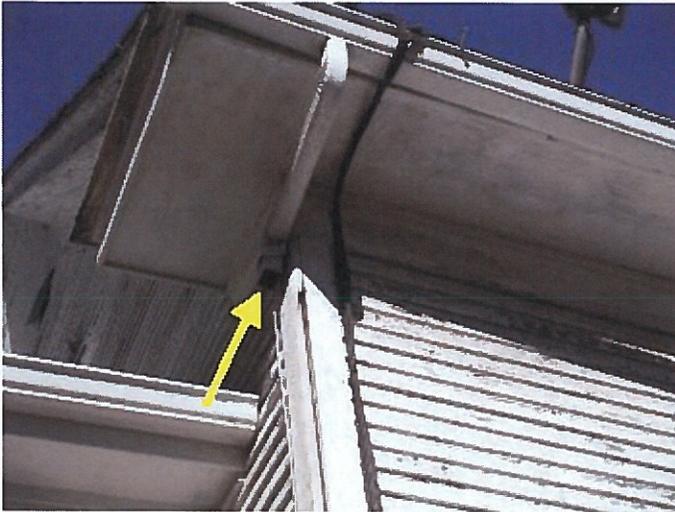
Missing downspout at SW corner

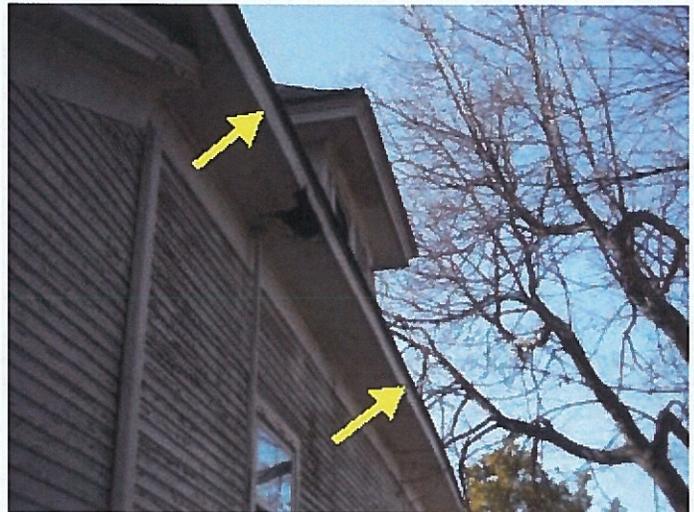
No guttering is installed on the north side

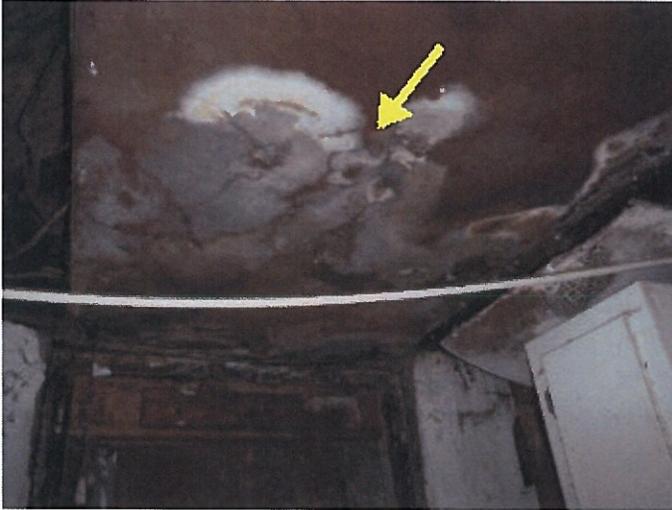
- Trash and debris is present on floor at west 1/2 of basement. Needs cleaning.
- Moisture stains and signs of past water observed at base of walls in middle of basement.
- Most every basement window was damaged and boarded up with wood.
- Cracks in mortar joints at east foundation walls need tuck pointing/repair.
- Areas of deterioration and signs of past water intrusion present on areas of foundation walls. Needs repair by a qualified contractor.
- Black mold and fungal growth present on walls and ceilings in basement. Needs complete tear out and remediation by a qualified mold contractor.

Mold growth on ceiling at SE room in basement

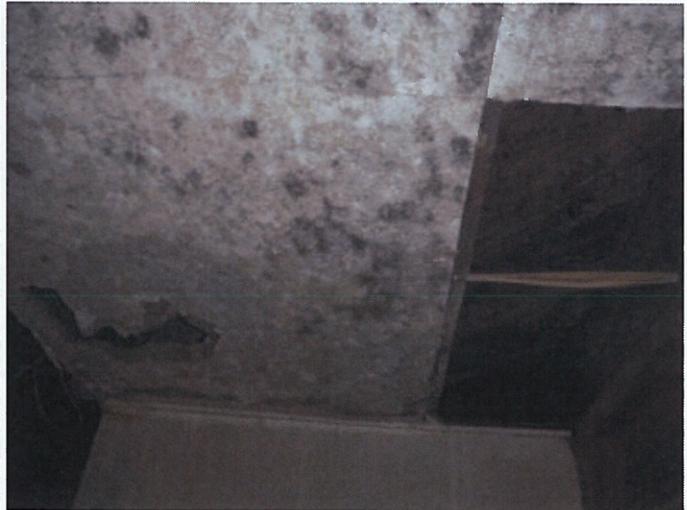
Mold/fungal growth on ceiling at middle east part of basement

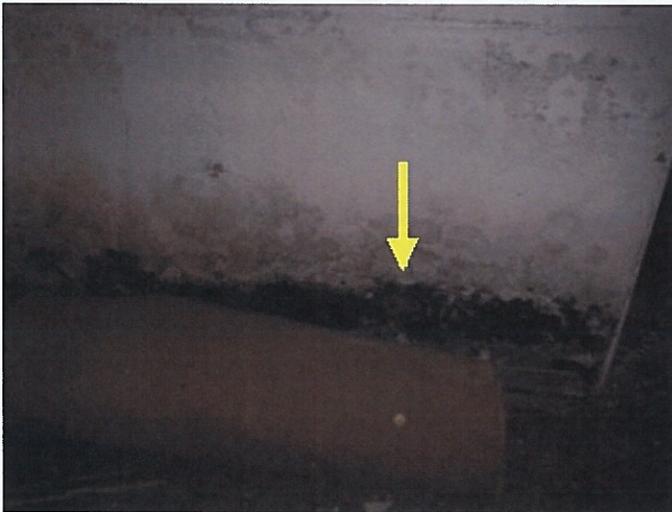
Black mold on base of wall at NE basement room

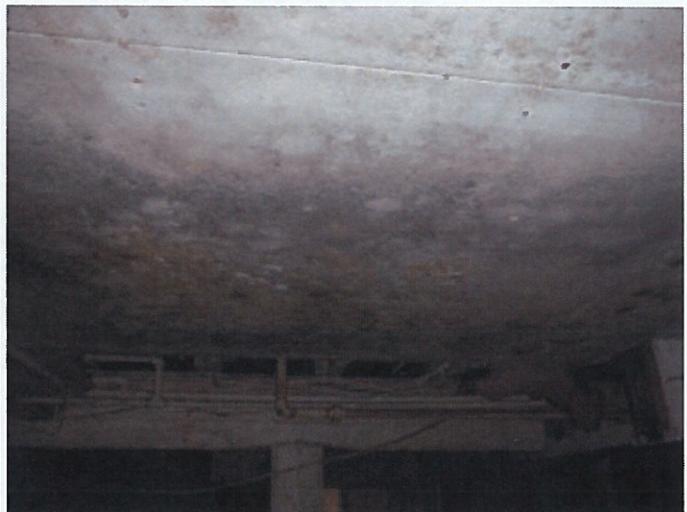
Fungal growth on ceiling in middle part of basement

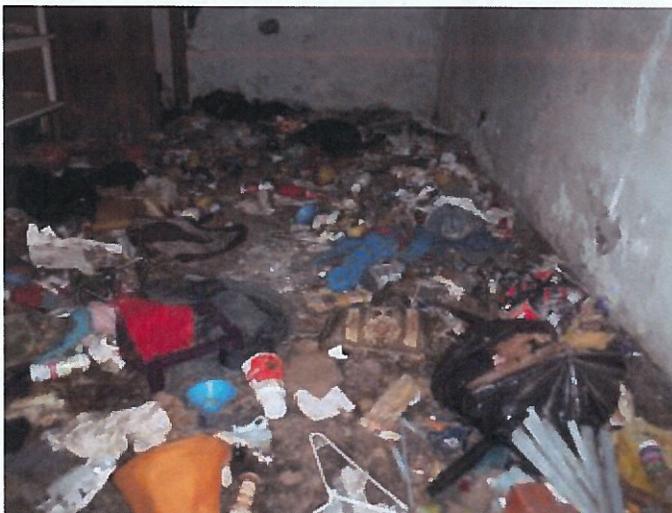
Trash and debris at west room in basement

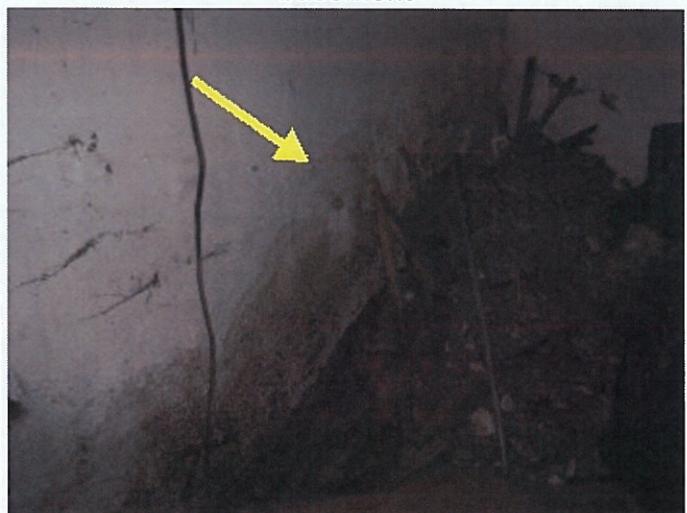
Insulation and debris at NE corner of basement

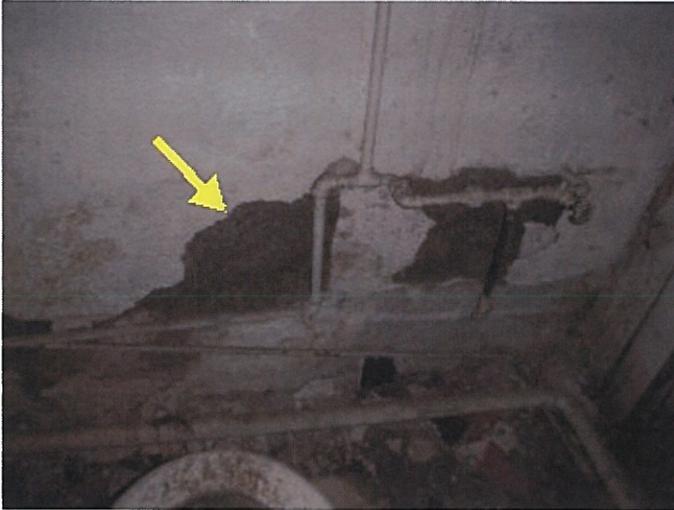
Evidence of past water penetration at south foundation wall and main water line

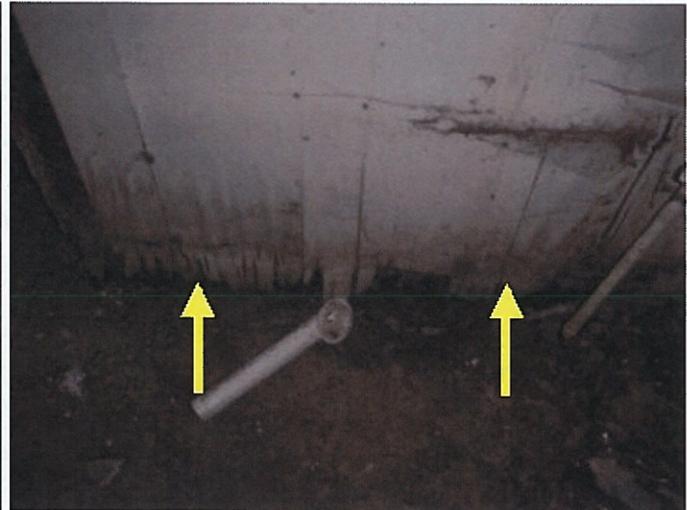
Water damaged wall at basement bathroom area

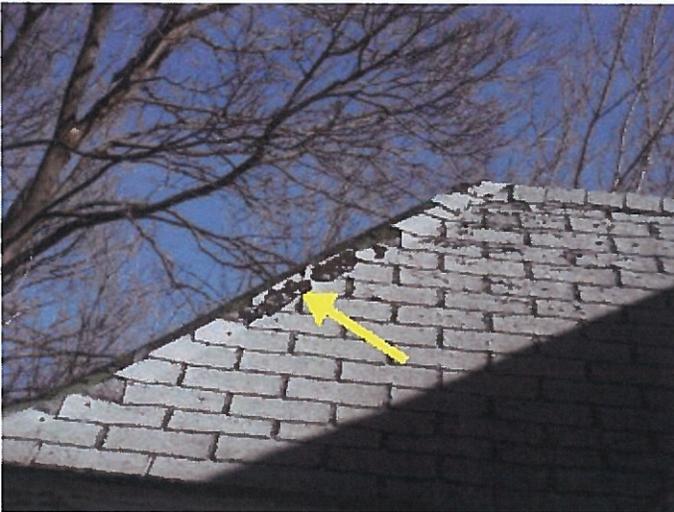
- Missing shingles at NW hip need repair/replacement.
- **Roof is badly deteriorated and shingles are beyond their normal life. Needs complete tear off and replacement by a qualified roofer.**
- **Improper repair and active leakage found at south field just east of the dormer. Needs repair by a roofer ASAP.**

Missing hip shingles at NW corner

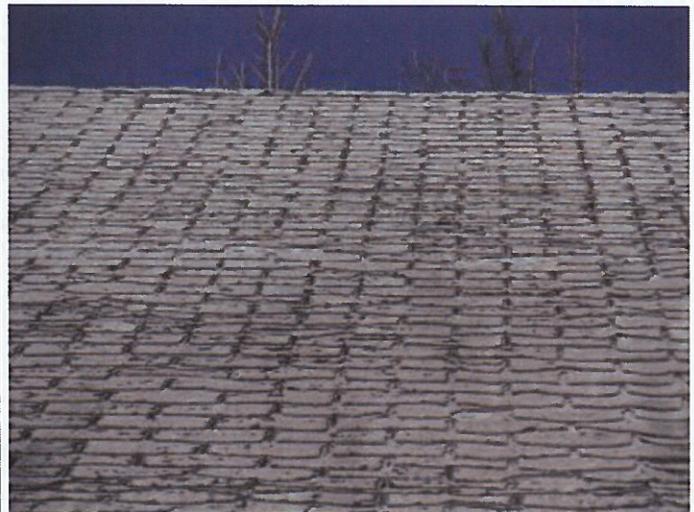
Shingles are beyond the end of their normal life

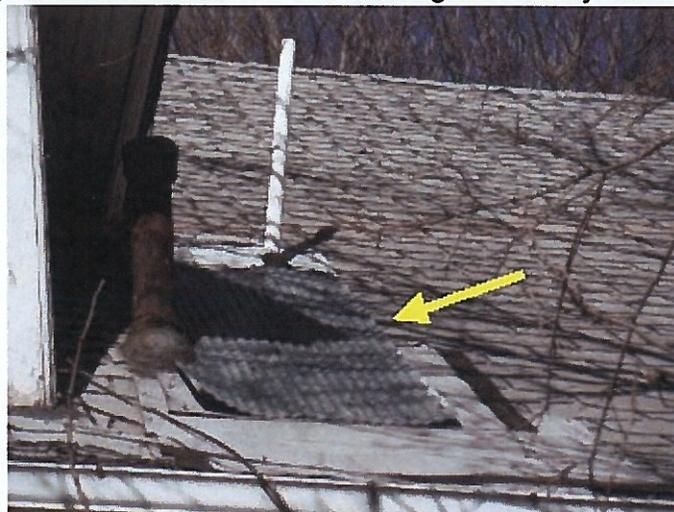
Inadequate repair to south field just east of dormer

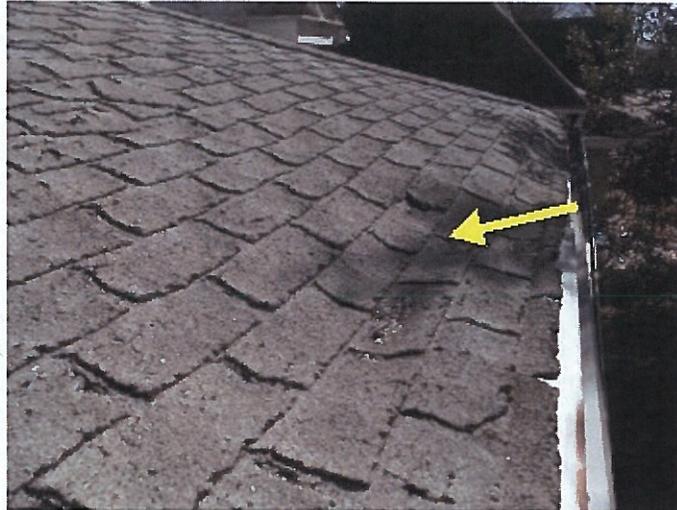
- **The porch roof is actively leaking and has an area of moisture damaged decking at front middle edge. Needs repair by a qualified roofer.**

Moisture damaged decking from active leakage and deteriorated shingles

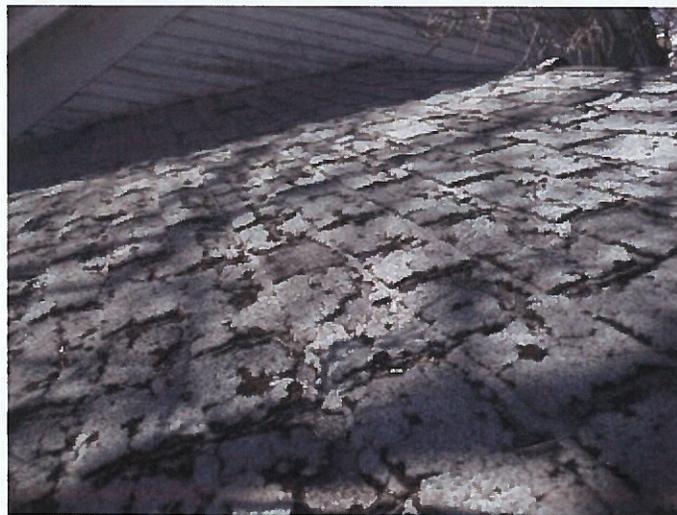
- Shingles on back addition are beyond their normal life and in need of complete replacement.

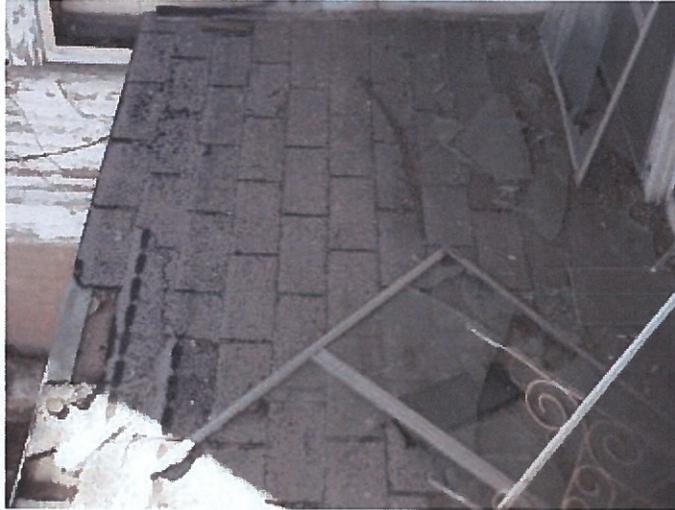
- Shingles are improperly installed on a flat surface. Needs replacement with the proper type of material for low/flat surfaces.

Shingles are improperly installed on a flat surface above the basement entry

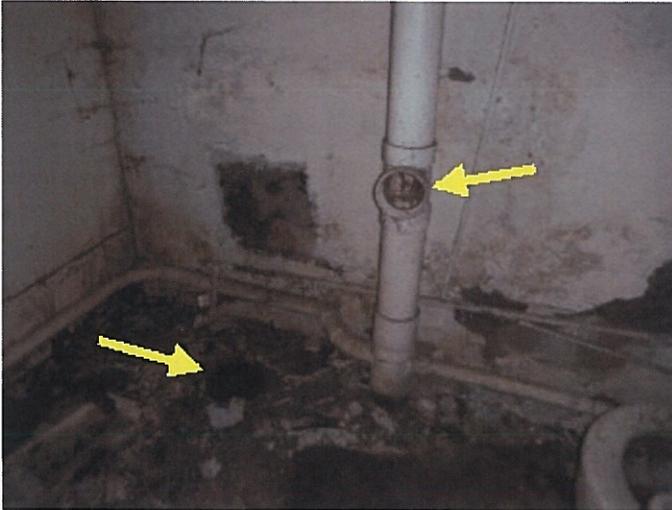
- Water was off at time of inspection. Unable to test drain piping.
- **Open sewer lines in basement bathroom and upstairs laundry area need repair by a plumber.**

Open sewer lines at basement bathroom

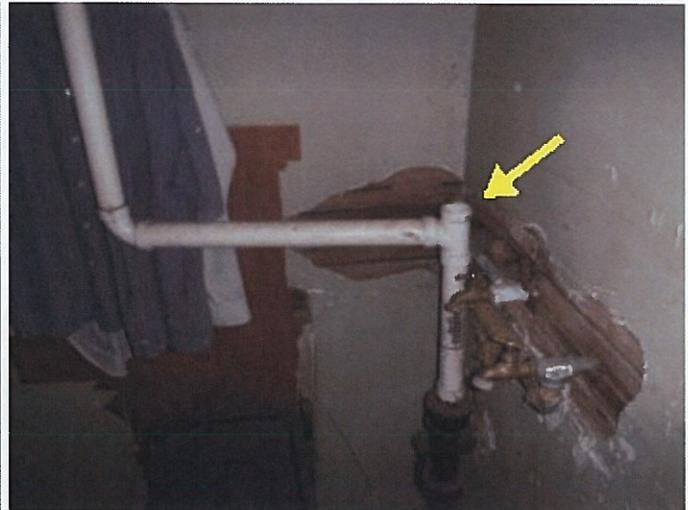
Improper open drain pipe at upstairs laundry area

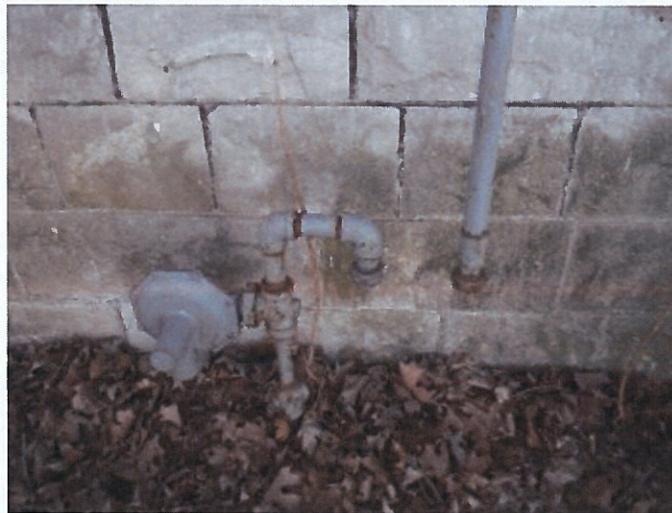
- **Home had no gas at time of inspection; meter was missing on north side.**

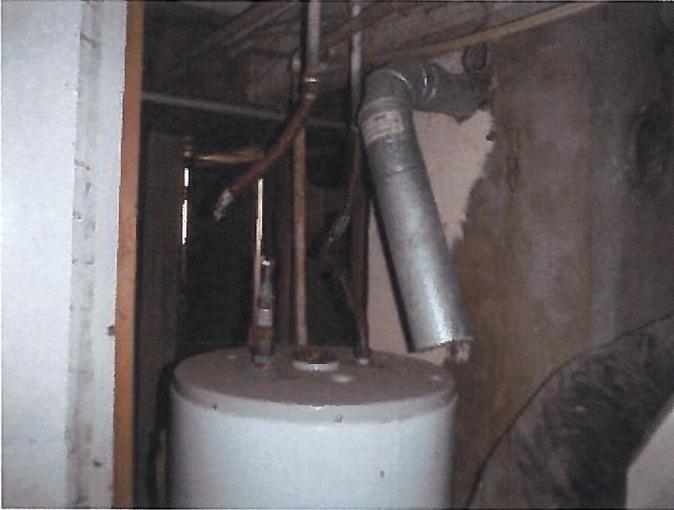
- Combustion air is adequate
- TPR valve installed on tank
- **Water heater had cut supply lines, gas line, and displaced flue pipe. Needs repair by a qualified plumber.**

Water heater flue is displaced from heater

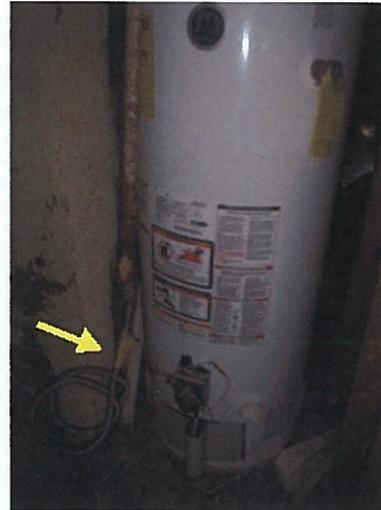
Gas line was cut/disconnected

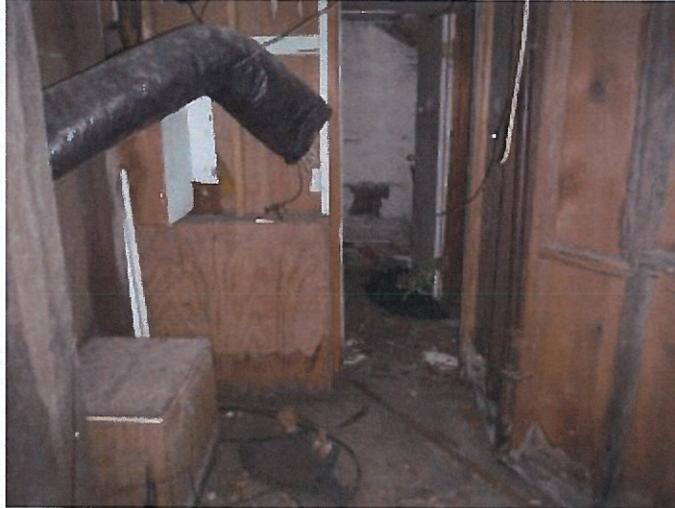
- **Furnace appears to have been stolen; missing at time of inspection. Needs complete replacement by an HVAC technician.**

Furnace appears to have been stolen; missing at time of inspection

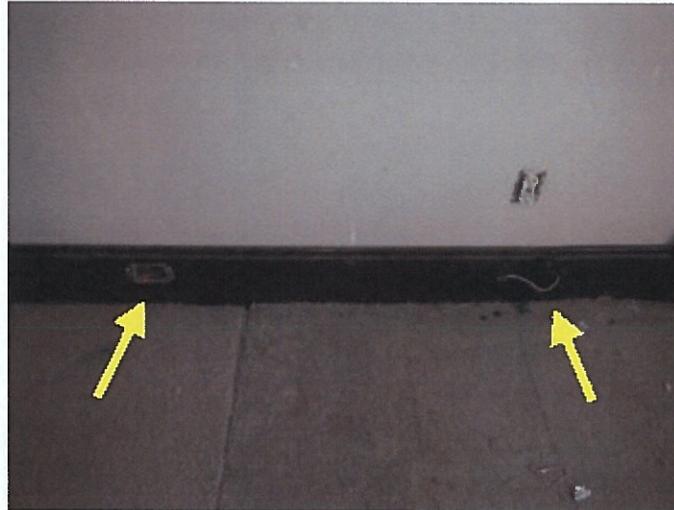
- No power; unable to test
- Baseboard heaters were missing in upstairs bedroom and bath.

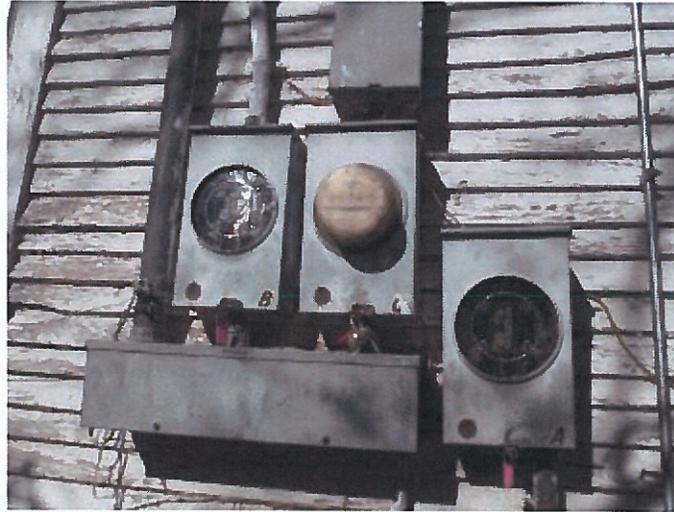
- Ground clamp/system not visible
- No electrical service was provided at time of inspection

Electric service was off at time of inspection

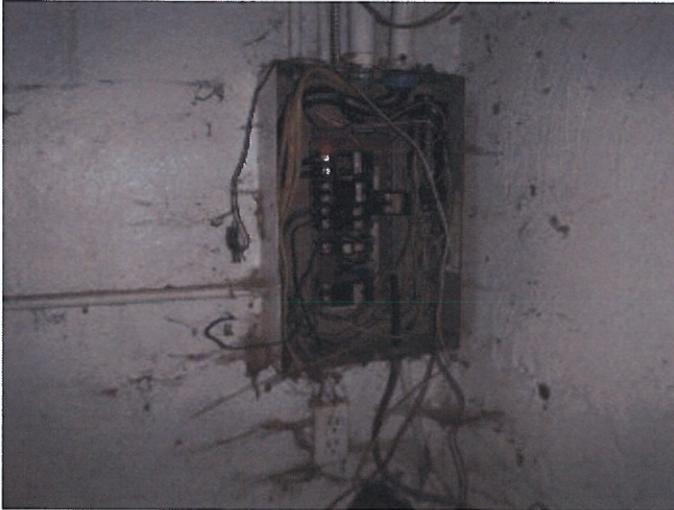
- Basement and upstairs panel covers were missing and exposed wiring is present; unsafe. Needs repair by an electrician.
- All three electrical panels appear improperly installed. All wires coming into the panels lack bushing/wire clamps installed and neutral and ground wires are improperly connected together.

Exposed wiring and missing cover at panel in basement

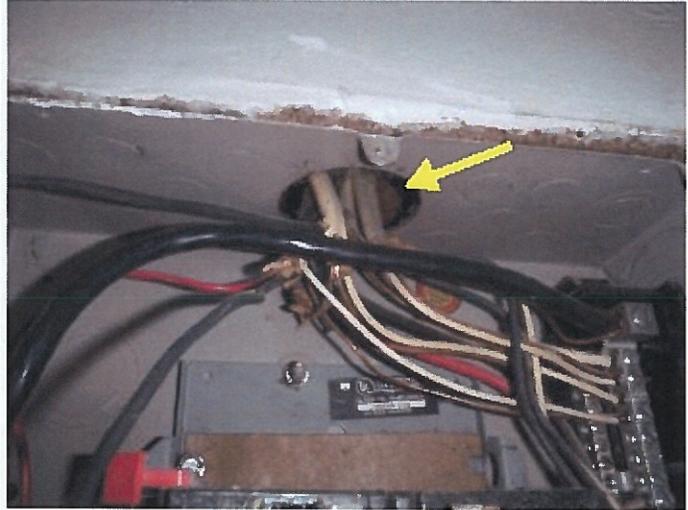
All wires enter upstairs panel without bushings/wire clamps

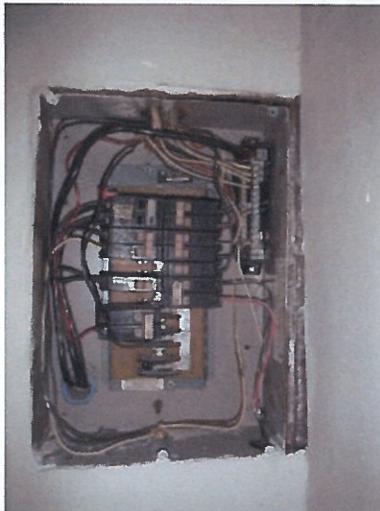
Upstairs panel cover was missing and all wires enter panel without bushings

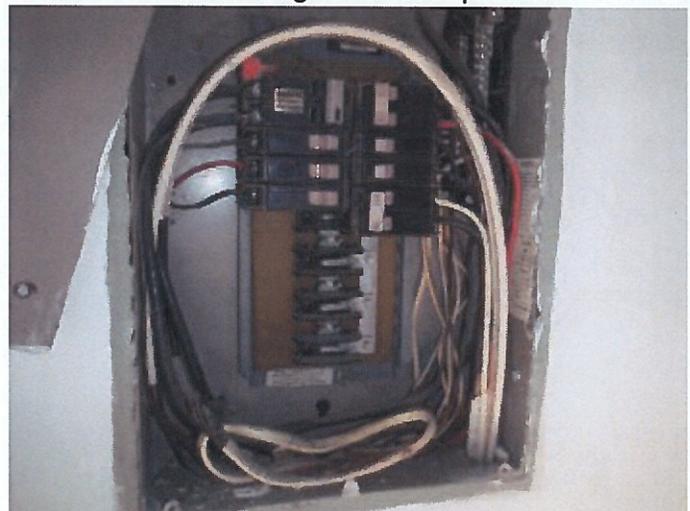
Improper wiring inside main level panel

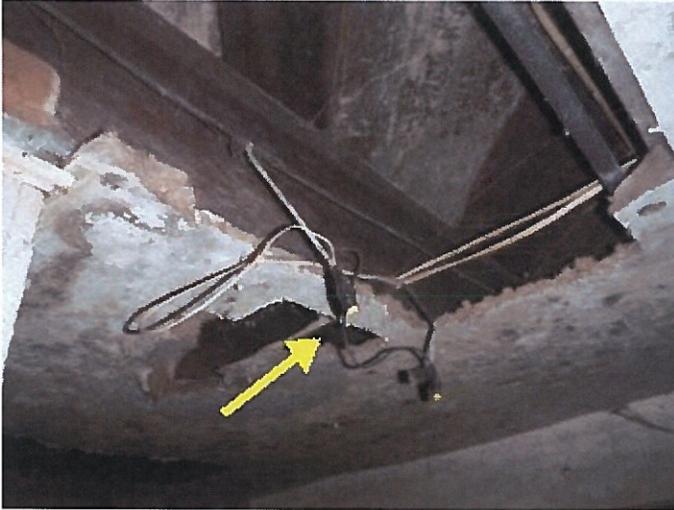
The House also contains active knob and tube wiring.<sup>22</sup> Knob and tube was an early method of electrical wiring in buildings in North America from about 1880 to the 1940s. It is an ungrounded system, which creates a risk of electrical shock or fire. Today, this system is considered obsolete and can be a safety hazard, especially when improper modifications are made to the wiring. Due to the risk of fire associated with knob and tube wiring, many insurance companies will not insure houses containing this type of wiring. To fully eliminate these dangers, all of the existing knob and tub wiring must be removed and new wiring installed.

- No electricity was provided at inspection; unable to test outlets/lights.
- Several improper and exposed wiring observed in all areas of home. Needs repair/protection by a qualified contractor.
- Several improper, open air splices in basement and attic need protection in junction boxes for safety.

Exposed knob and tube spliced wiring at middle east part of basement

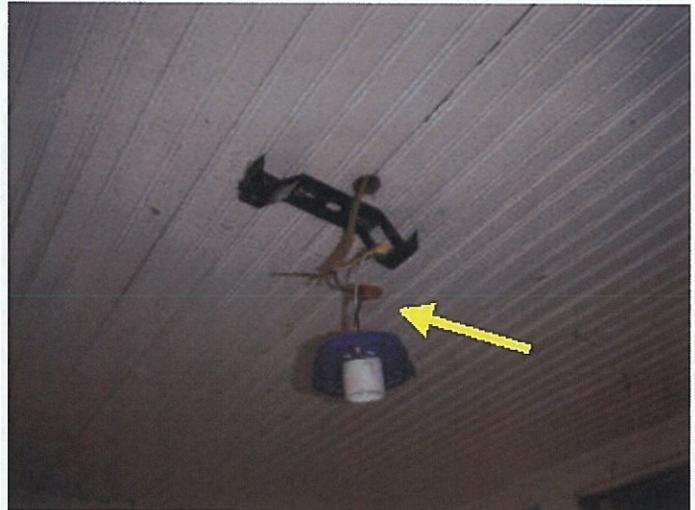
Improper fixture at rear main sunroom

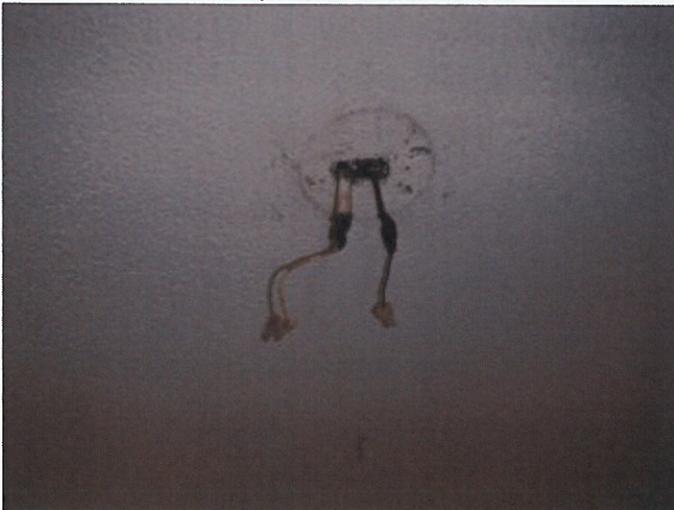
Exposed wiring from missing light fixtures at upstairs hallway/stairway

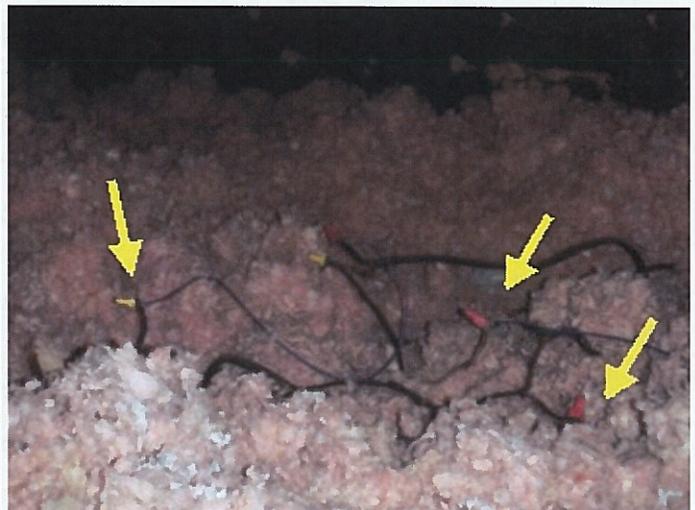
Improper exposed splices at middle west part of attic

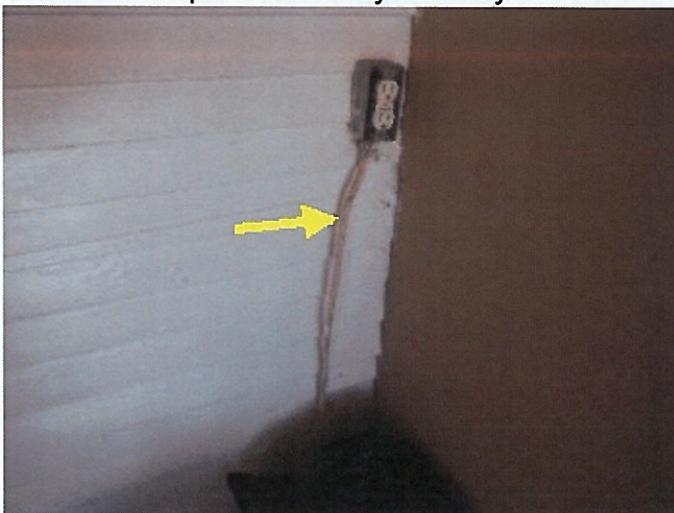
Exposed wiring and uncovered outlet at NW corner of upstairs sunroom

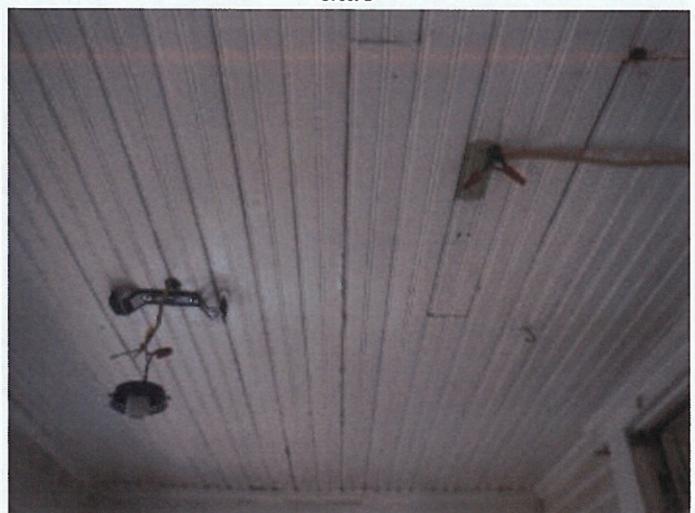
Exposed wiring at ceiling of main level sunroom

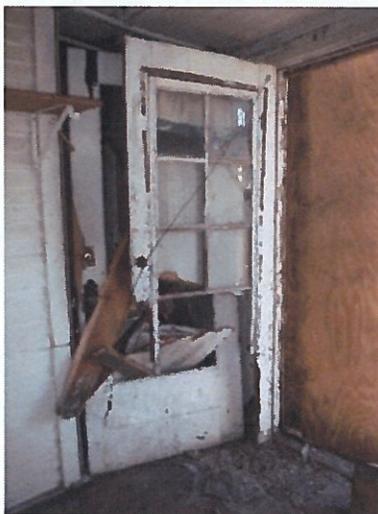
- Main level exterior door was damaged beyond repair. Needs replacement.

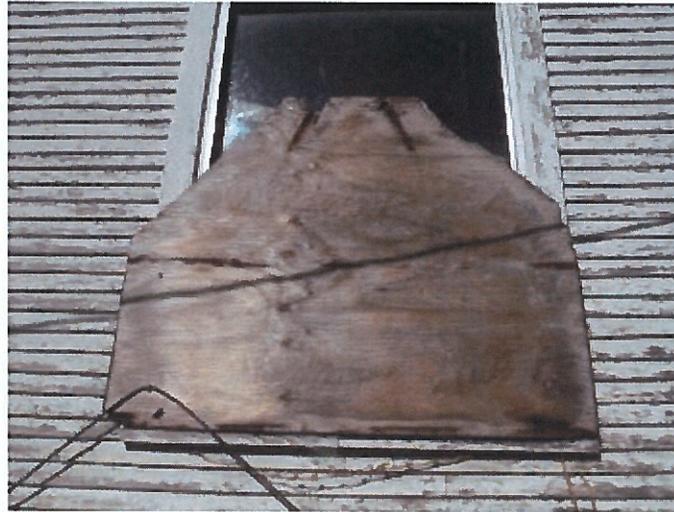
- Most every window is damaged and has broken glass. Needs repair/replacement.

Boarded up broken south living room window

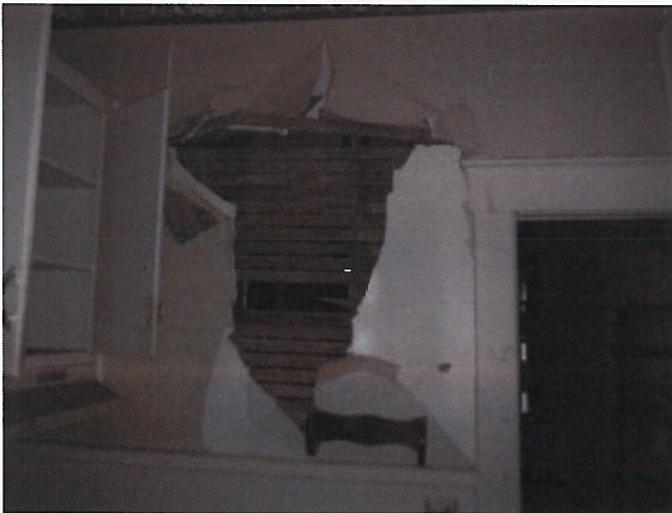
- Areas of missing plaster at wall between entry and main level kitchen.
- Water damage present from active roof leakage at south wall in SE mail level room. Needs repair.

Damaged wall between kitchen and entryway

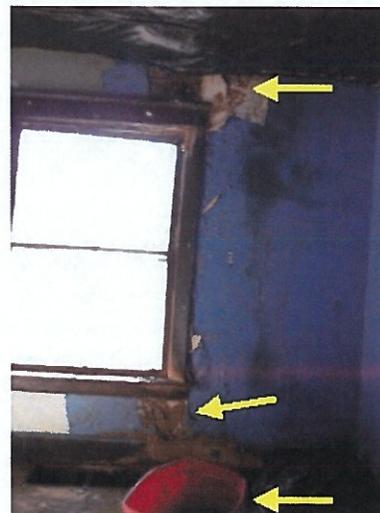
Water damaged wall from active roof leakage at SE main level bedroom

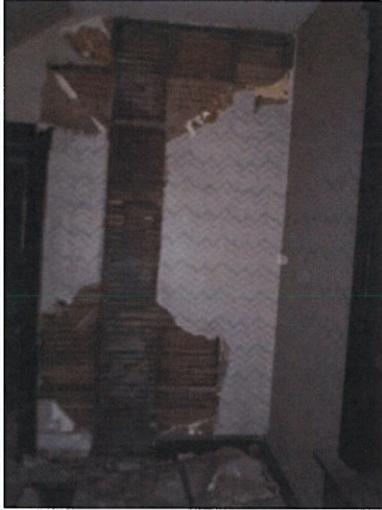
Damaged east wall in front entry

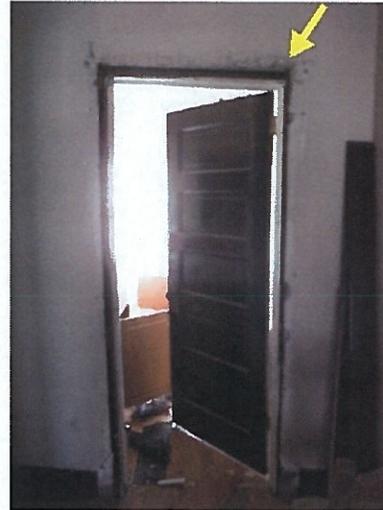
Door to the upstairs bathroom is out of plumb

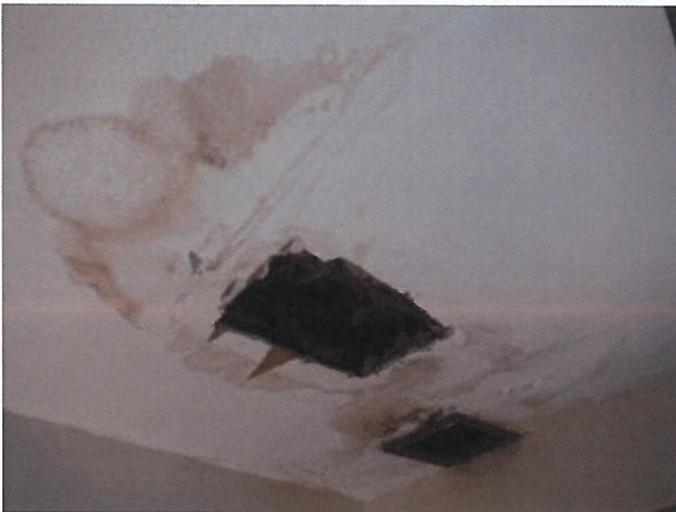
- The SE main level room is completely covered with plastic. Appears to be some type of containment from active roof leakage.
- Stains and signs of plumbing leakage at SE corner of SW main level room.
- Many areas of missing plastic from probable active roof leakage at east closets in upstairs room.

Stains and holes in ceiling in SW main level room

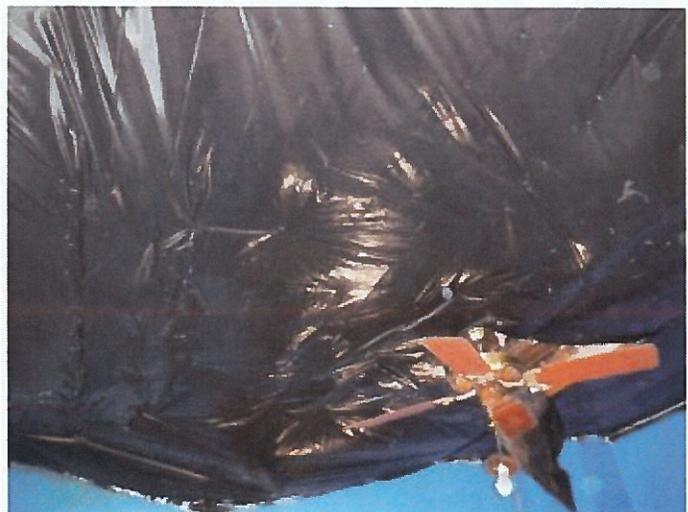
Ceiling in SE main level room is covered with plastic

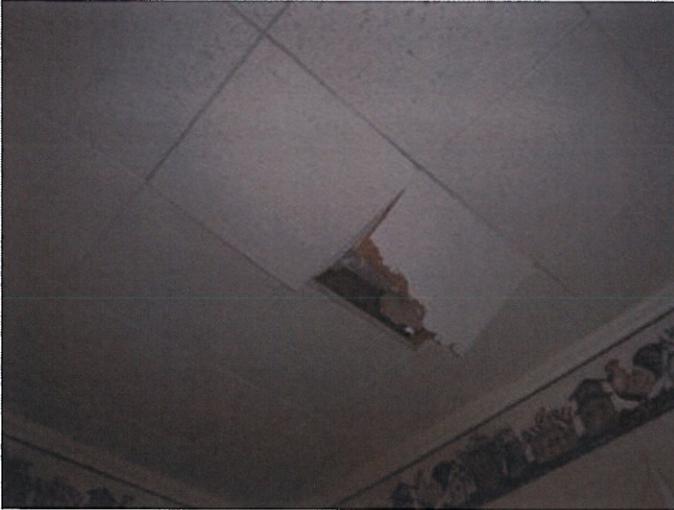
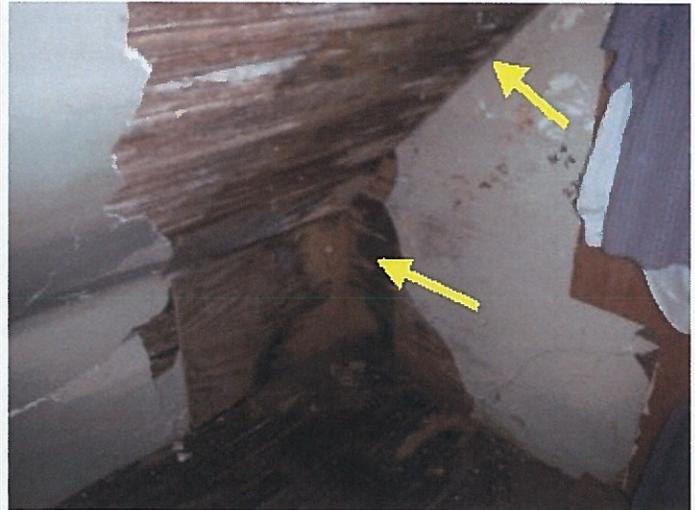
Damaged ceiling tiles at SW corner of main level kitchen    Damage from active leakage at SE upstairs closet

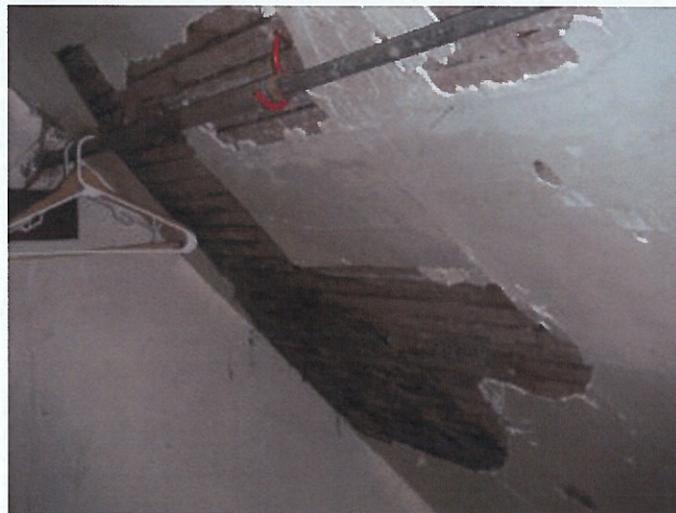
Damaged/missing plastic at upstairs SW closet

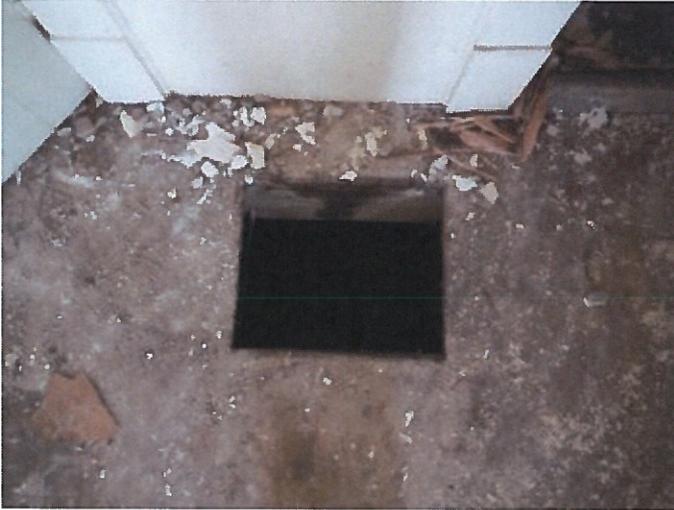
- Holes are present in many areas of flooring at main level and upstairs hallway. Needs repair for safety.

Several holes in main level flooring from lack of ductwork

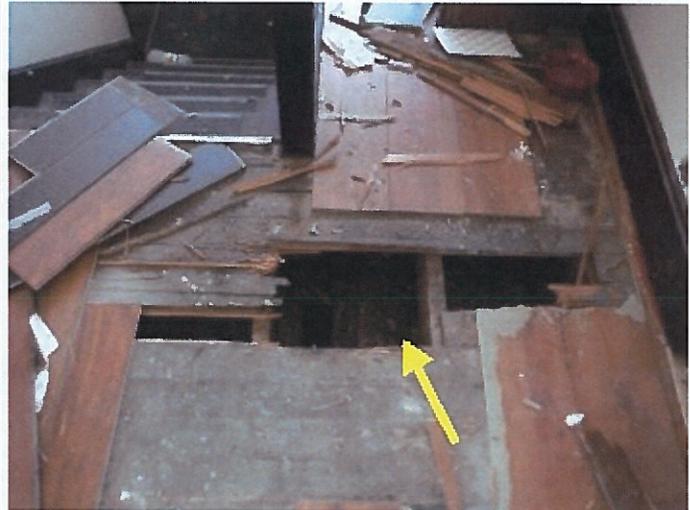
Holes in floor at upstairs hallway

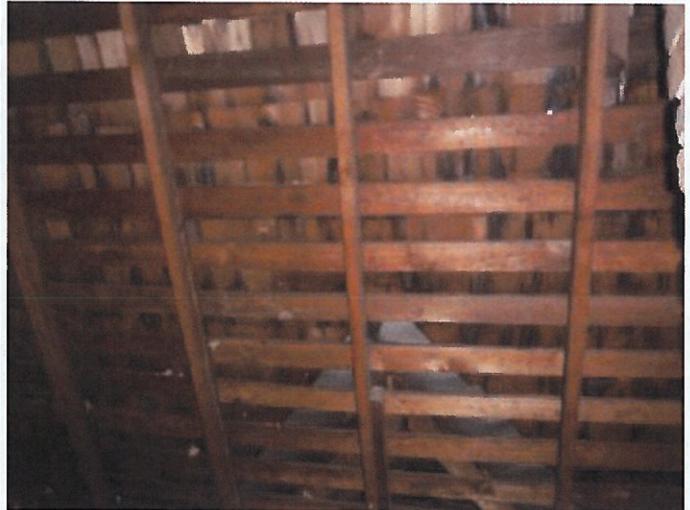
Original wood shingles are still present below two layers of comp shingles

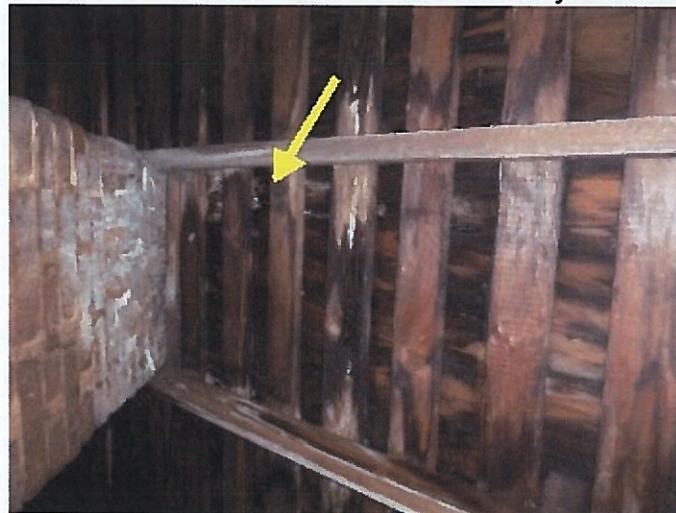
Moisture stains below chimney indicating past leakage

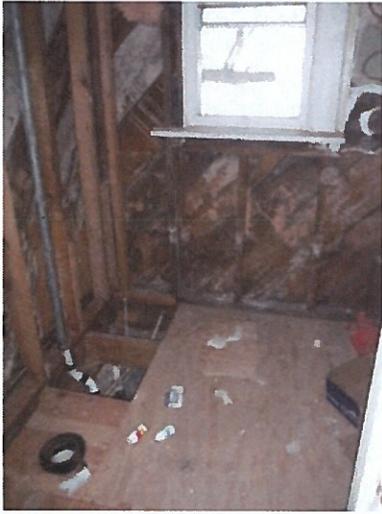
Main level NE bathroom appeared to be a work in progress

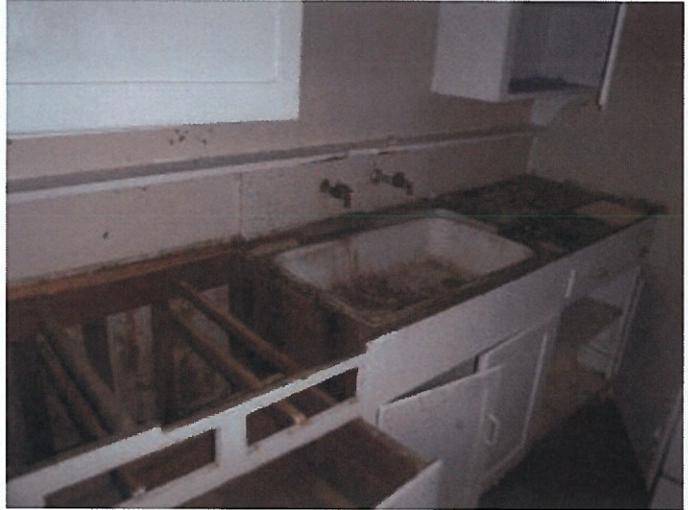
Upstairs kitchen has no countertop and is in poor condition
