Springfield Land Clearance for Redevelopment Authority

4.I. **Blight Report And Redevelopment Plan For The East Cherry Townhomes Redevelopment Area, Generally Located At 1361 And 1365 East Cherry Street; Say You Can, LLC, Applicant**

Report Summary of Defects

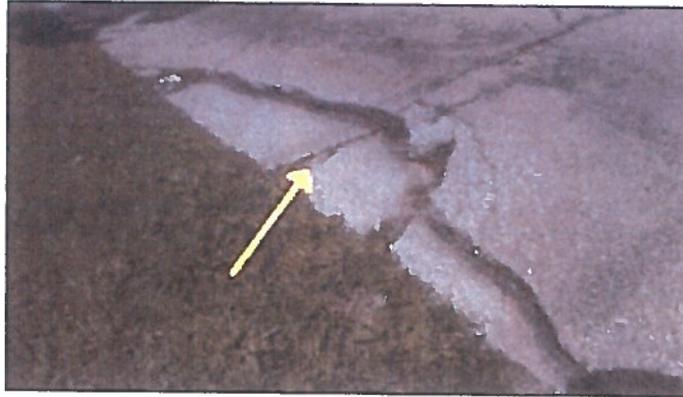
- Major cracks and displacement noted with potential trip hazard; needs repair/replacement.
- Drive is near end of its lifespan.

Drive deteriorated

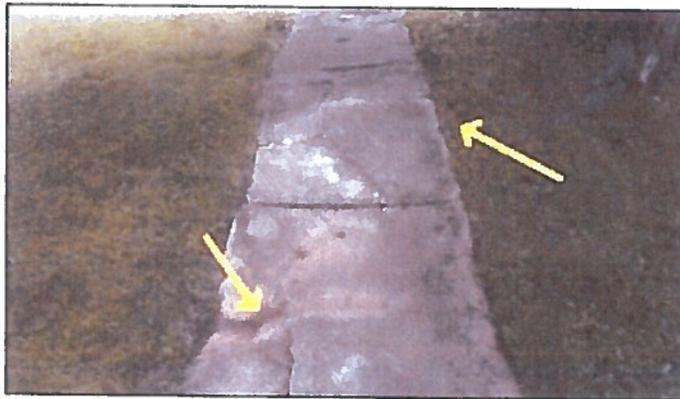
Observations: Major cracks and displacement noted with potential trip hazard; needs repair/replacement.

Sidewalk damaged

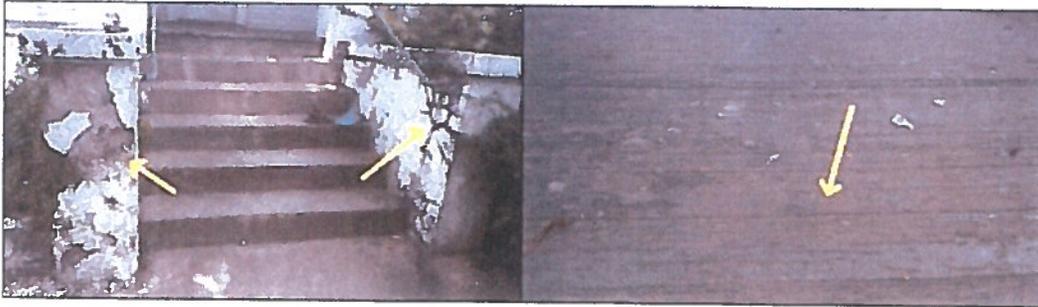
- Concrete walls at front steps are damaged and deteriorating; need full evaluation and repair.
- Not fully visible
- Railing too low at porch (relative to home's age).
- Porch is due to be sealed/painted.
- Footings not visible.
- Porch is not bolted to house (Nailed/screwed); Recommend correction.

Damaged walls

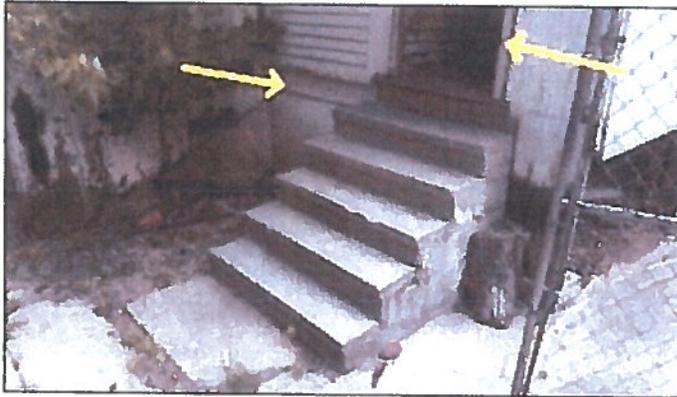
- Handrail needed at front sidewalk and back steps for safety.
- Cracks and deterioration noted

Handrail needed at back steps

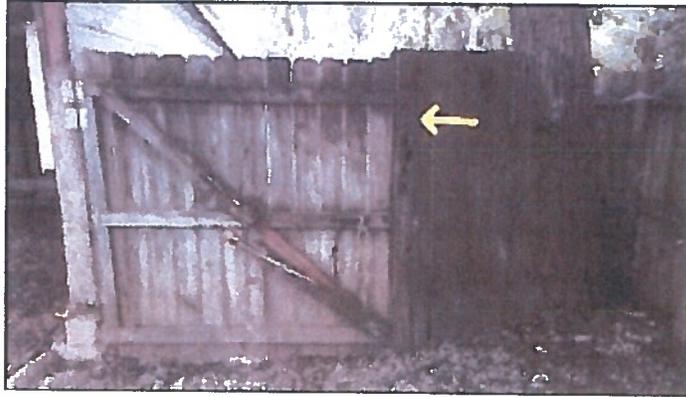
- Noted a couple of cracked/damaged fence pickets.
- Some weathering of wood fence observed.
- Back gate will not close/latch. Needs adjustment/repair.
- Loose/rotted posts observed.
- Nearing end of lifespan
- Not fully visible due to plants.
- Sections of the fence are leaning.

Sagging back gate

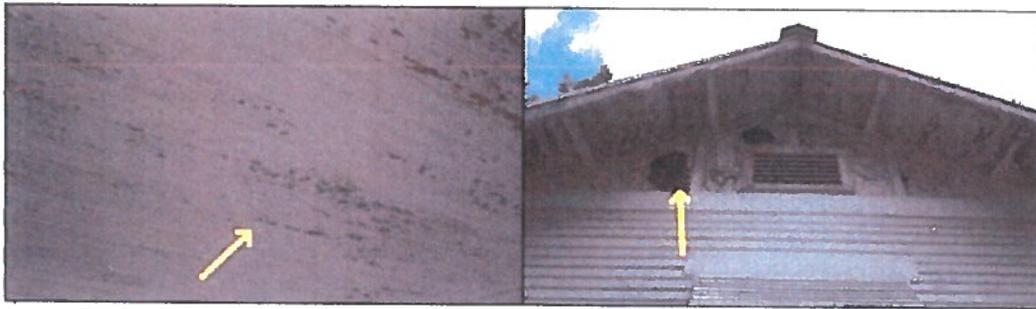
- Observed flaking paint/deterioration on trim, eaves and fascia; needs repair/repainting.
- Damaged asphalt/tar paper noted at gables.

Flaking paint at ceiling of front porch

Holes in asphalt paper on West gable

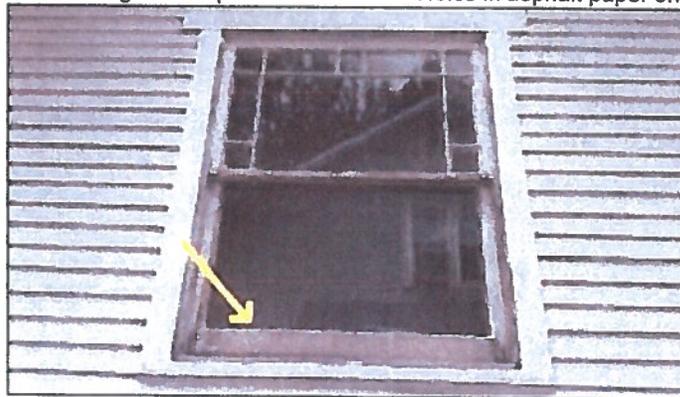
Worn paint

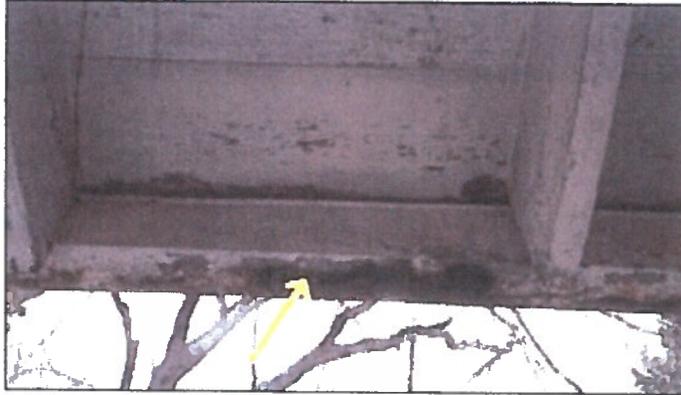
- Guttering is damaged and at the end of it's normal life; needs replacement.

Gutters rusted through

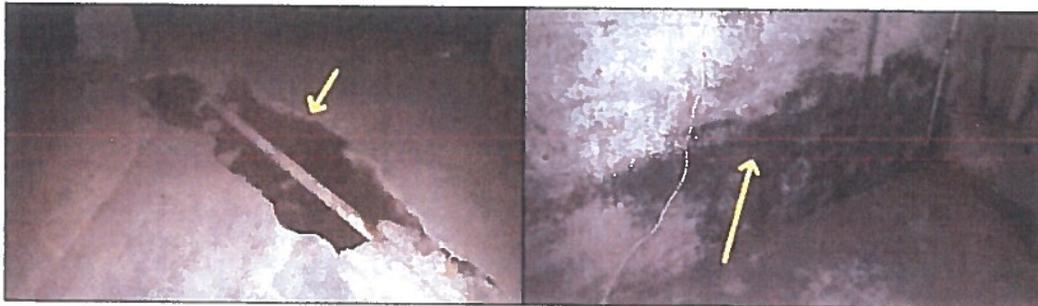
- Common shrinkage cracks observed in foundation stem walls.
- Observed past repair in NE corner.
- Hole in floor needs repair.
- Evidence of past/present water in basement; recommend full evaluation/repair by qualified foundation contractor.

Large hole in concrete floor

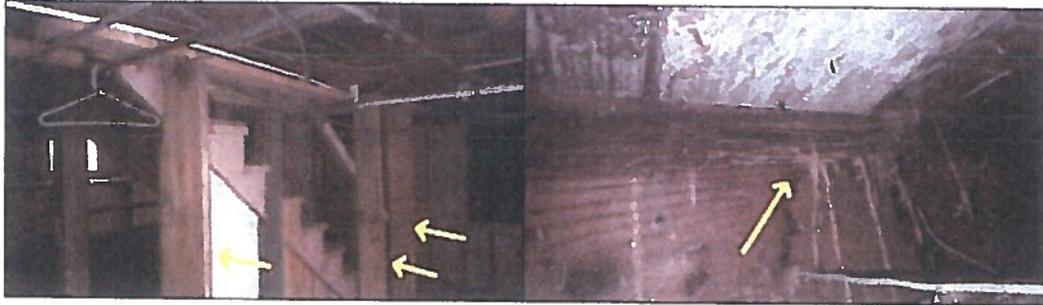
- Anchor bolts were not found.
- Added support noted.
- Moisture stains noted on floor structure below bathroom and utility areas.
- Floor and interior basement stairway poorly supported; needs evaluation/repair by qualified contractor.

Floor and interior basement stairway poorly supported

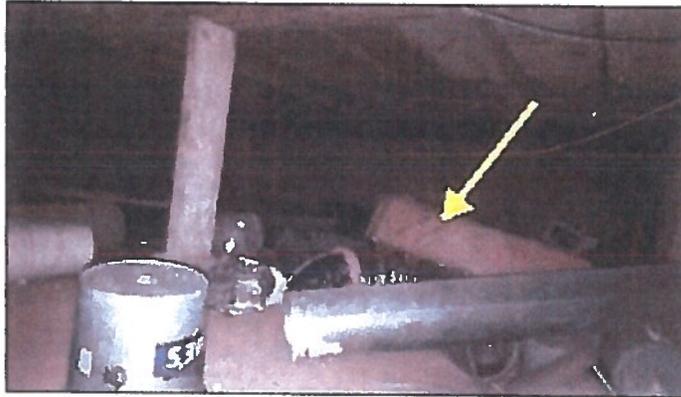
- Crawl space was dry today.
- Observed signs of past moisture along foundation walls.
- Recommend installing a plastic vapor barrier on the ground to prevent moisture from causing abnormal conditions in the future.
- Better control of roof water should help prevent problems in the future.
- Some scrap wood and construction debris needs to be removed from the crawl space.

Construction debris in crawlspace

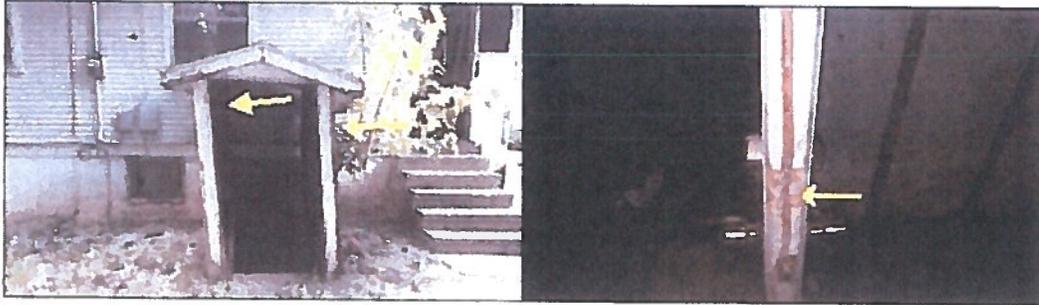
- Basement exterior stairway walls and roof are damaged and leaning; need replacement by qualified contractor.
- Exterior basement door has been damaged and does not close; needs repair.

Stairway covering damaged and leaning

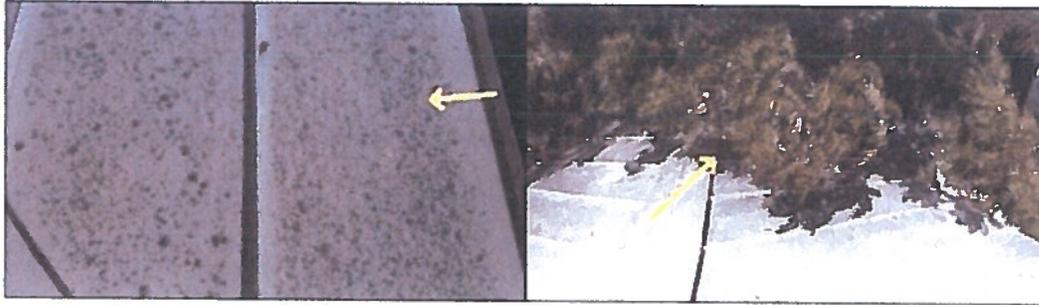
- Appears to be in good condition.
- Observations:
- Trees need to be trimmed away from roof to prevent damage.
 - Regular maintenance and inspection advised.
 - Observed weathering and moss.

Moss

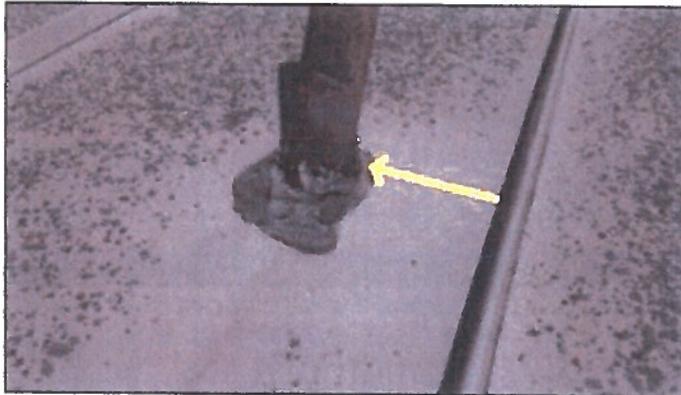
- Heavy sealant/repair observed at chimney flashing, around all roof vents, and flue pipes.
- Signs of past hail noted at metal flue cap(s).
- Sealant needed around kitchen plumbing vent flashing.

Kitchen plumbing vent

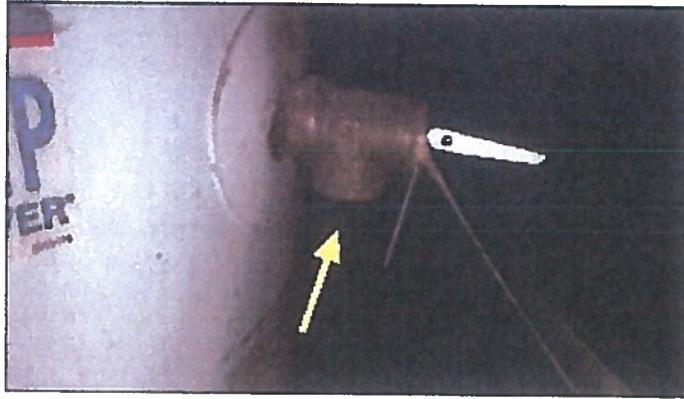
- Combustion air is available
- Vent flue piping is not fully visible
- Shut off valve is missing on the cold water supply above the heater; recommended.
- Heater is at/near the end of its normal life; may need replacing at any time.
- Stains noted around water heater.
- Utilities off, unable to test.
- TPR pipe is missing from valve; needs correction.

TPR pipe is missing from valve.

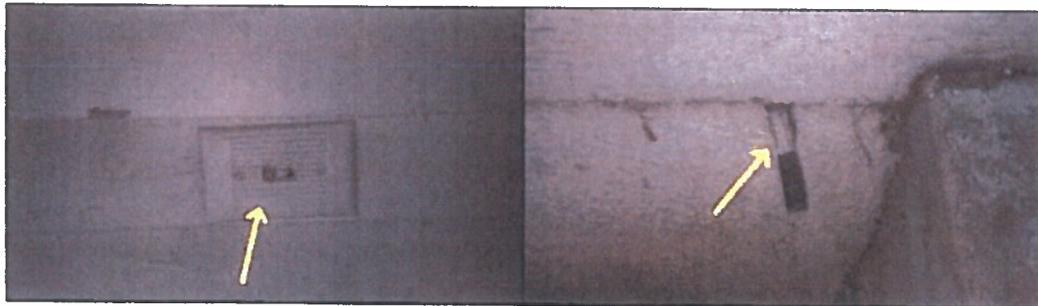
- No exterior receptacles were found • Utilities off, unable to test
- Exposed wire noted near back porch; needs to be removed or properly terminated.

Broken switch at back porch

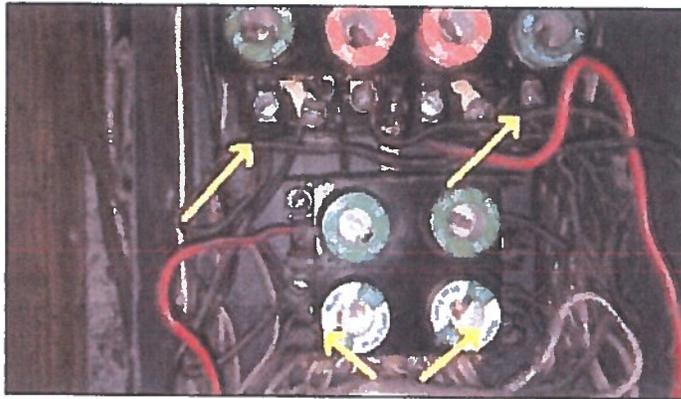
- Electrical system appears outdated by today's standards
- Labels missing
- No space remains in panel for additional circuits.
- Panel covers have been removed; need replacement.
- Double tapped fuses observed - Need repair by qualified electrician.
- Several 20 amp fuses appear to have been replaced with 30 amp; needs evaluation/repair by qualified electrician.

Double tapped fuses

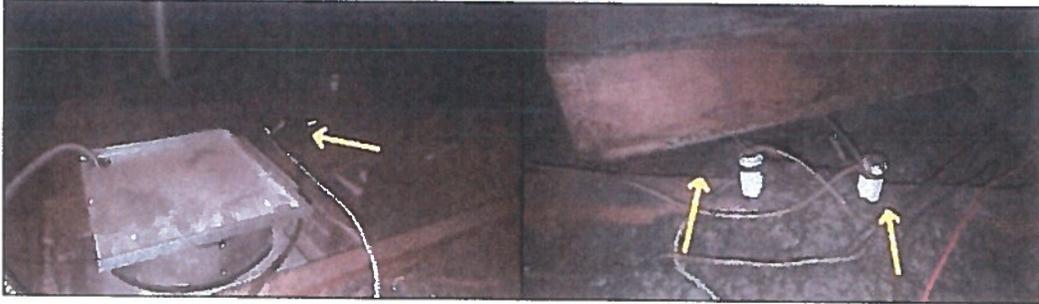
- Doorbell button damaged; needs repair.
- GFCI protection recommended for kitchen and bathrooms
- Missing globes noted and cover plates noted.
- Utilities off, unable to test.
- Exposed splices in attic need to be put in proper junction boxes
- Exposed splices in basement need to be put in proper junction boxes.

Exposed splice near access

Knob and tube wiring noted

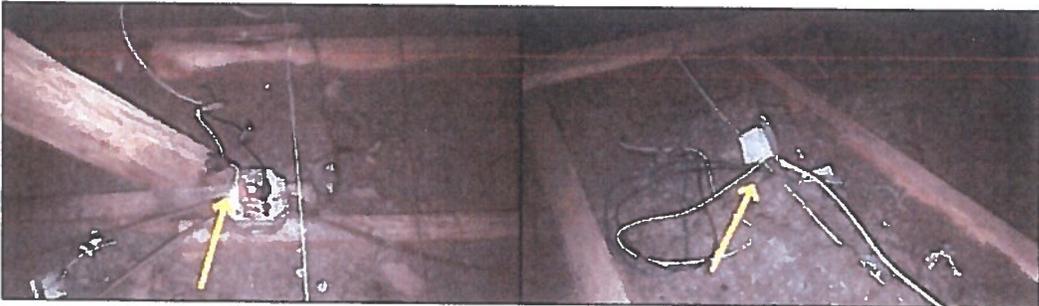
Exposed splice in center of attic

Improper and exposed splice above entry

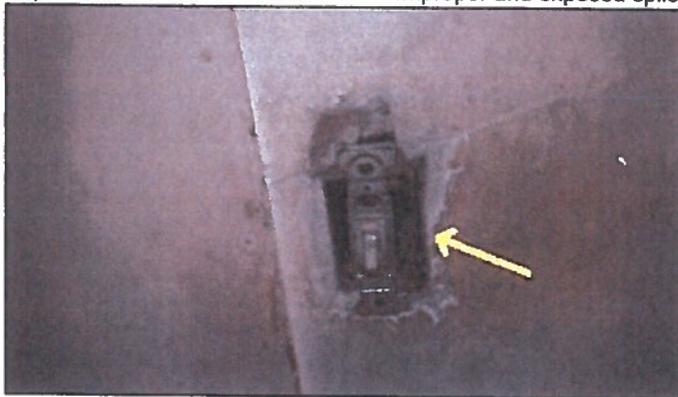
Outlets and switches missing plates in various locations.

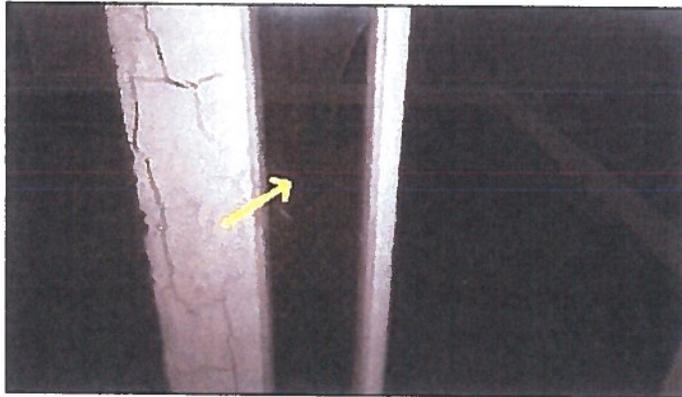
- Several doors do not close properly and have loose hardware; need repair.
- Broken glass observed in living room doors; need repair or replacement.

Broken glass in main living area doors.

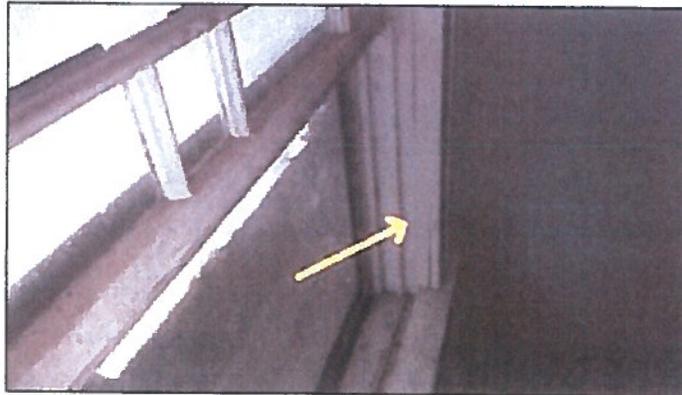
- Appears serviceable
- Back door is in poor condition.

Lower dining room window is missing

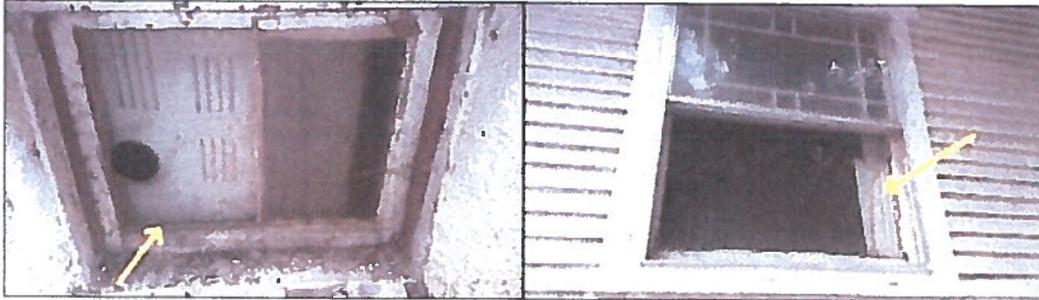
Missing window on back wall of basement

North window on East side is broken

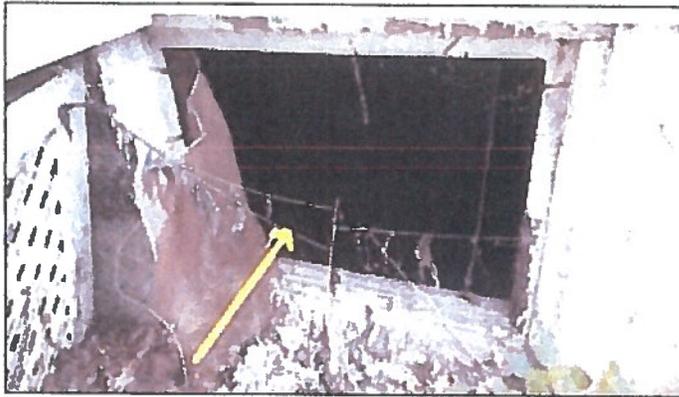
Missing basement window bear back porch.

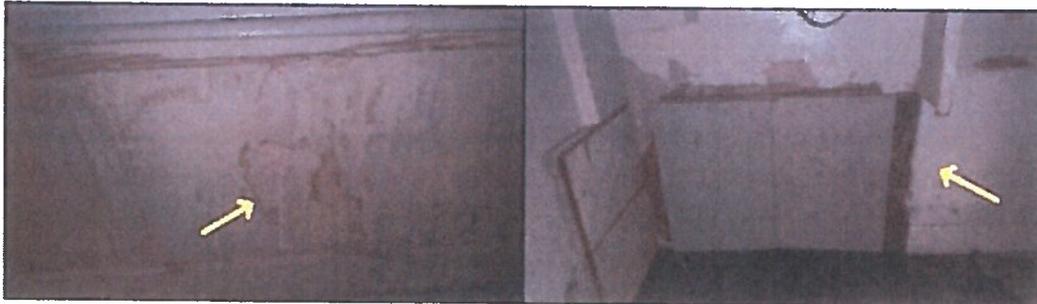
- Walls are in poor condition; need full evaluation, touch up and repair.

Moisture stains and cracks

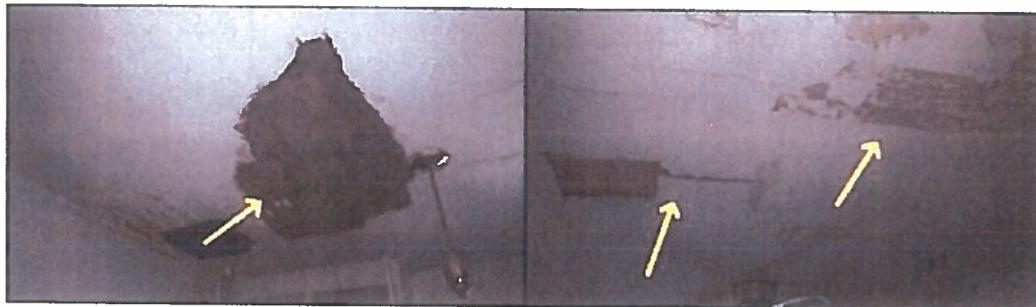
- Common cracks
- Some sagging and damaged areas noted; needs full evaluation and repair by qualified contractor.

Dining room ceiling

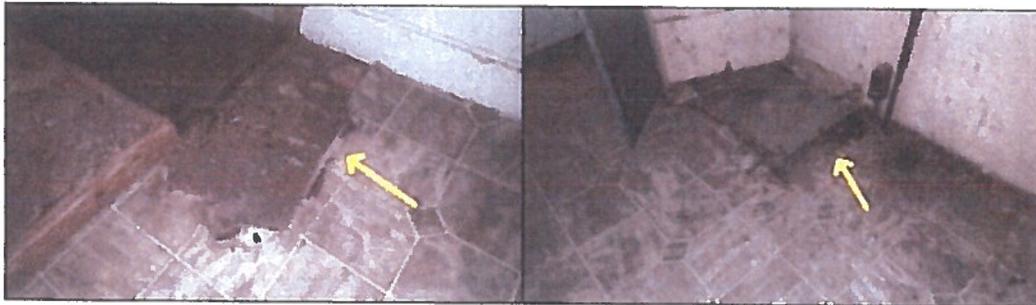
- Uneven areas in the floor noted.
- Stained/damaged flooring observed in various areas.
- Wood flooring is due to be refinished.

Dining room floor

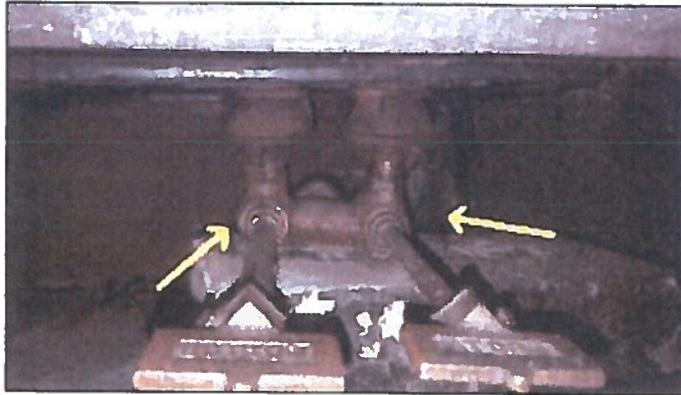
- Gas logs lack pilot and modern safety features; need to be replaced.

Direct gas valves without pilot or automatic shut off.

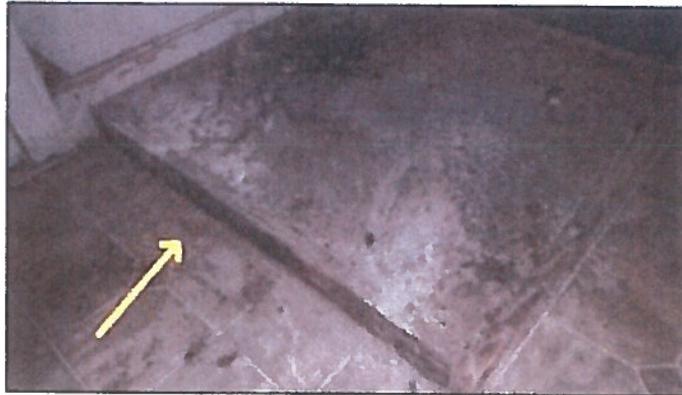
- Hearth and woodstove flue pipe noted in dining room; recommend removal.

Stone/concrete hearth in dining room

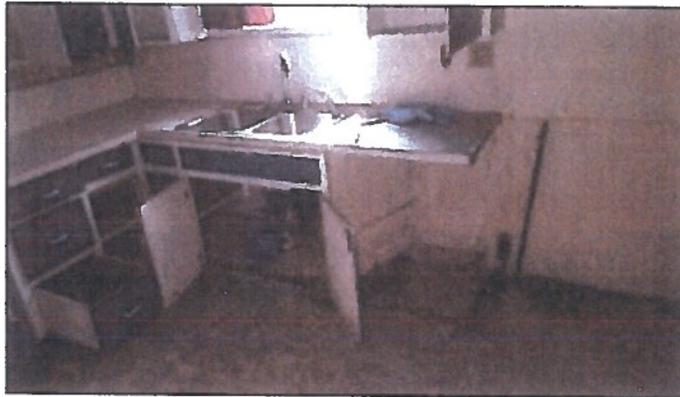
- General condition is poor.

Kitchen is in poor condition overall.

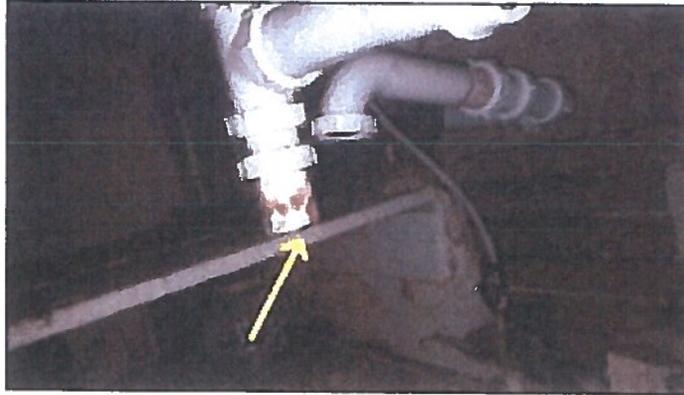
- Moisture stains/damage below sink
- Plumbing disconnected below sink.

Trap has been removed

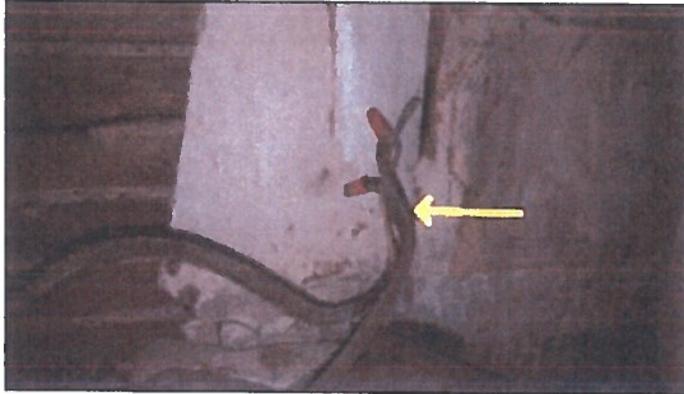
- Near end of lifespan
- Improper wiring noted; splice needs to be put in junction box.

Exposed splice

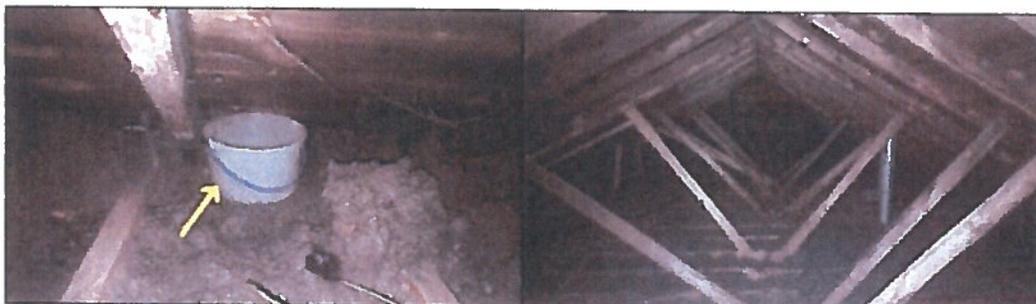
- Entered
- Vents provided
- Roof structure has solid 1x decking.
- Moisture stains observed on roof structure in various locations indicating past leaks (Dry today).
- Access too small, needs correction.

Bucket indicating past leak

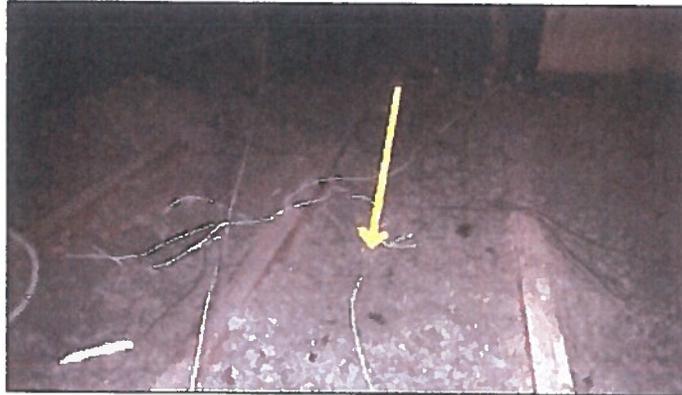
- Attic is poorly insulated; all joists are visible. Recommend adding insulation for energy efficiency.

Attic poorly insulated

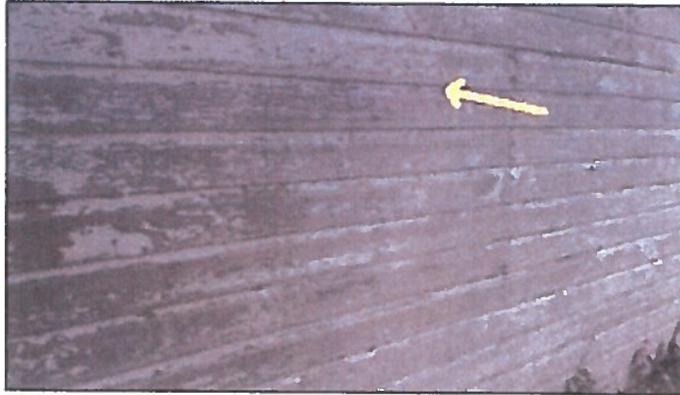
- Not fully visible
- Moisture damage noted; Minor repair needed in various areas.
- Wood to earth contact observed; may provided direct access for termites.

Worn paint on exterior

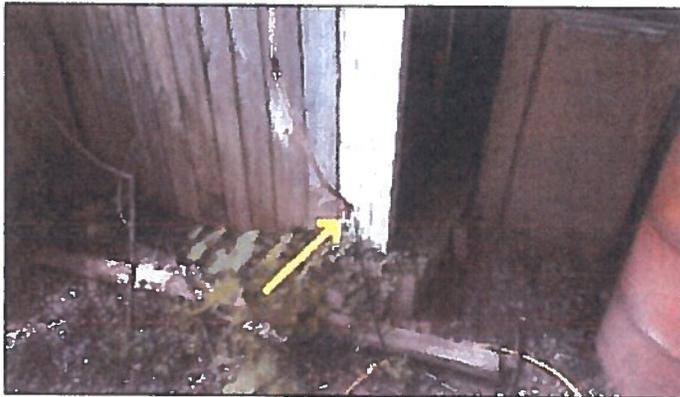
- GFCI protection recommended for garage circuit
- Improper wiring
- Garage electrical is connected to a damaged power cord; needs to be removed or properly wired by a licensed electrician.

Cord with exposed splice powers garage

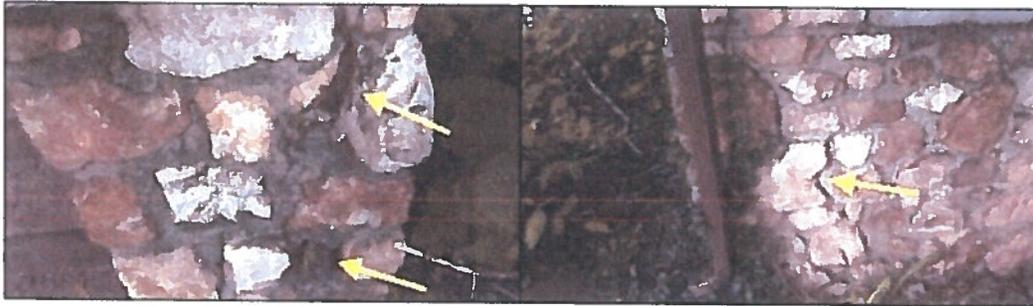
- Stone and mortar missing in various locations; needs full evaluation and repair by qualified mason.
- Common cracks
- Railing too low at porch (relative to home's age).
- Areas of spalling/deterioration observed.
- Flaking paint noted on concrete and wood surfaces.

Stone missing at front steps

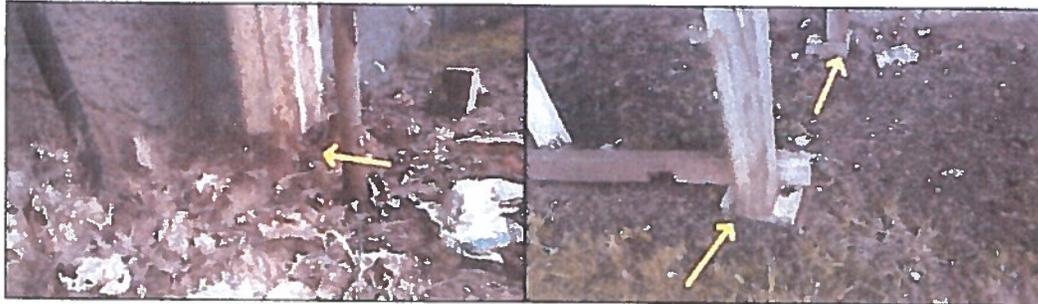
- Steps and handrail are in poor condition; need replacement.
- Handrail recommended at front and NW steps for safety.
- Footings are improper/temporary - Recommend correction with proper poured footing.
- Signs of settlement and loose footing observed; steps/deck to unit 3 need full evaluation and repair by qualified contractor.
- Glass at level of steps up to unit 3; needs to be protected by rail and spindles for safety.

Missing footing below stairway - Unit 3

Improper/temporary footing

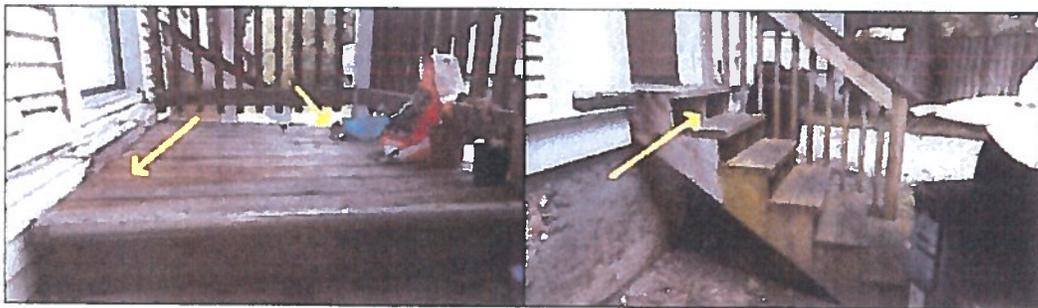
Landing has settled - Unit 3

Handrail missing at back steps

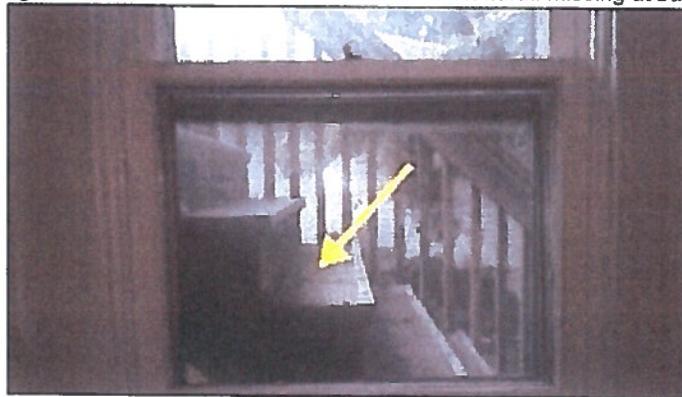
Glass level with steps

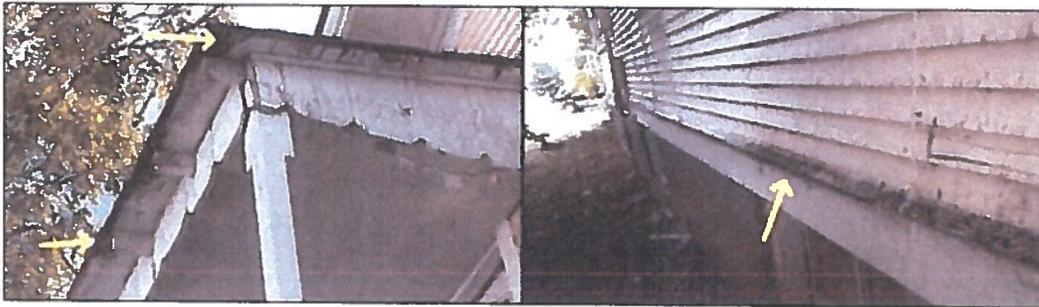
- Observed flaking/worn paint on wood trim; needs to be sealed/painted to prevent further deterioration.
- Eave damage noted, partially above door to unit three.

Deterioration above door to unit three

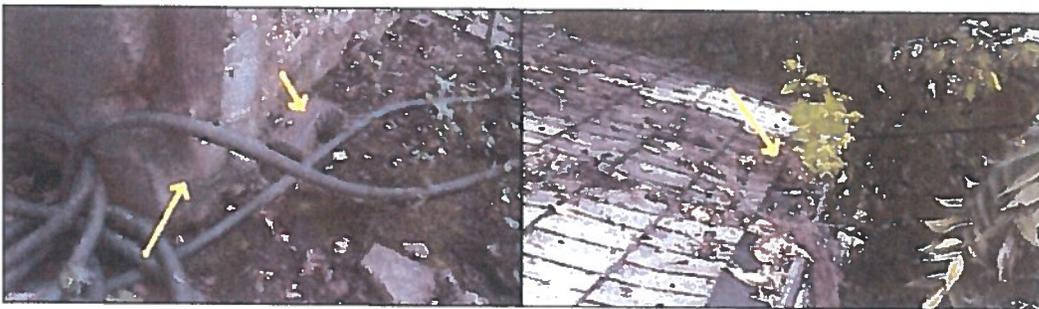
- Sections of gutter guards are missing, gutters are filled with debris and need cleaning for proper drainage.
- Downspout are nearing the end of normal life, consider replacement.
- Damaged/missing downspout elbow noted at NE corner.

Missing downspout elbow

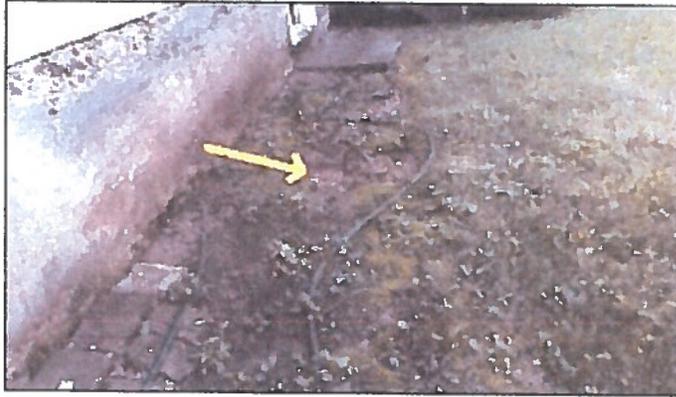
- Extend downspouts for improved drainage and control of roof water.
- Recommend adding soil around foundation to improve drainage.
- Some erosion noted from water running over the guttering.

Erosion from overflowing gutter at back of home

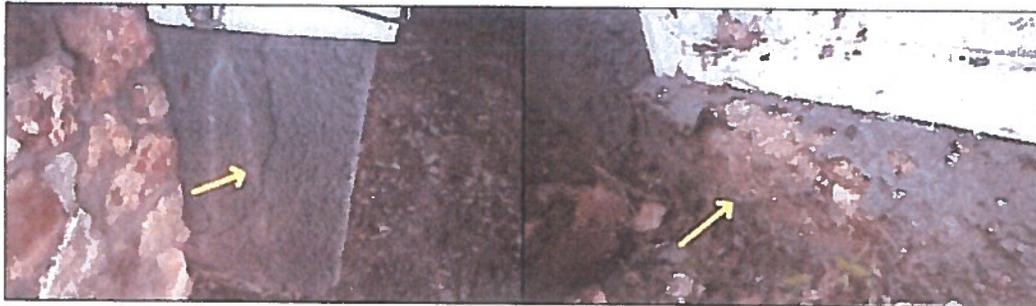
- Trees planted close to structure, not recommended as roots may cause damage to foundation.
- Evidence of past/present water in basement; recommend full evaluation/repair by qualified foundation contractor.
- Typical cracks in basement floor slab.
- Cracks, deterioration and minor displacement noted on the foundation walls; recommend evaluation, sealing and parging by a qualified foundation contractor.

Crack at SE corner (1/2" displacement)

Deterioration on foundation walls, west side pictured.

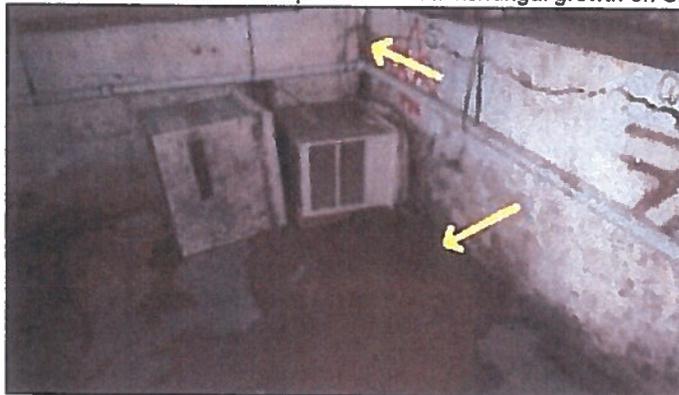
Signs of moisture penetration at NE corner (below downspout)

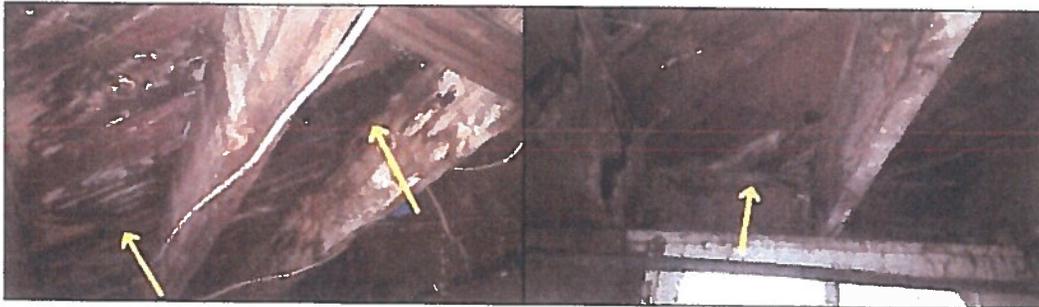
- Anchor bolts were not found.
- Wood to earth contact noted near electrical panel; recommend correction. (Prone to deterioration and may attract termites.)
- Moisture stains/damage noted on floor structure in various locations.
- Some spotty mold growth was observed on the floor structure in a few areas particularly in the Western portion; needs full evaluation and cleaning/removal by a qualified mold contractor.

Fungal growth and damaged subfloor in NW portion of basement

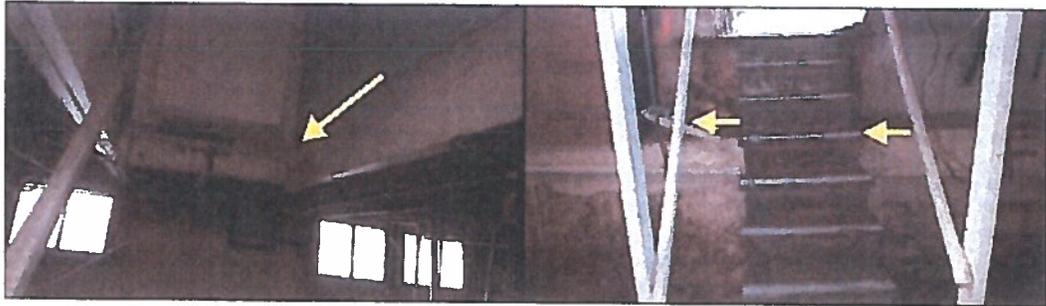
- Lock is broken on door to basement stairway.
- Ceiling height is too low on steps to the basement.
- Stairway is not full width, does not reach handrail and step rise is higher than recommended. Stairway needs full evaluation and repair by qualified contractor.

Interior stairway has been removed and door locked with deadbolt

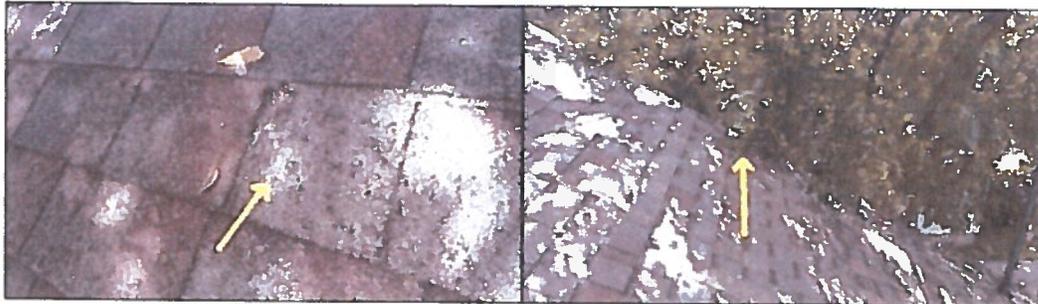
- Waves noted in roof structure
- Trees need to be trimmed away from roof to prevent damage.
- General condition favorable, with signs of weathering and aging; regular maintenance and inspection advised.
- Observed blistering/granular loss.
- Observed weathering and moss on north side and in shaded areas.
- Observed slight signs of past hail.

Moss below trees

Trees touch roof

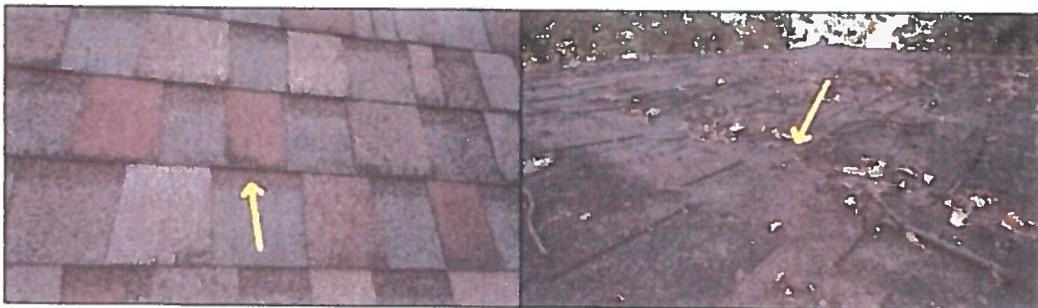
Granular loss and wear

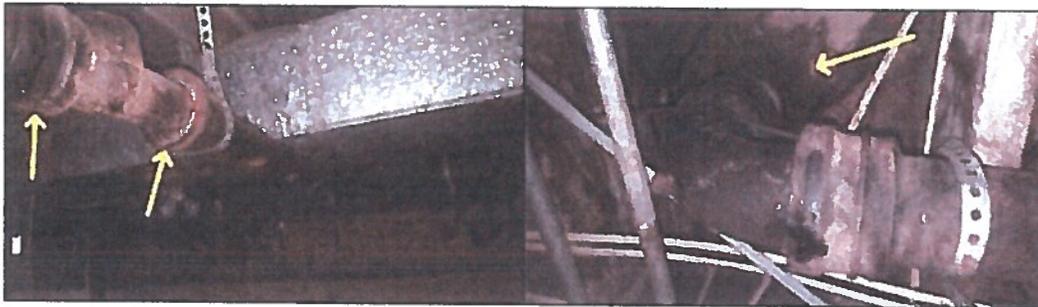
- Not fully visible
- Notice: City sewer service and all underground pipes are not a part of this inspection. Future drainage performance cannot be determined.
- Main sewer clean out located at back of home
- Several leaks noted on waste lines south of the furnace in the basement; needs full evaluation and repair by qualified plumber.

Several unions leak in basement.

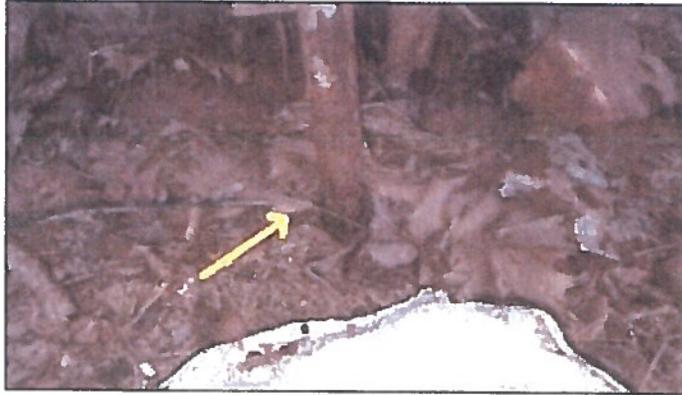
- Near end of lifespan
- Heavy rust/corrosion noted at gas main; needs evaluation/repair.

Heavily deteriorated main gas line

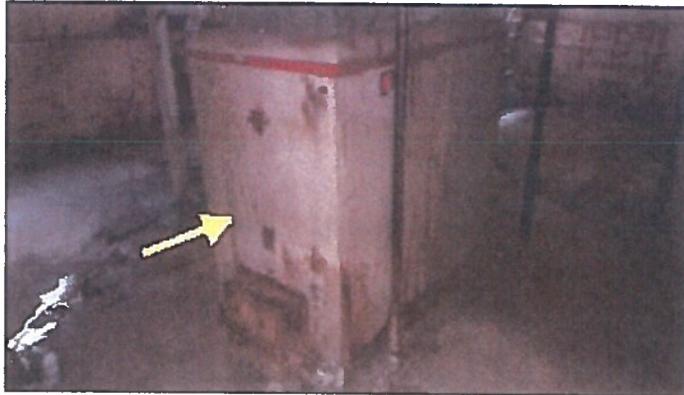
- Observations:
- Unit operated normally today.
 - Noted stains and rust, particularly at lower edge.
 - Dusty inside unit; recommend servicing.
 - Furnace is the original unit and well beyond its normal life, may need replacement. Recommend full evaluation by qualified HVAC technician.

Furnace beyond its normal life.

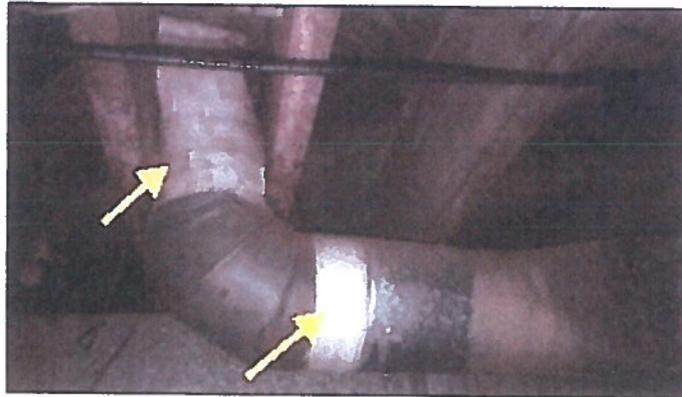
- Recommend ductwork cleaning by a qualified contractor.
- Not fully visible
- Noted tape that likely contains asbestos on outside of ductwork; recommend evaluation by certified asbestos contractor.

Tape on ductwork likely contains asbestos

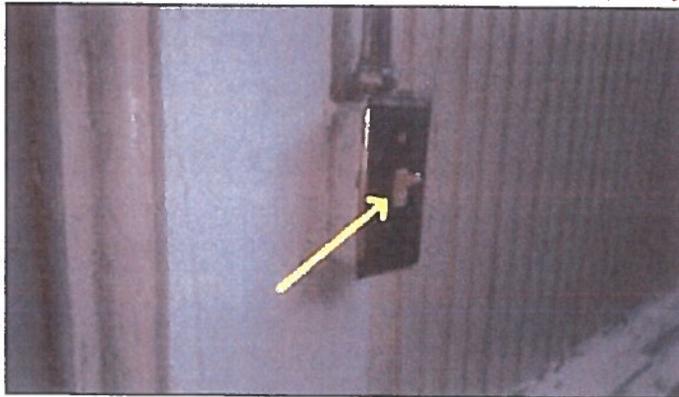
- GFCI protection recommended for exterior outlet
- Several lights did not turn on today (Bulbs or daylight sensor?)
- Indoor type switch installed on NW corner; needs replacement with water proof type.

Improper switch

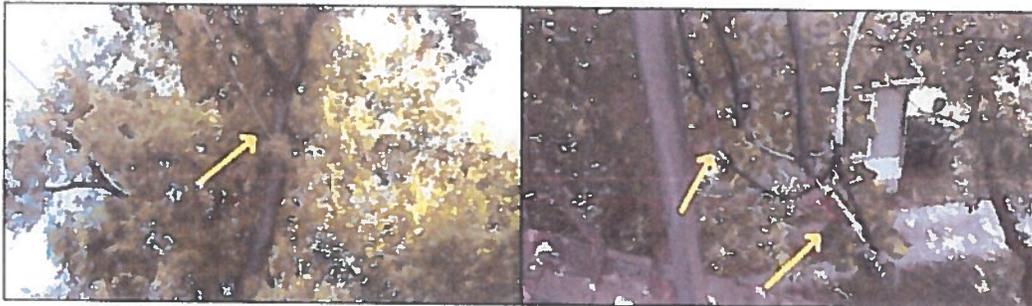
The wiring of the Houses also exhibit unsafe conditions. In particular, in the 1361 House, improper wiring is noted²³ and in the 1365 House, trees touch wires²⁴ – both of which are fire hazards.

- Ground clamp/system not visible
- Trees touch wires; recommend contacting utility company.
- Wires: Exposed connections noted; recommend correction by utility company.

Trees touch wires

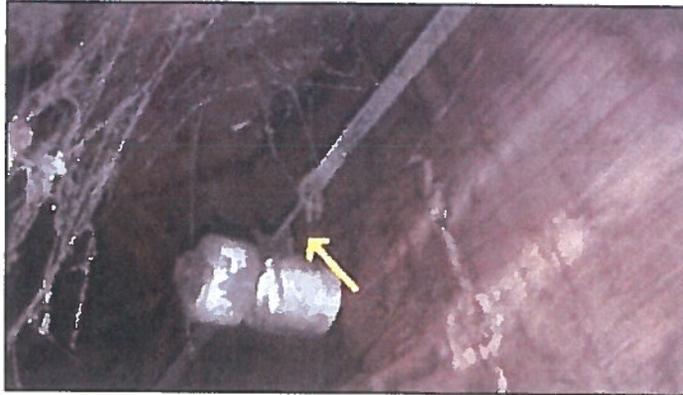
- Deteriorated knob and tube wiring observed in several areas - Recommend evaluation/removal by qualified electrician.

Knob and tube wiring with deteriorated insulator in SE portion of basement.

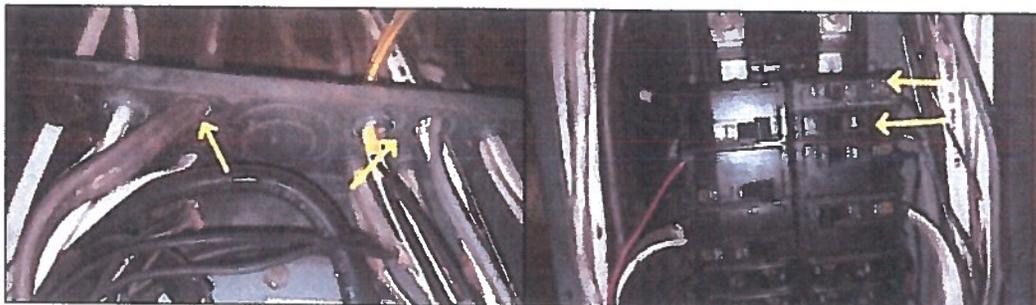
Missing protective clamps

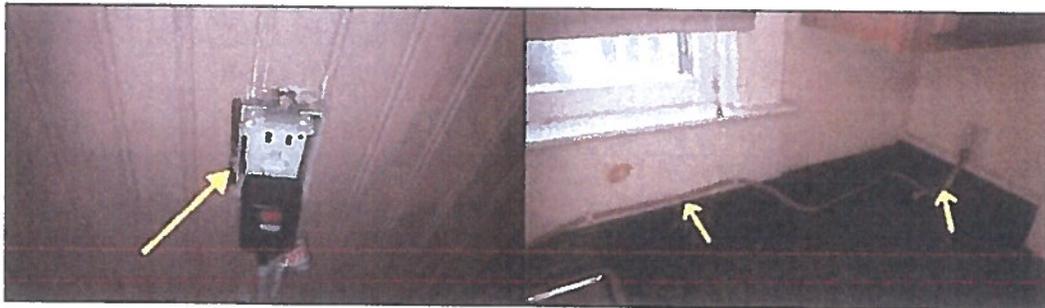
Missing plate in bathroom - Unit 3

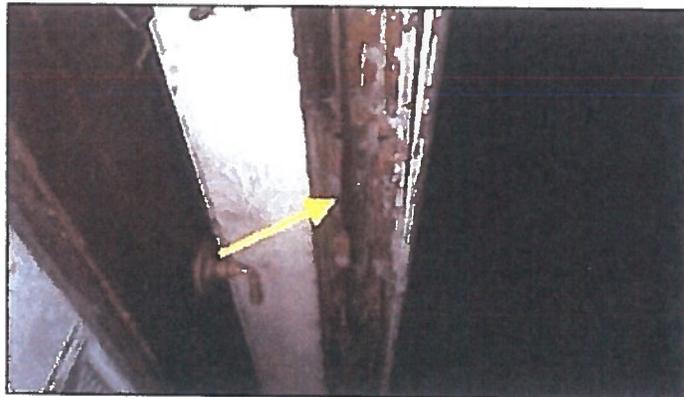
- Front door jamb is damaged and needs repair. Unit 1
- Front screen door is torn. Unit 1

Unit 1 - Front door jamb is damaged

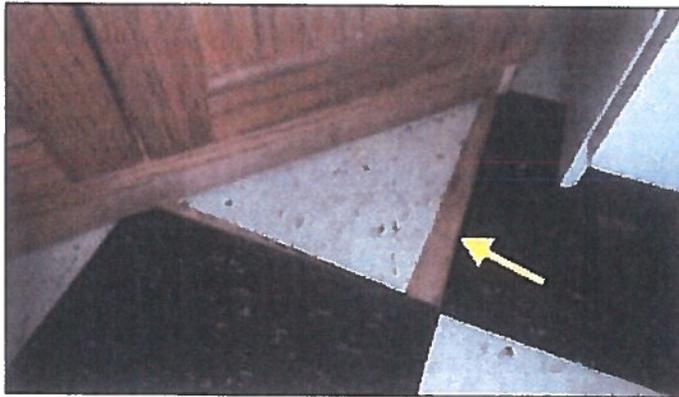
Loose tile below sink - Unit 1

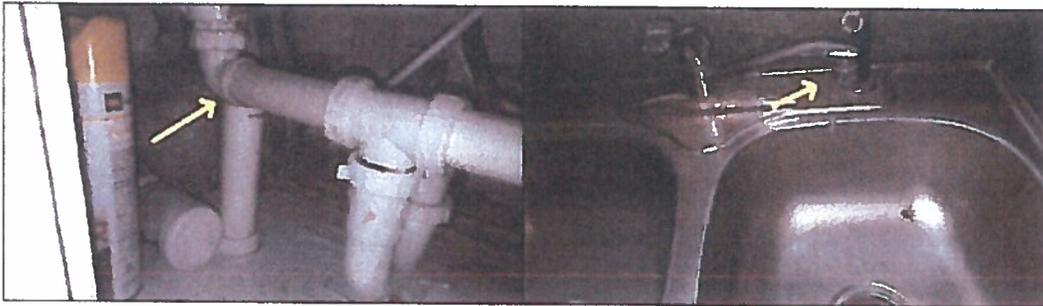
Drain missing fitting and supported by scrap pipe - Unit 3

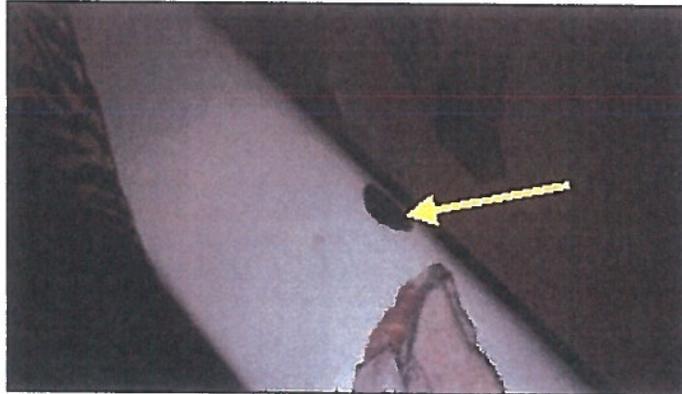
Chipped tub - unit 1

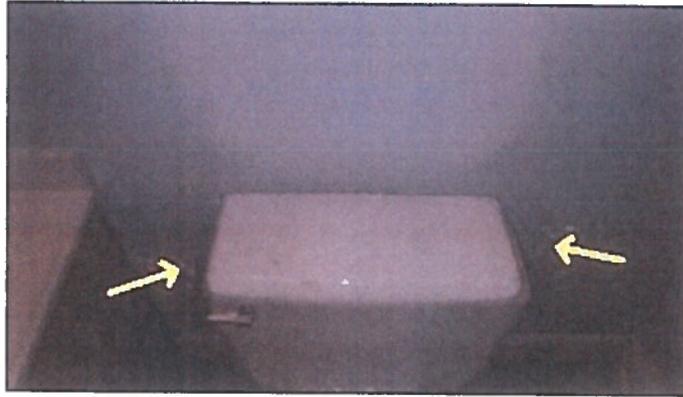
Tank cover too small

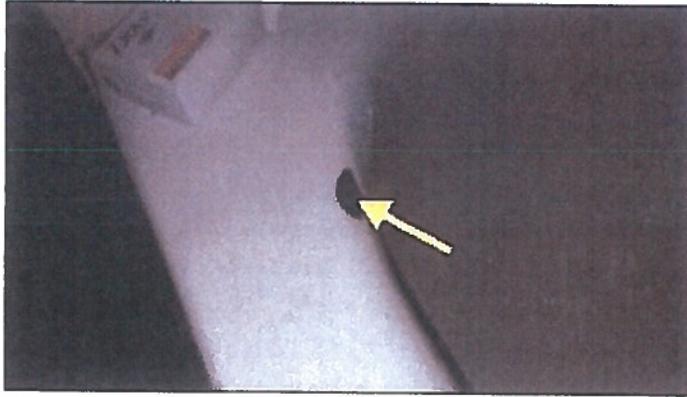
Several chips - Unit 3
