Jefferson Avenue Footbridge

Spencer Jones, P.E.
Great River Engineering

Field Inspection

Structural Evaluation

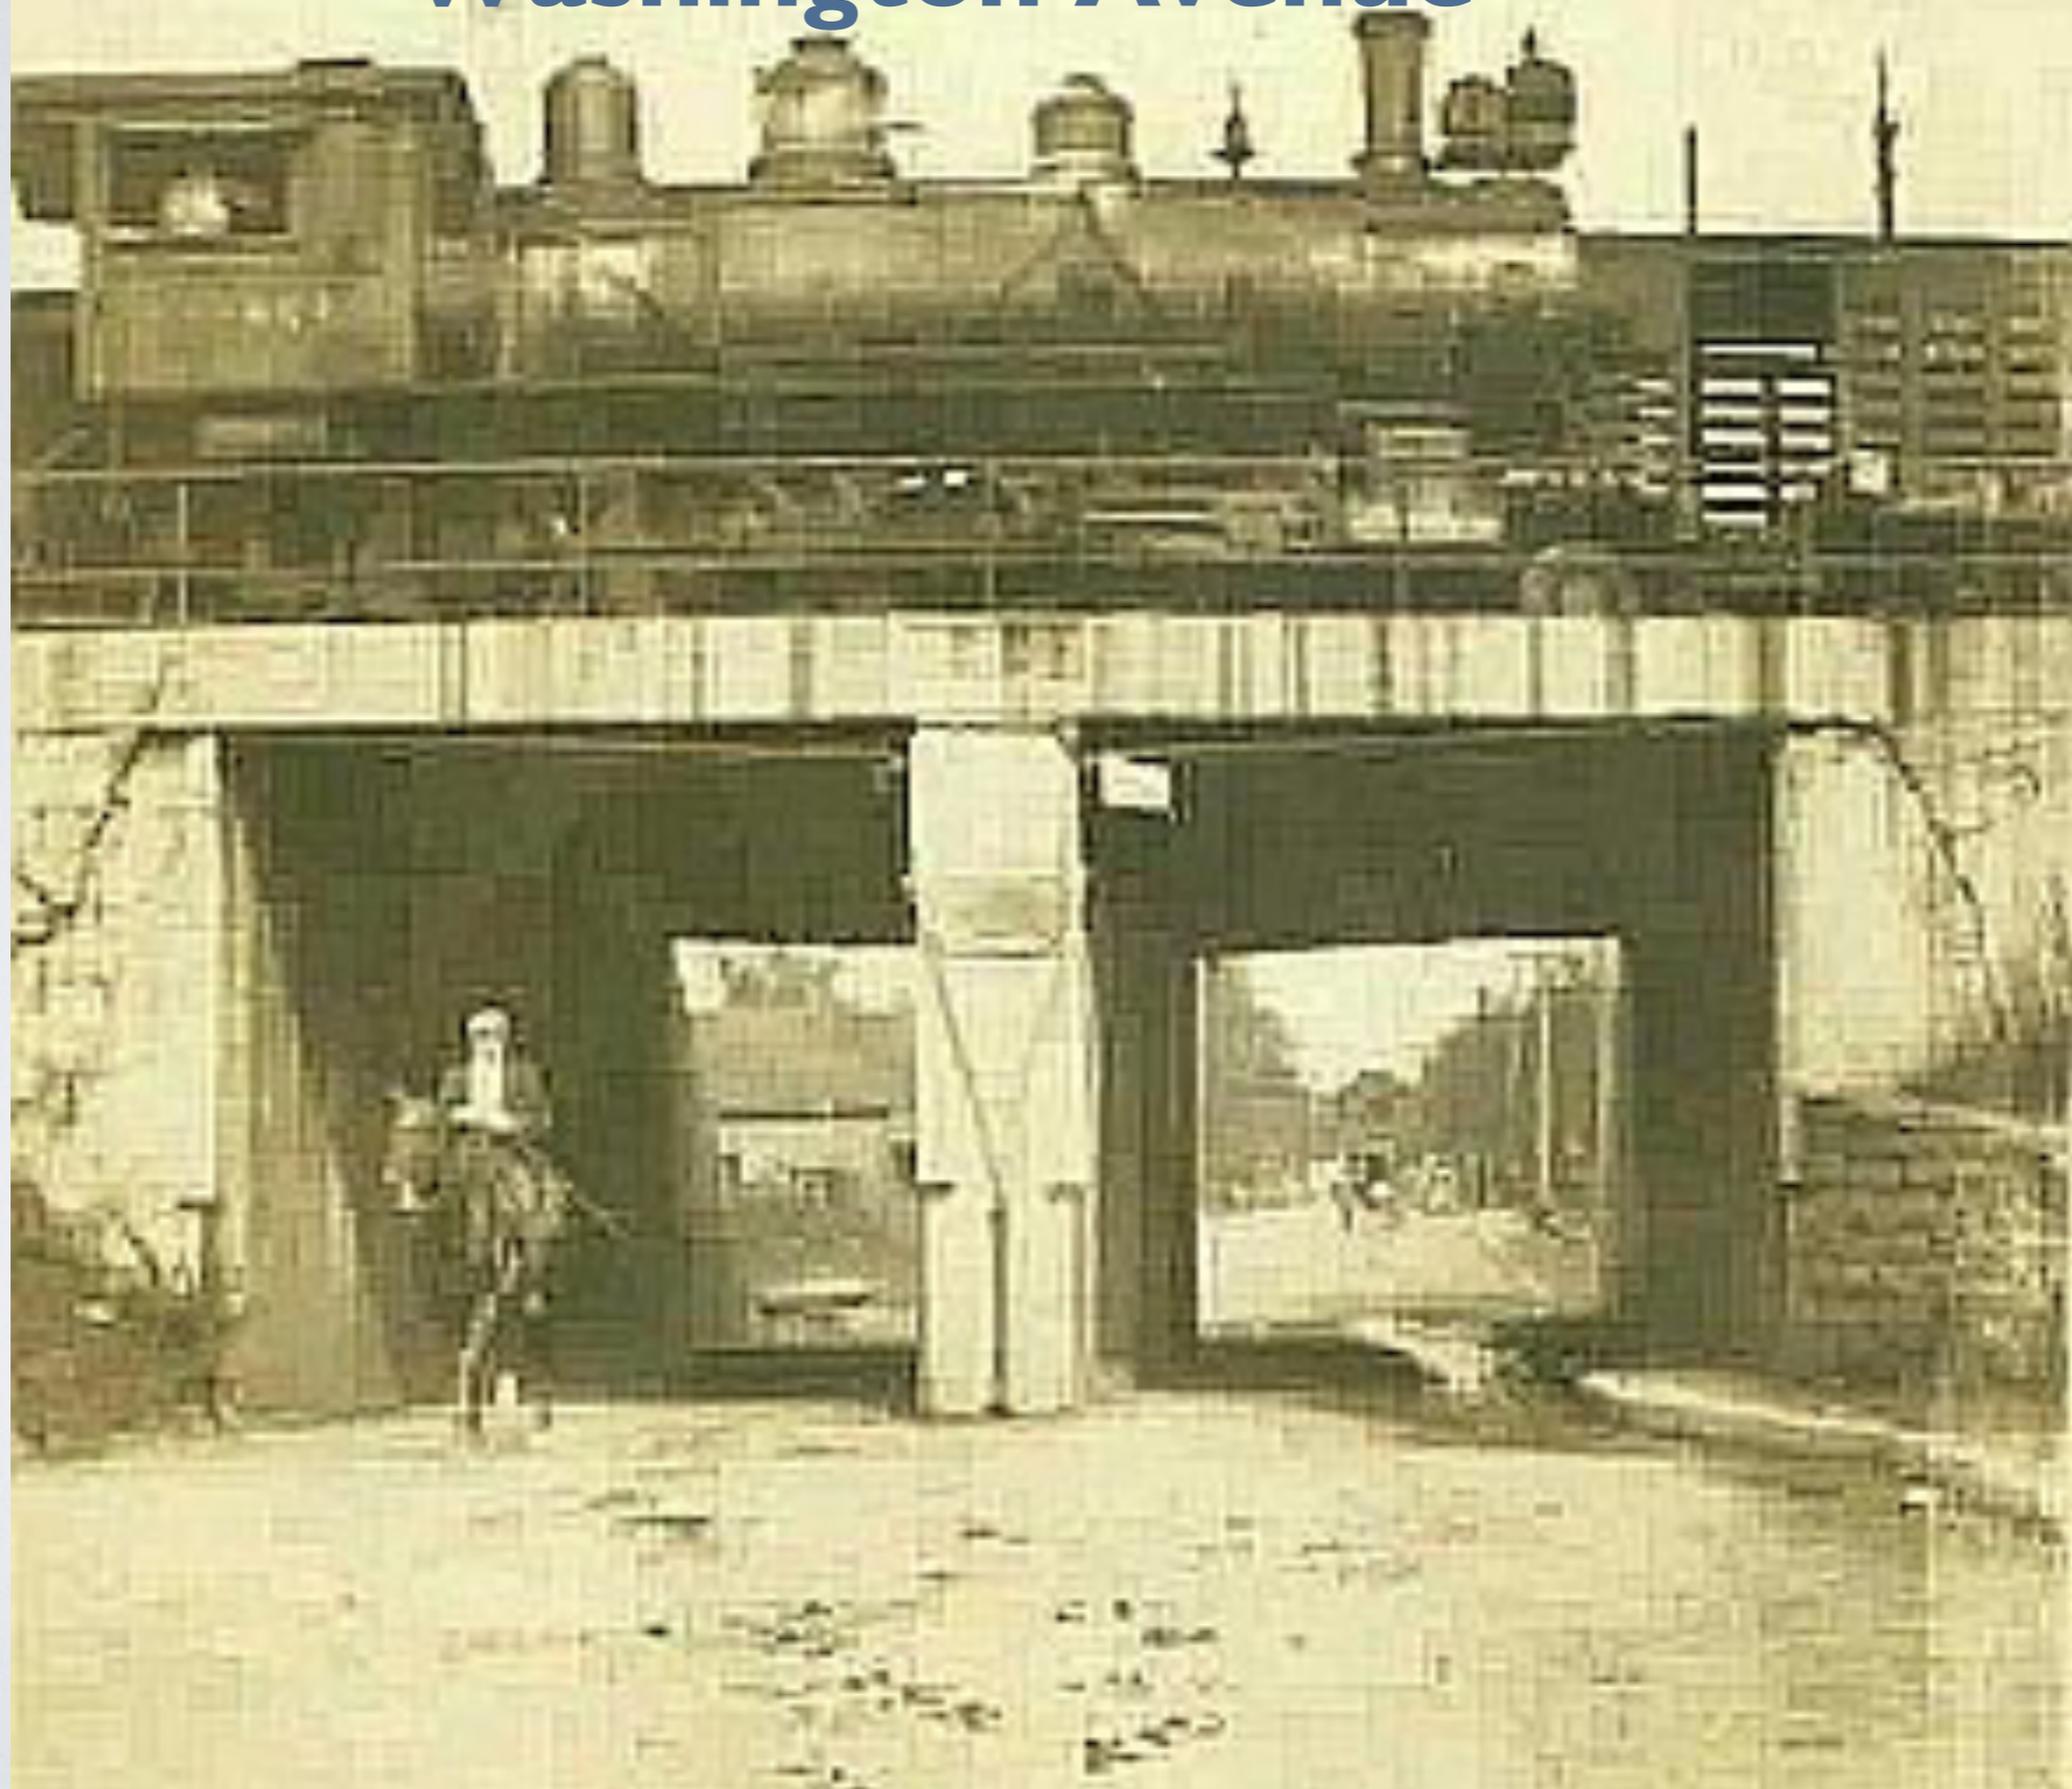
**1902 - Jefferson Avenue Footbridge built over
16 active tracks**

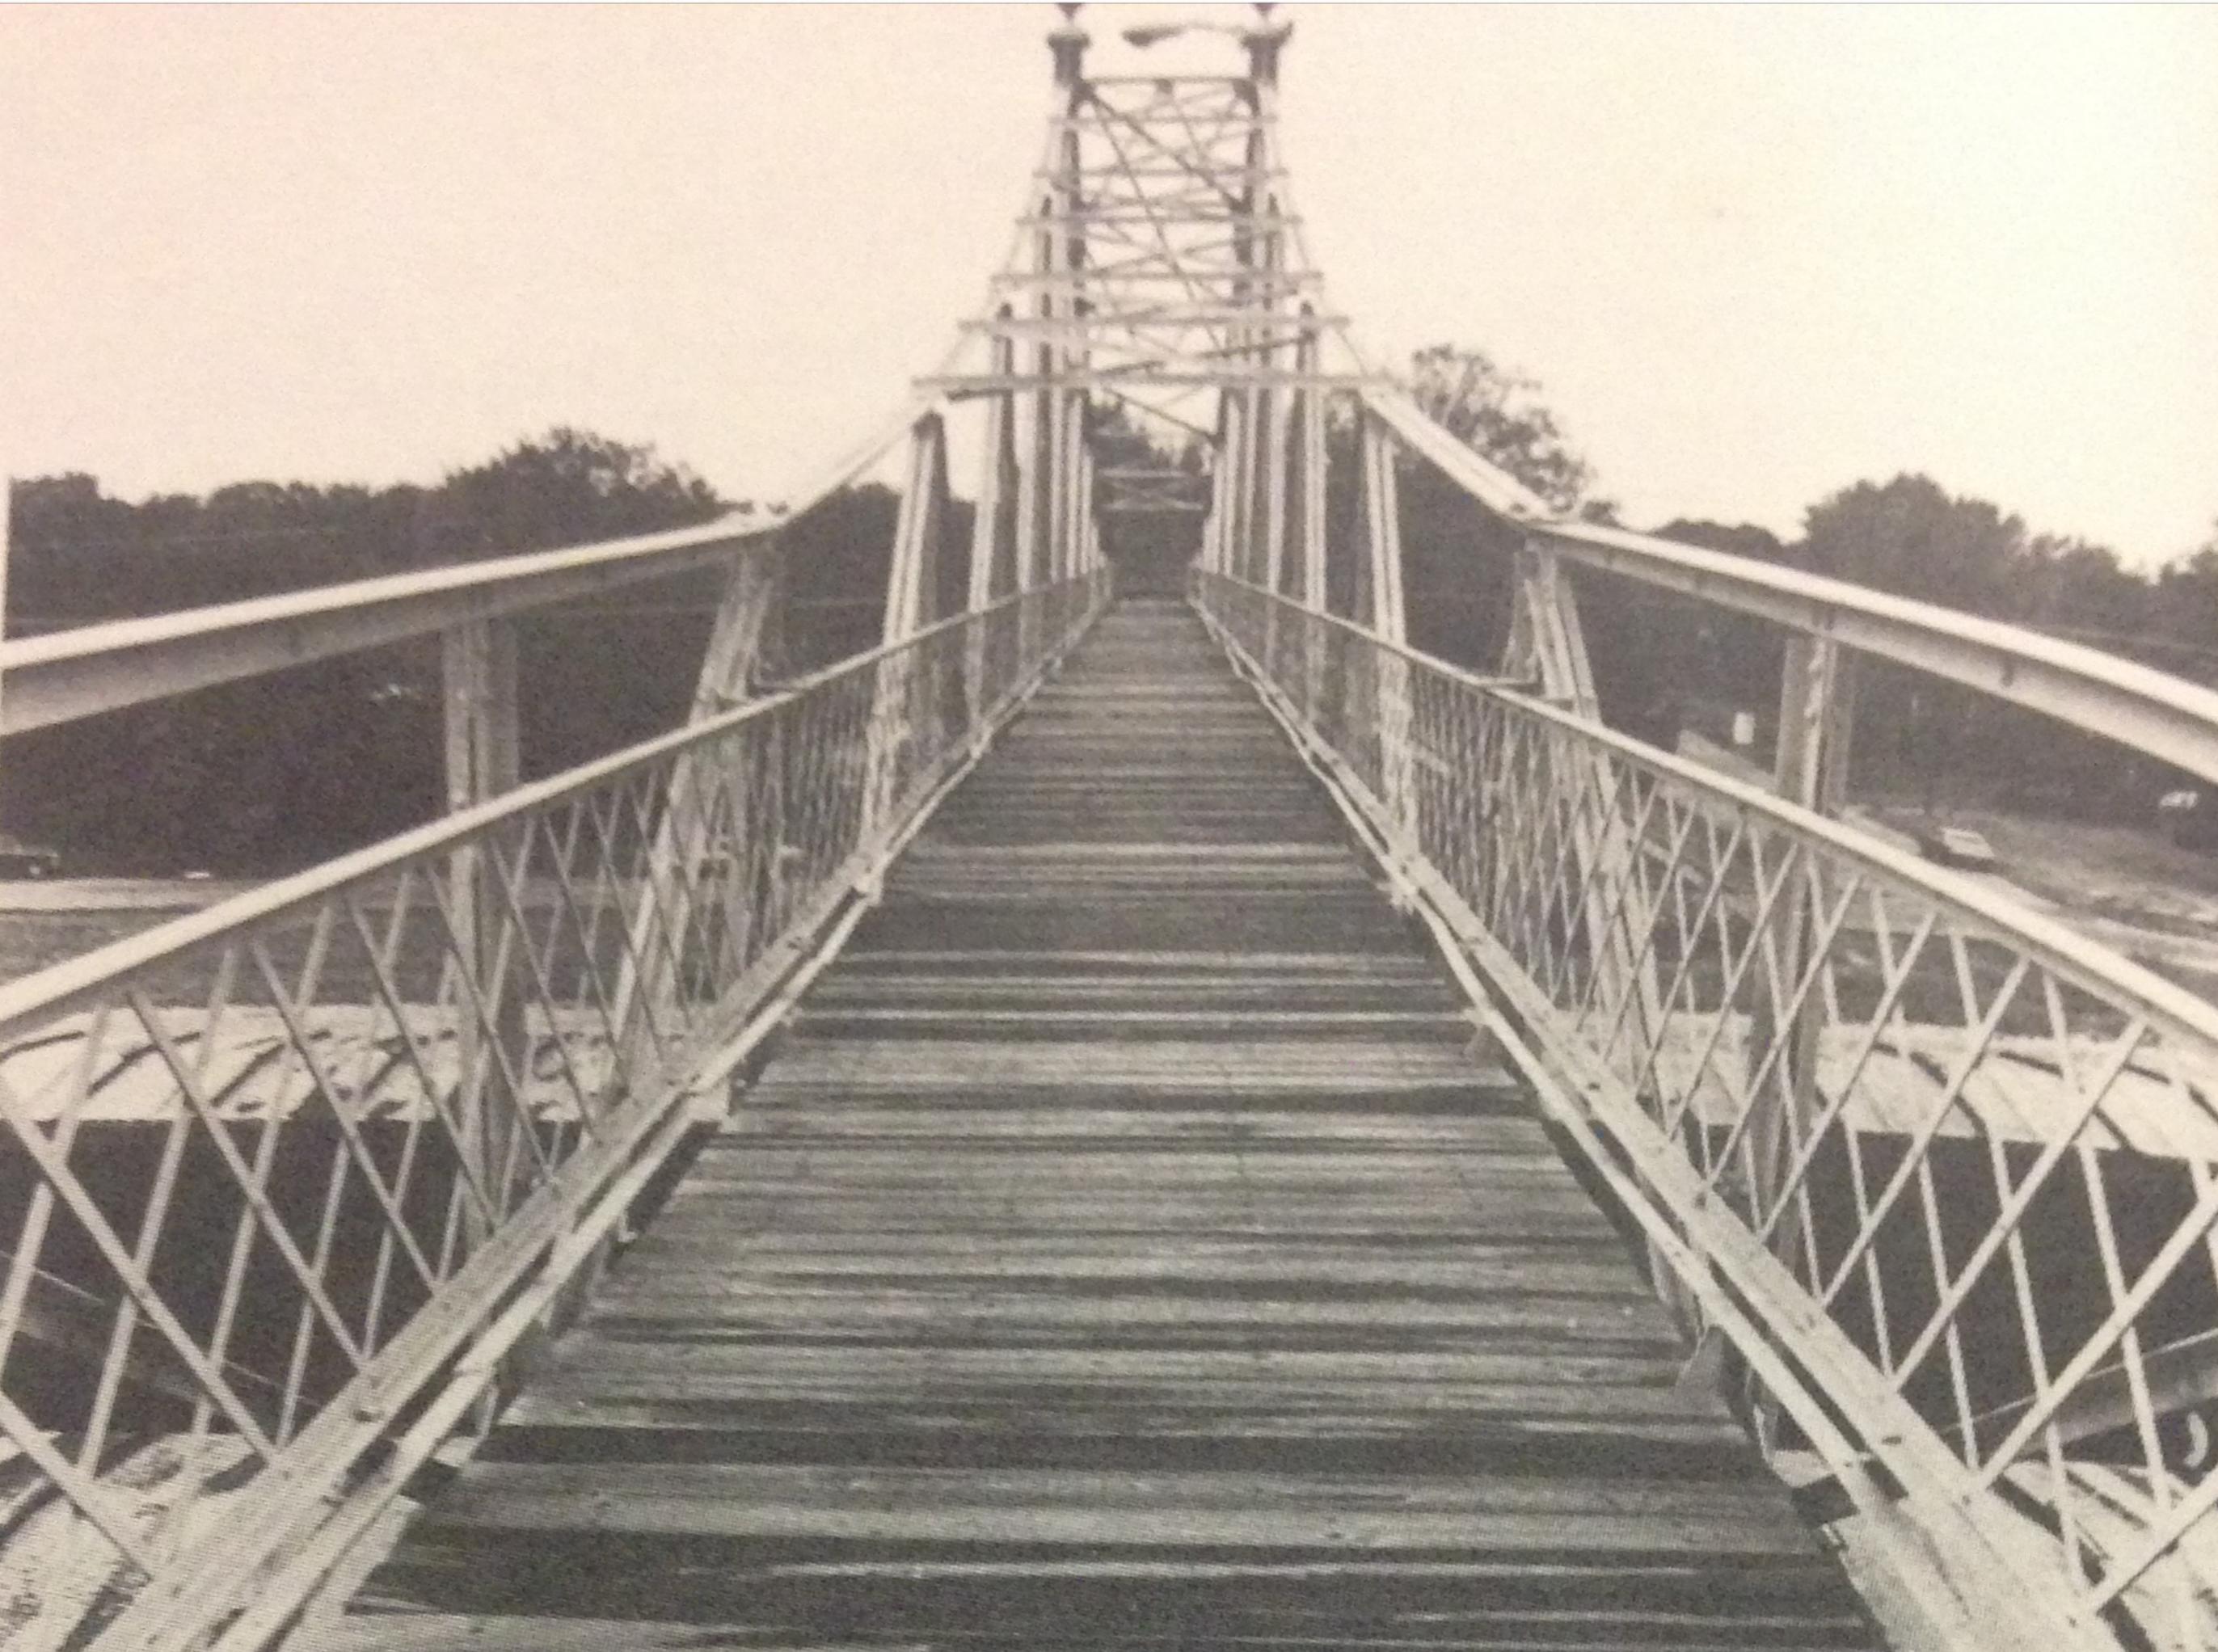
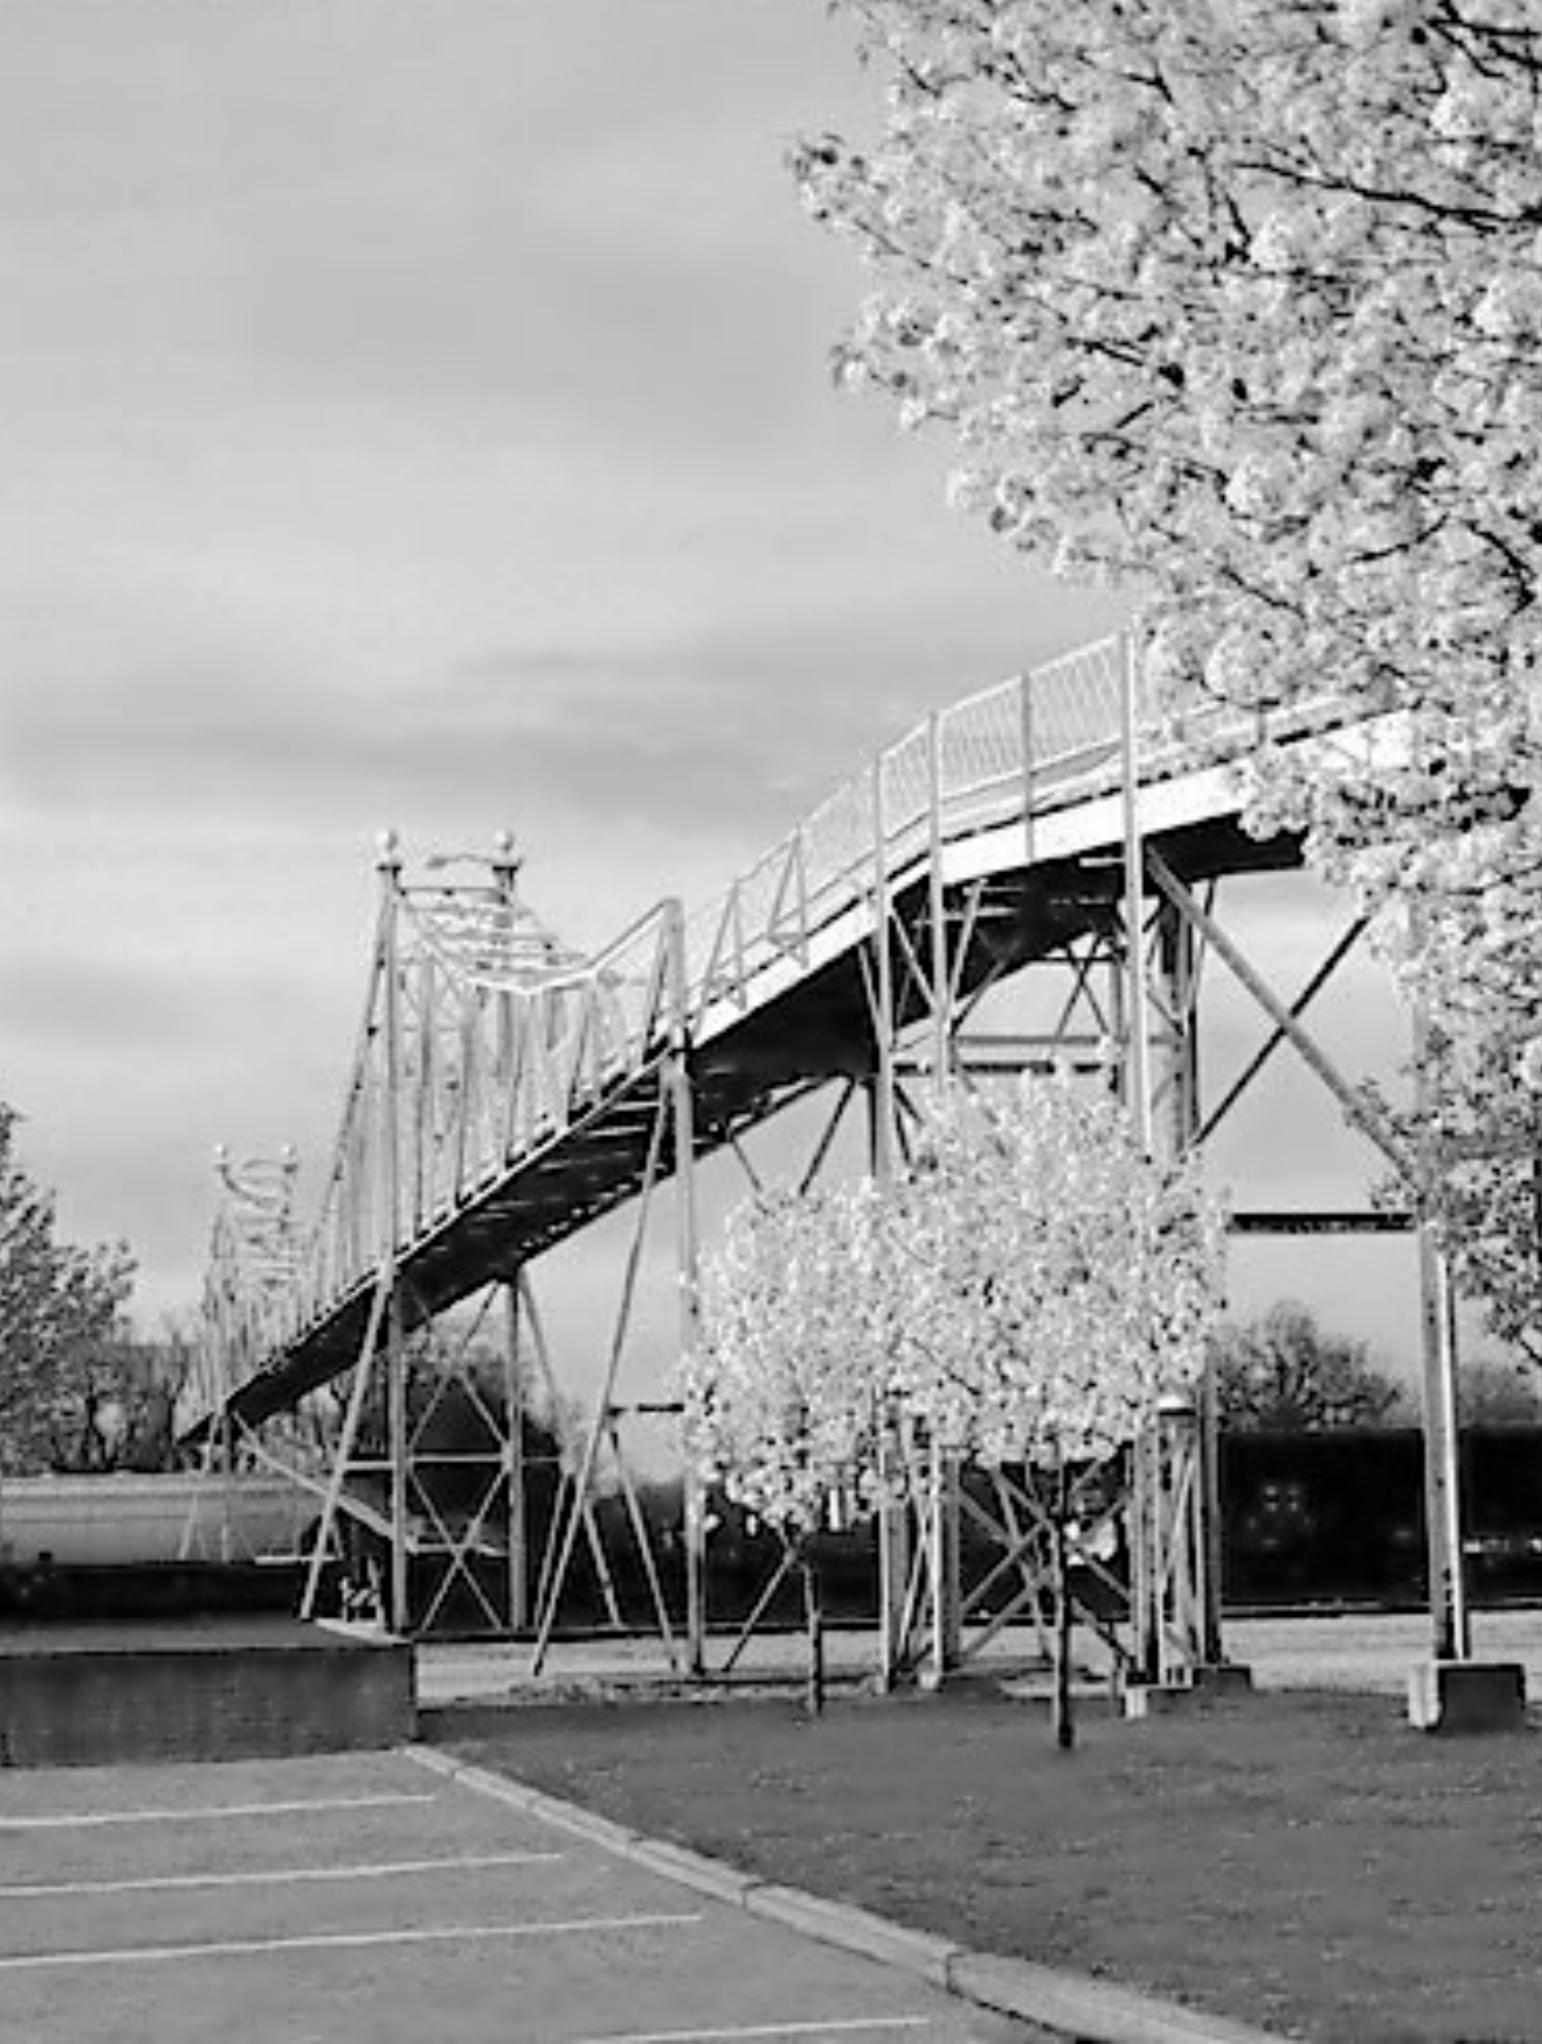
History

- Built in 1902
- Cantilever Through Truss Footbridge
- Length: 562 feet
- Width: 6 feet
- Towers: 45.5 feet (track-top)
- Bridge Rehabilitation in 2002.
- Placed on the National Register of Historic Places in 2003.

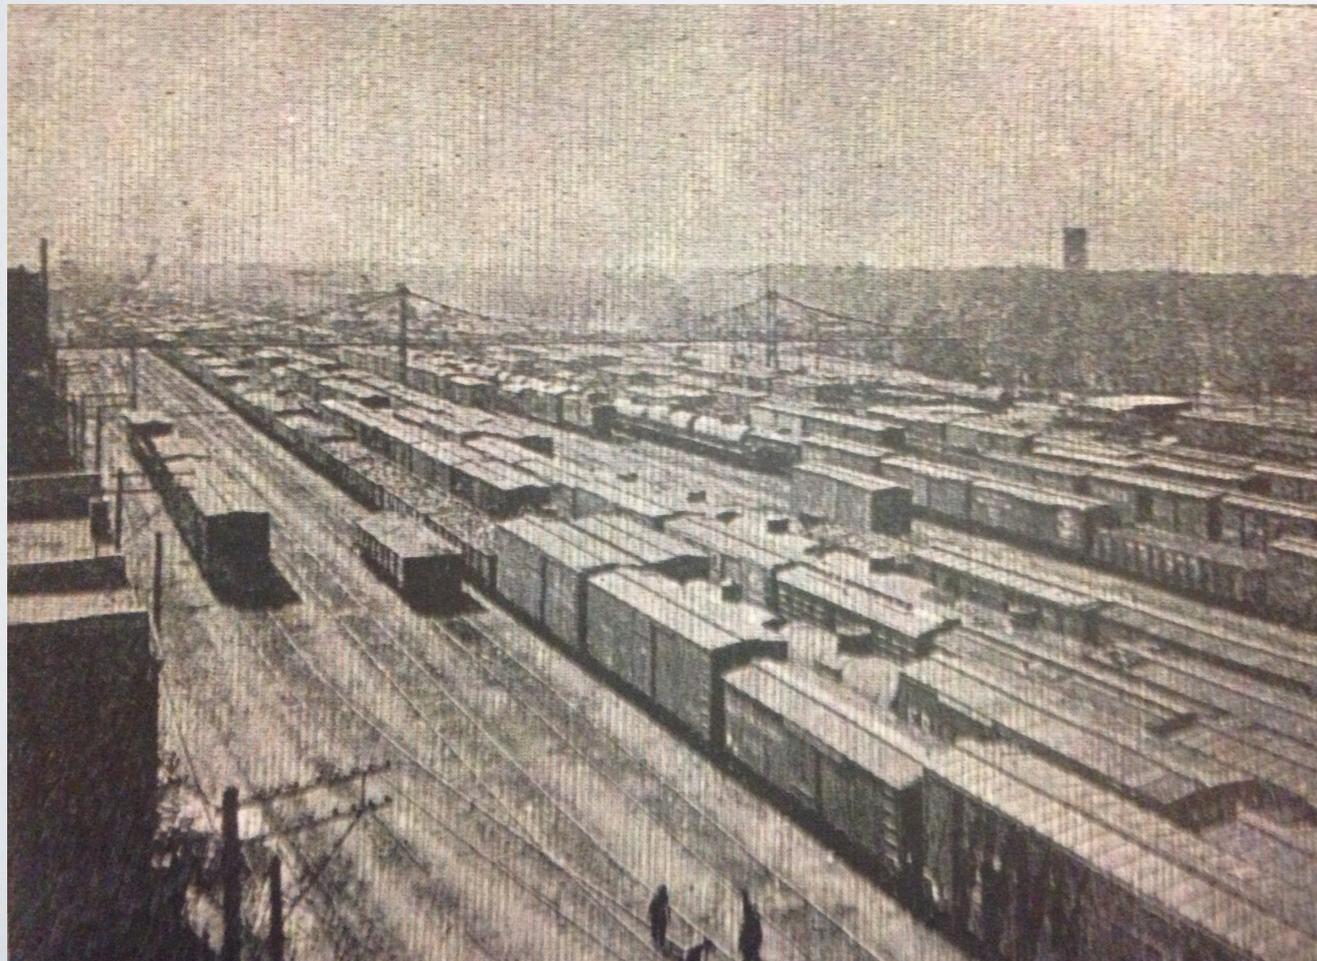
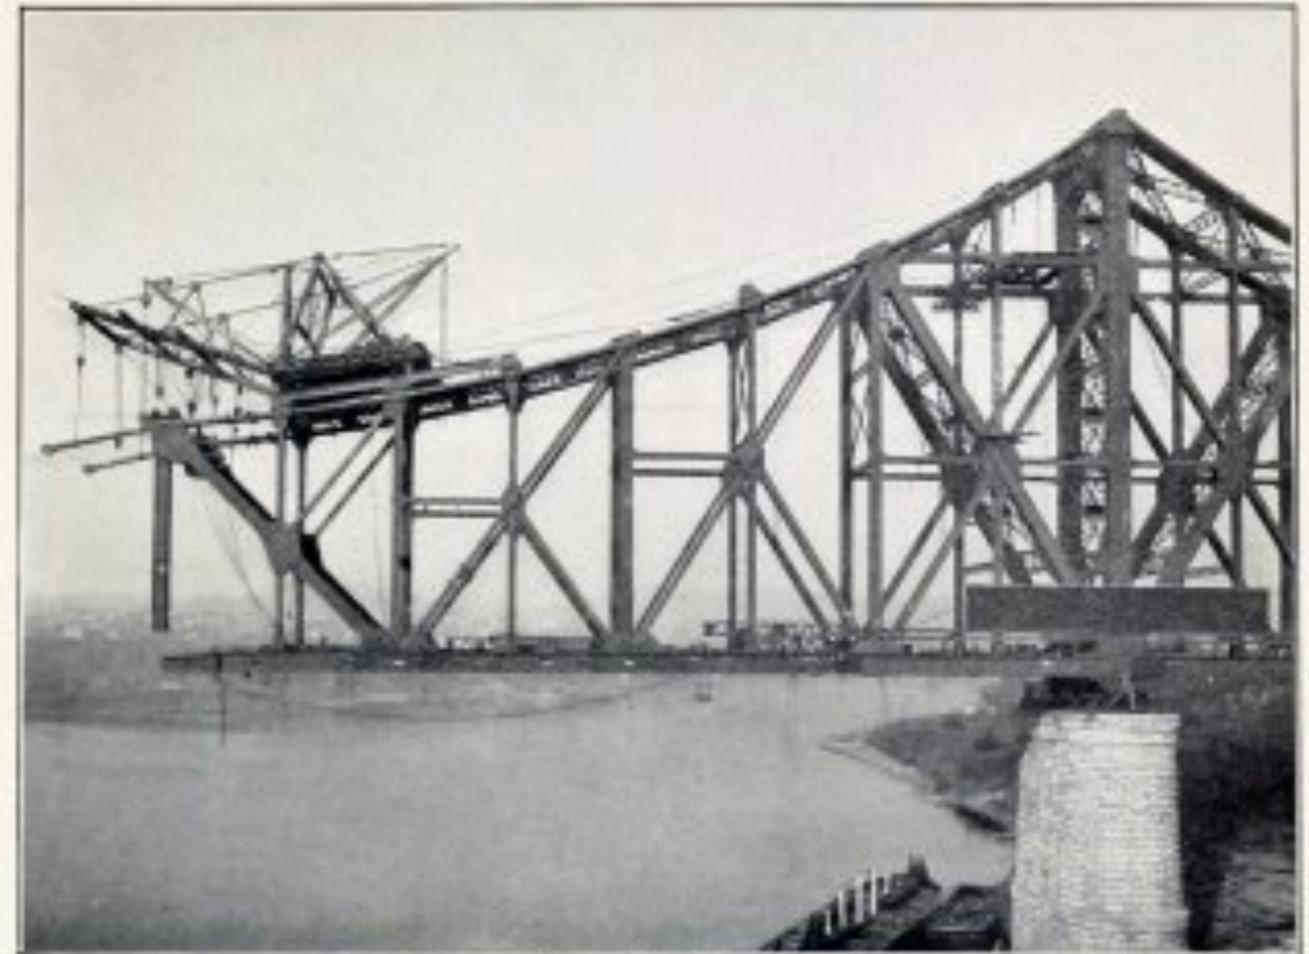
Construction of Cantilever Arm

- Constructed from readily available materials which are lightweight and able to be handled by workers.
- Floorbeam that support the timber deck are constructed of railroad track pieces.

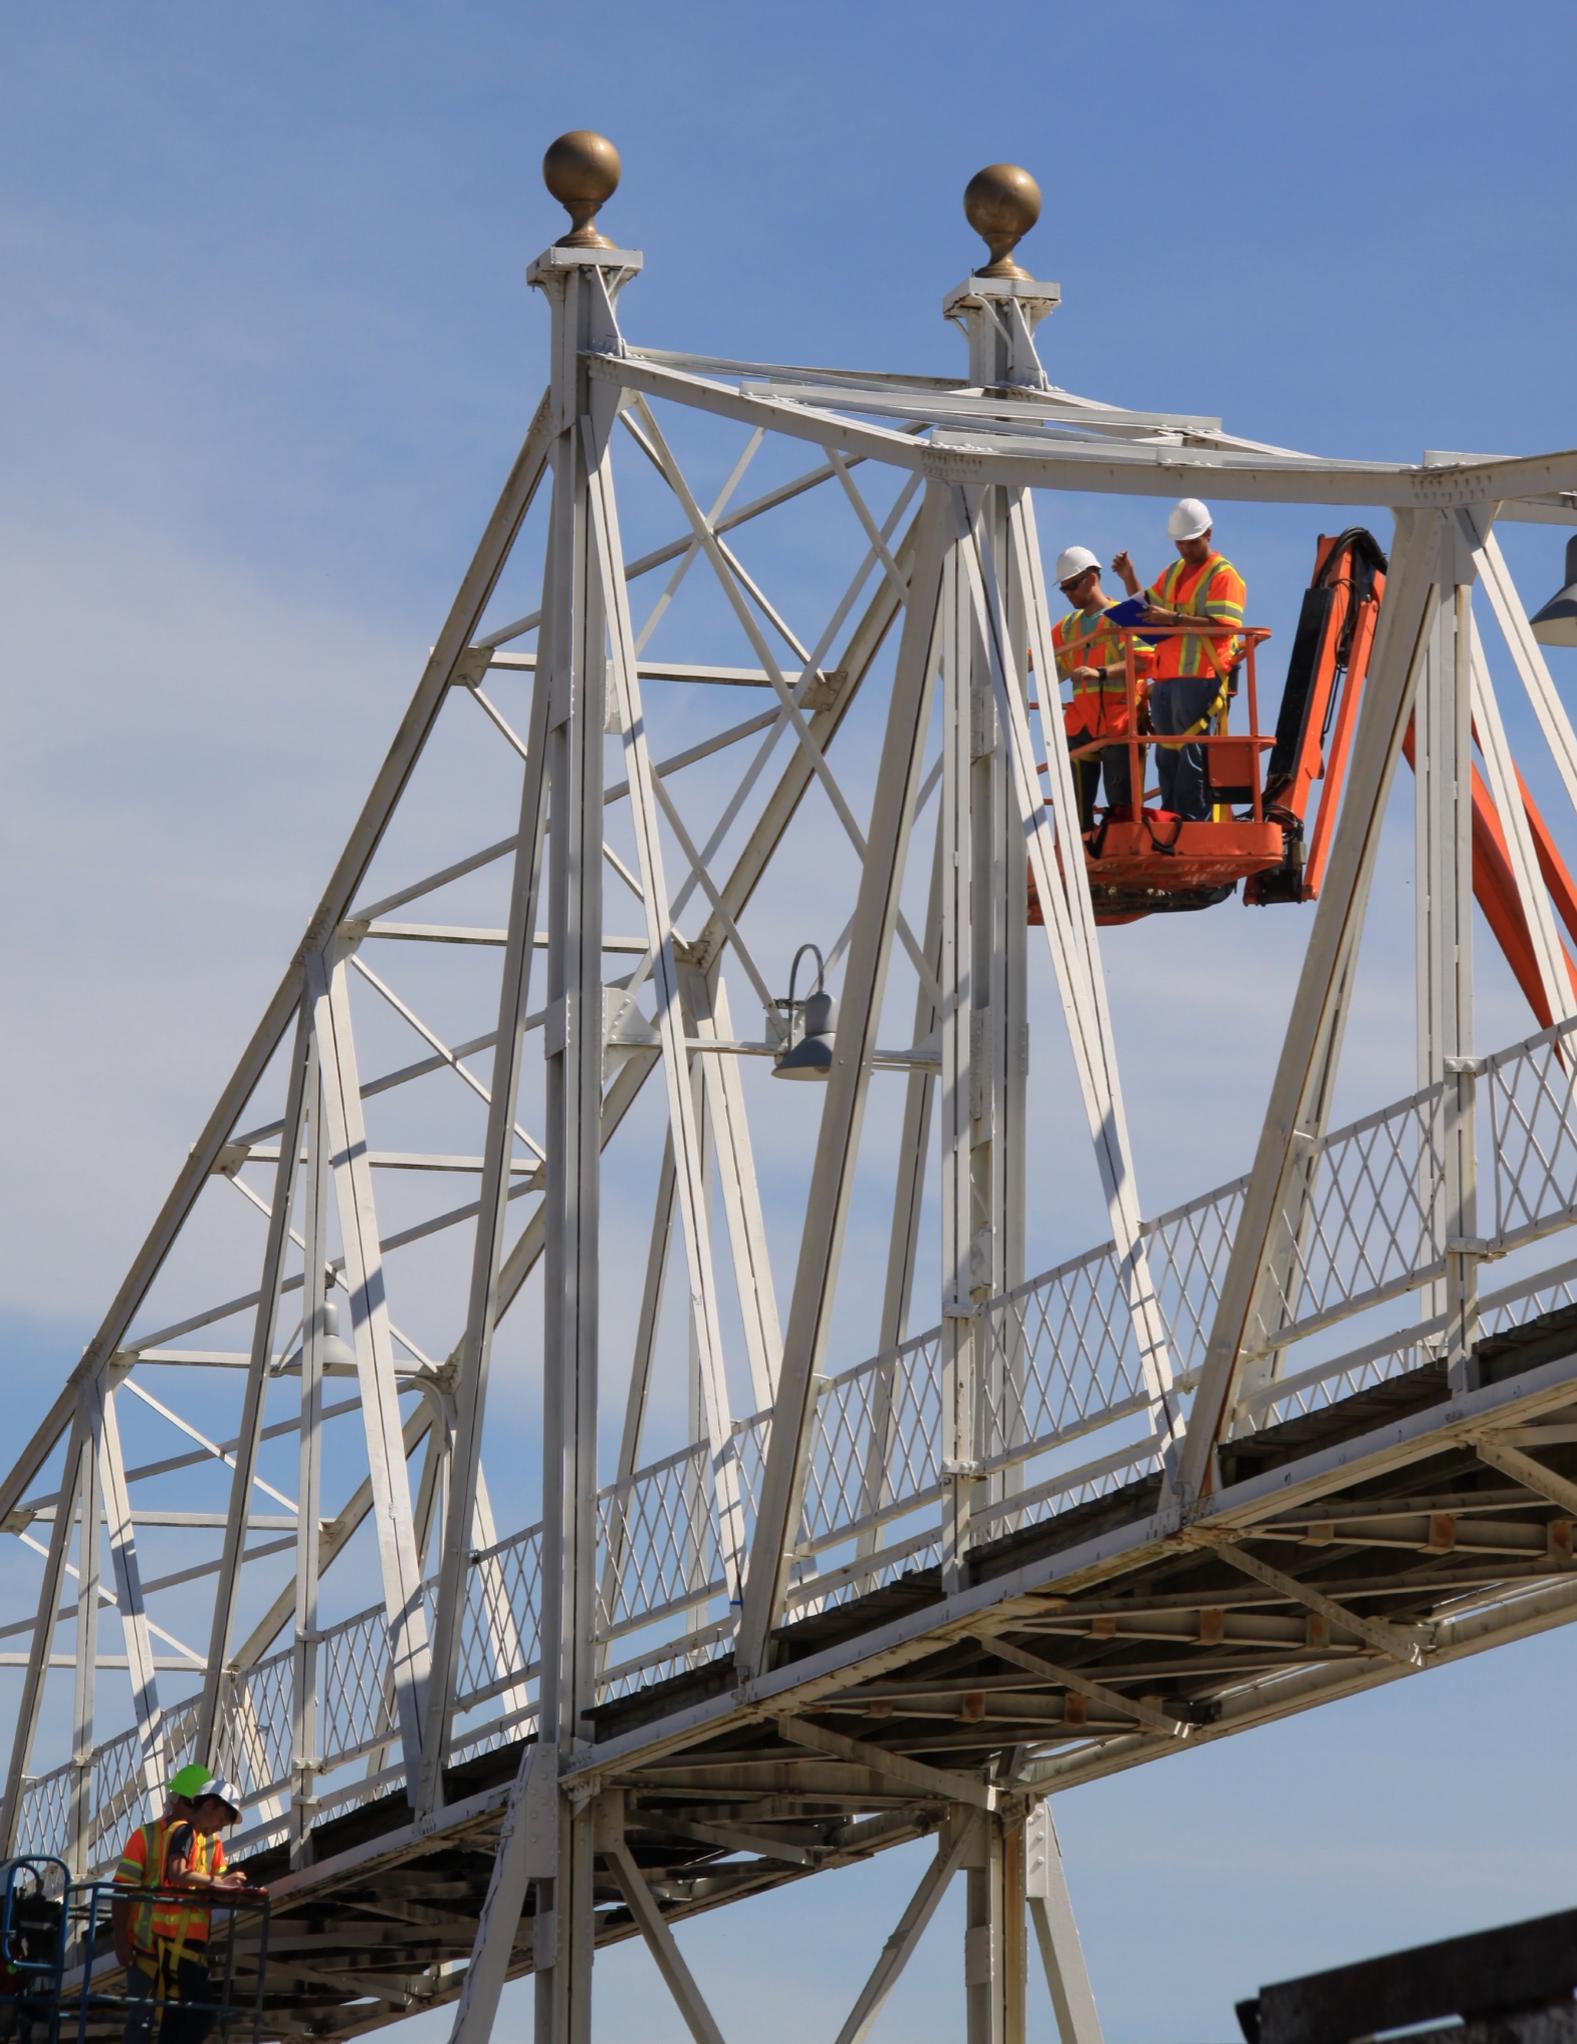
- Measure:
 - Dimensions
 - Corrosion of the steel
 - Alignment
 - Deformation
- Hands reach of all members
- Length inspected 6,658 feet

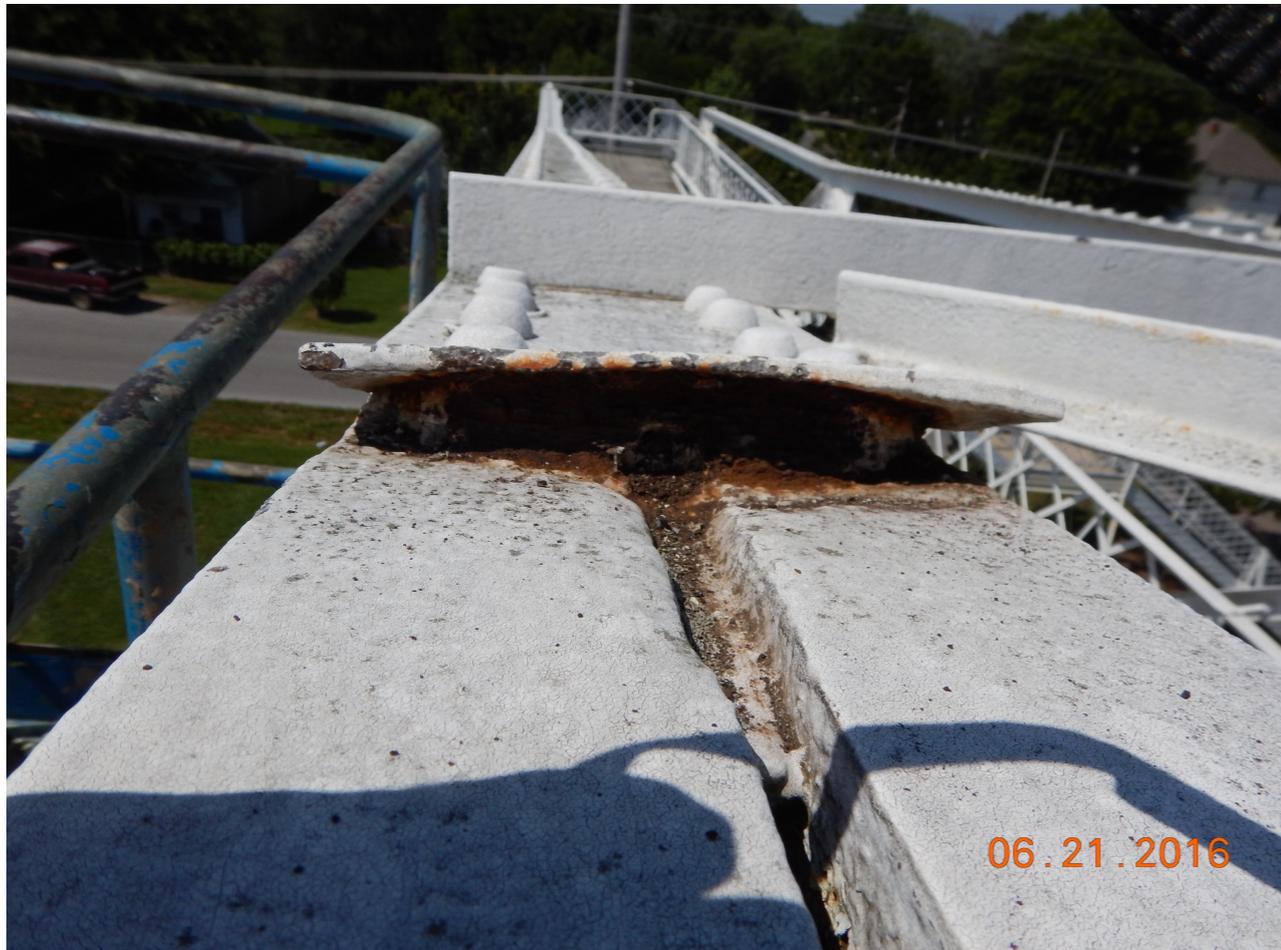
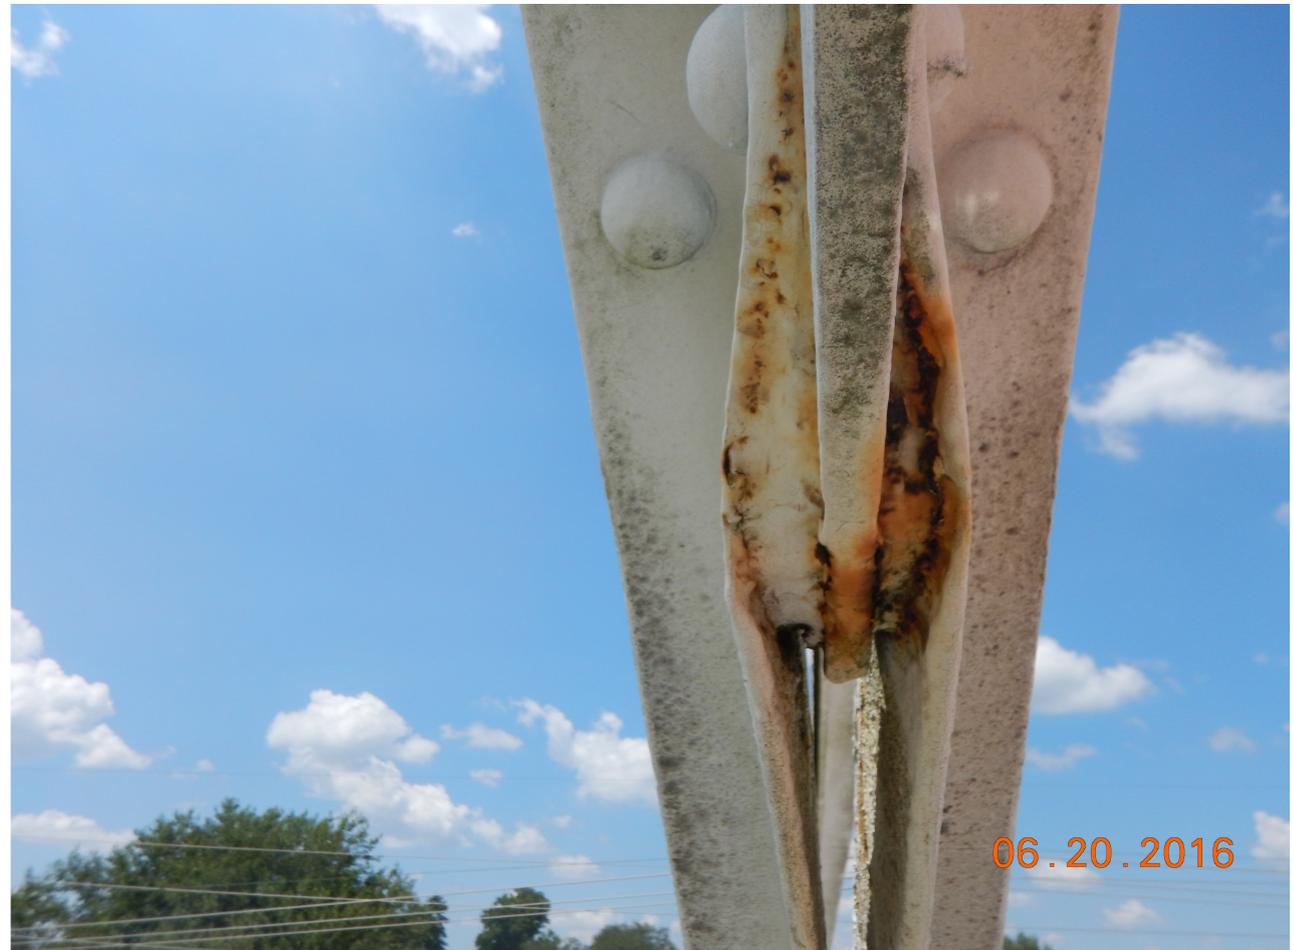
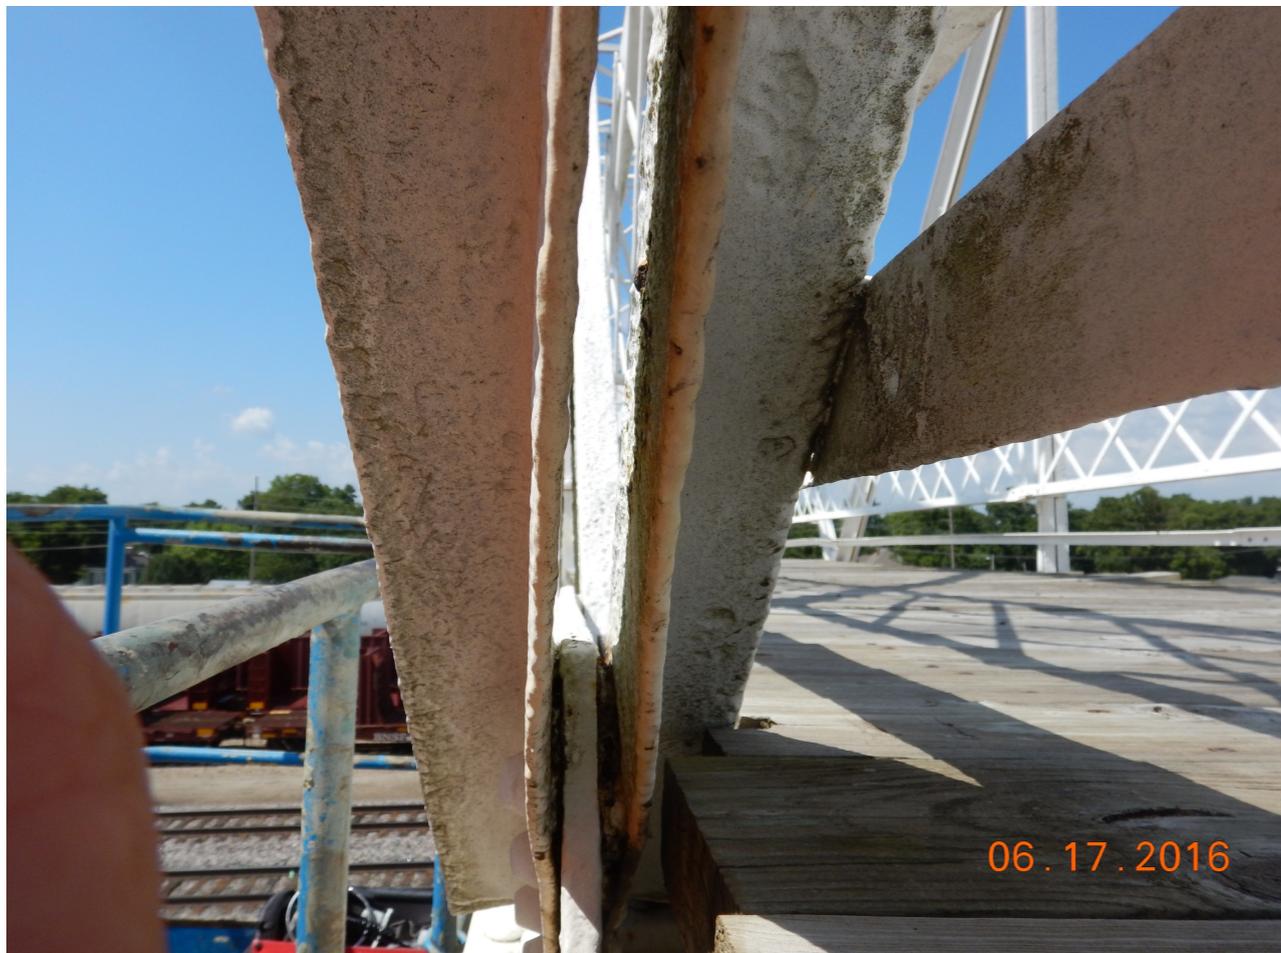
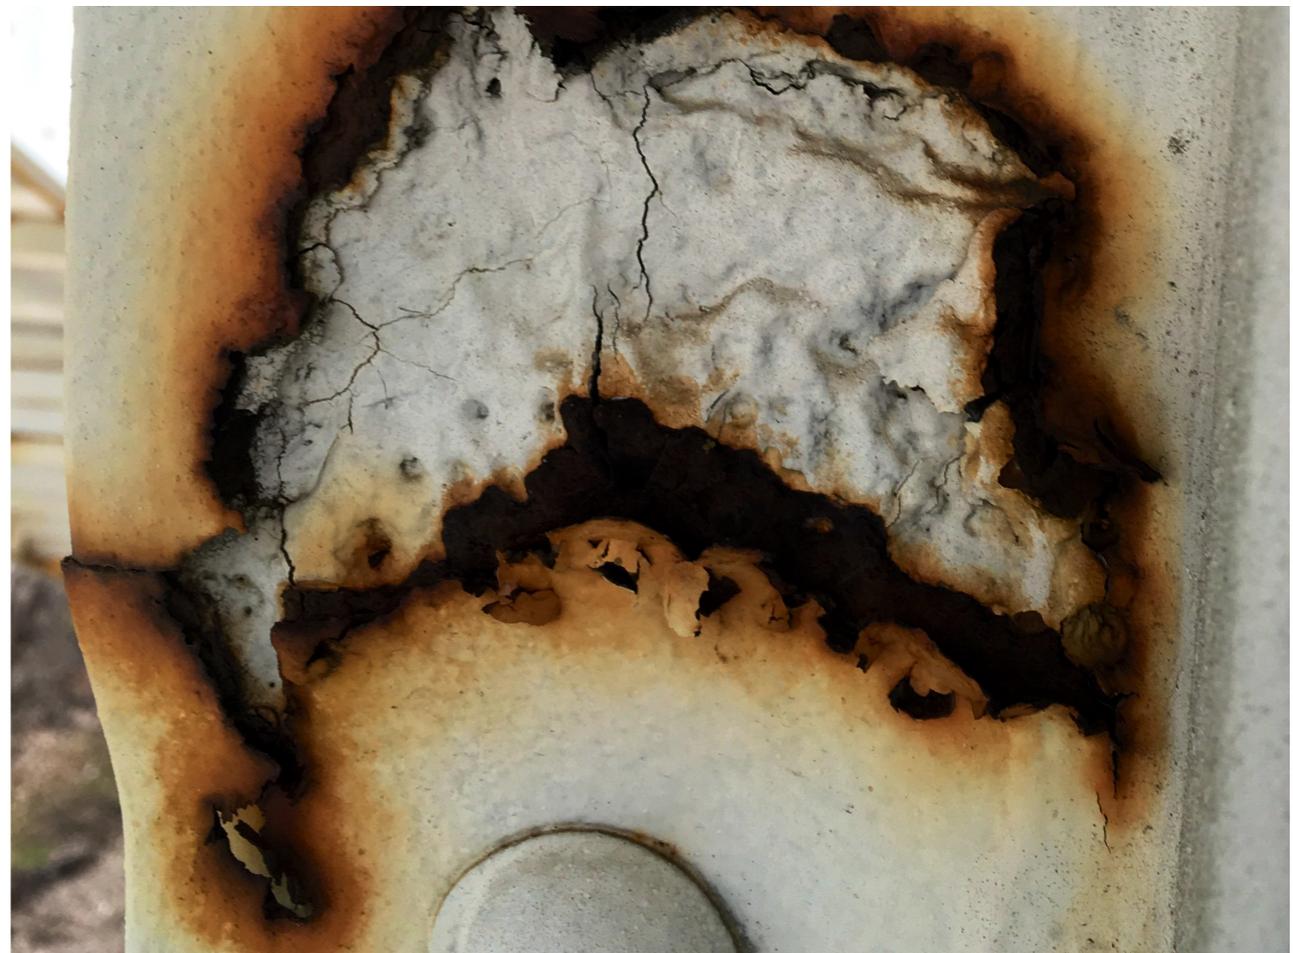
Corrosion

- Reduces structural properties
- Section Loss of Truss Members

Section Loss	Number of Members
50%	1
40-49%	6
30-39%	16
20-29%	44
10-19%	66
10%	117

- Truss & Towers: 1 out of every 3 members need repaired or strengthened (36.4%)
- South Approach: 6 of 10 vertical columns need strengthened
- Stairs (North & South): Both need replaced
- Paint: Paint system failing in numerous locations - new paint needed
- Bridge has 3 coats of paint (lower 2 coats contain lead based paint)

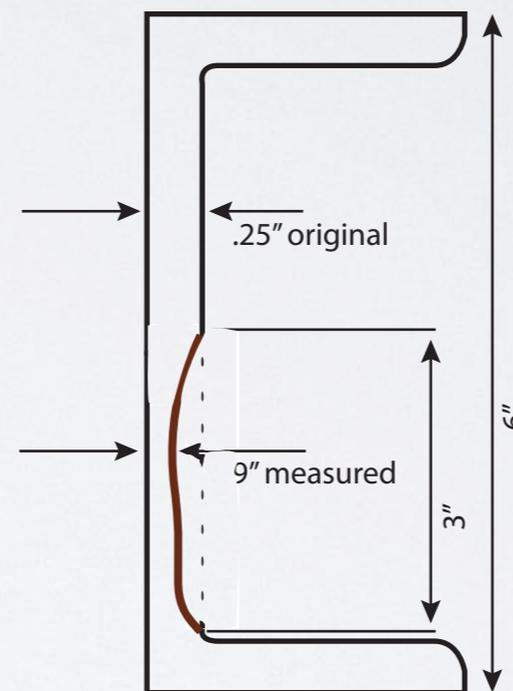
$$\% \text{ loss} = 3/6 \times .06/.25 \times 100 = 12\%$$

Enter 12% under depth. (Area loss)
