Jefferson Avenue Footbridge

Spencer Jones, P.E.
Great River Engineering

Field Inspection

Structural Evaluation

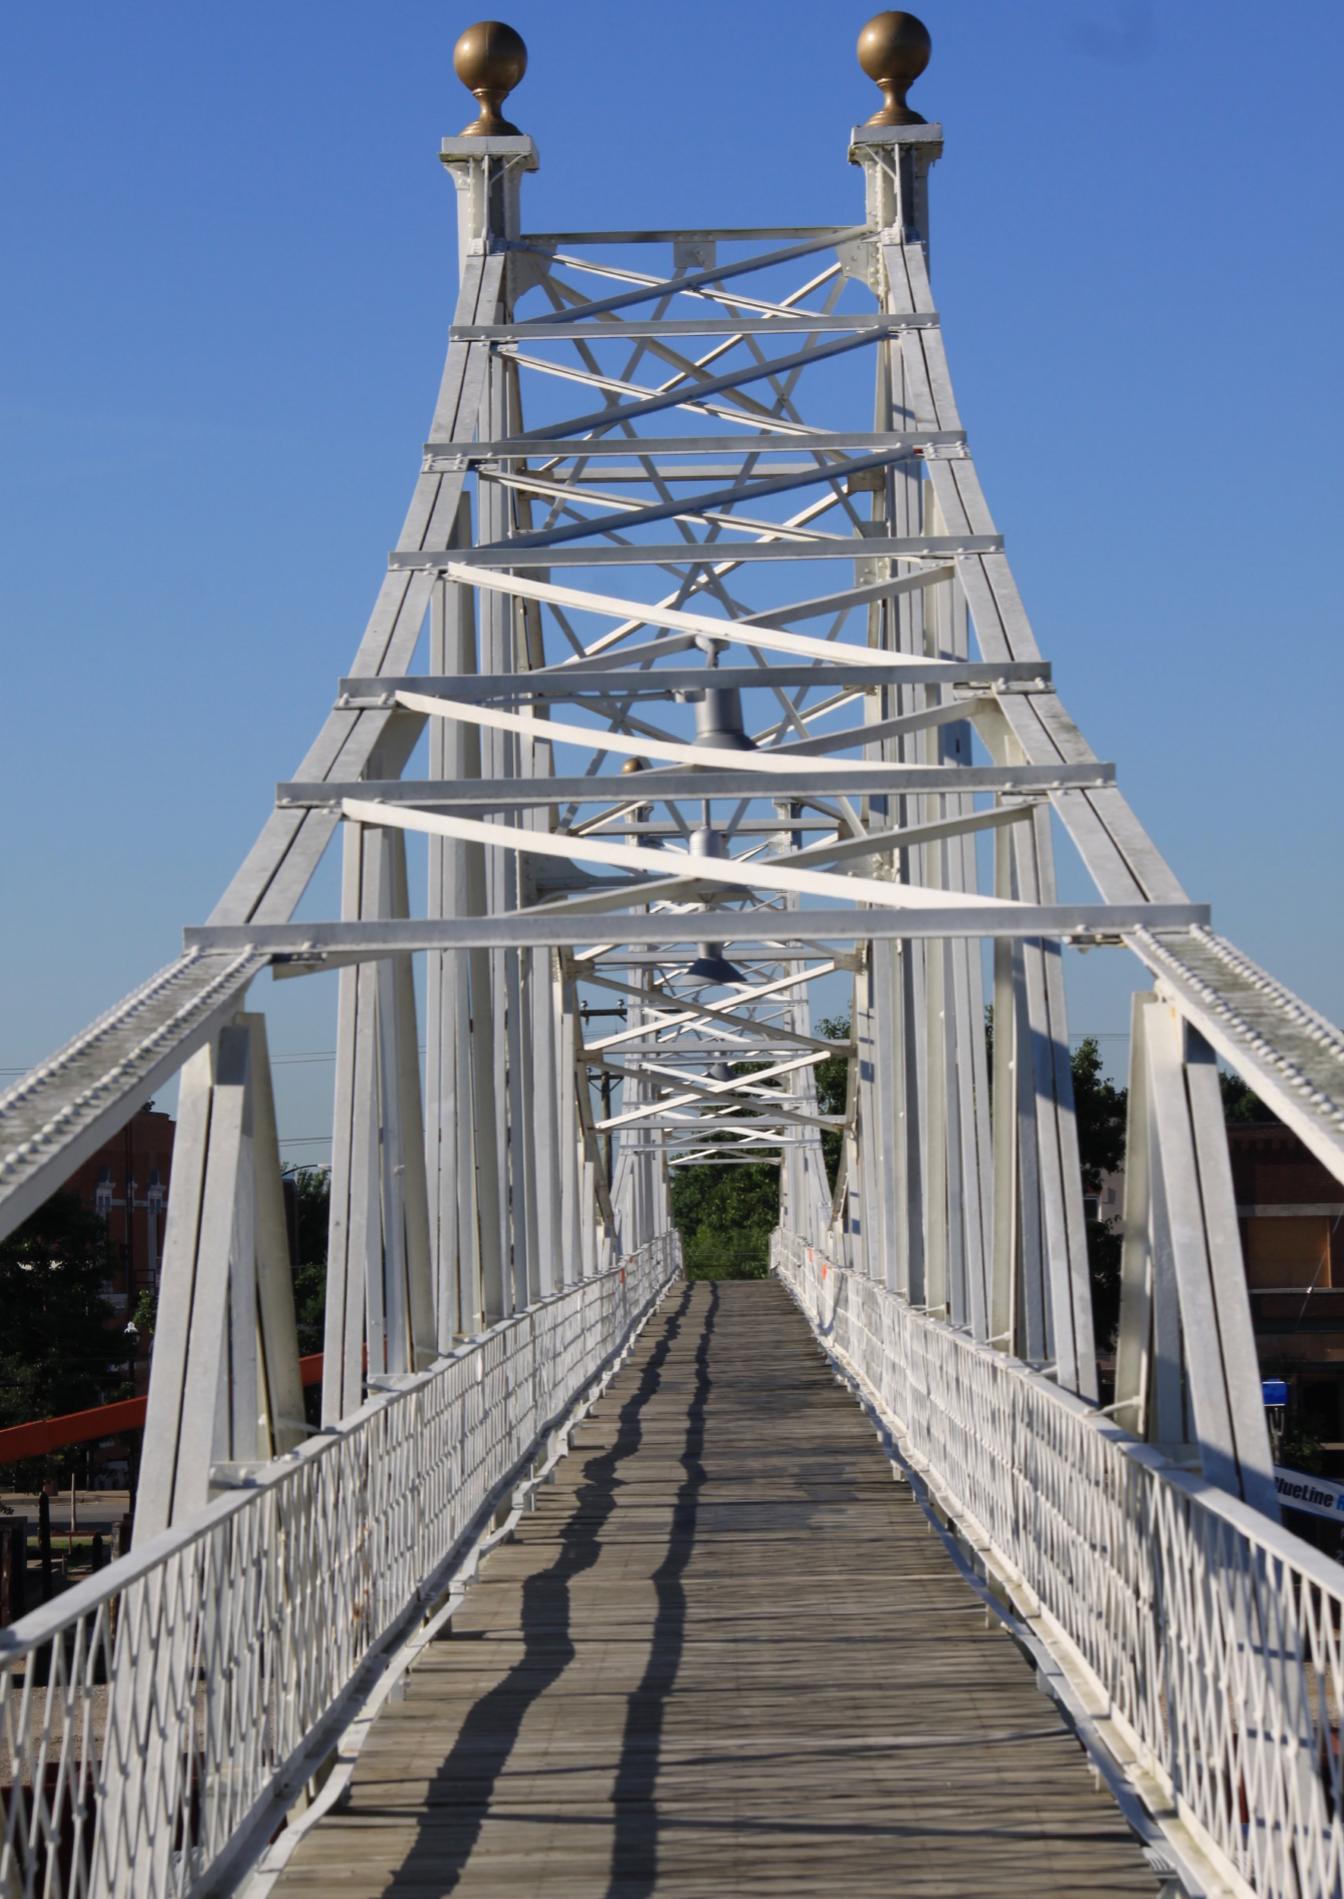
- **Current Design Code**

Pedestrian Live Load = 90 psf

- RF less than 1.0 member fails

- Truss & Towers: 1 out of every 3 members need repaired or strengthened (36.4%)
- South Approach: 6 of 10 vertical columns need strengthened
- Stairs (North & South): Both need replaced
- Paint: Paint system failing in numerous locations - new paint needed
- Bridge has 3 coats of paint (lower 2 coats contain lead based paint)

- **Do Nothing** \$414,154
Removal of the bridge.
- **Minimal Rehabilitation** \$2,299,500
Strengthen members by replacing or add plates to existing members and paint over existing.
- **Preserve Original Bridge** \$2,784,300
Replace existing members with new members, remove existing paint to bare metal and apply 3-coat paint system.
- **Replacement Bridge** \$2,997,300
Construct a replacement bridge with similar characteristics of existing bridge.

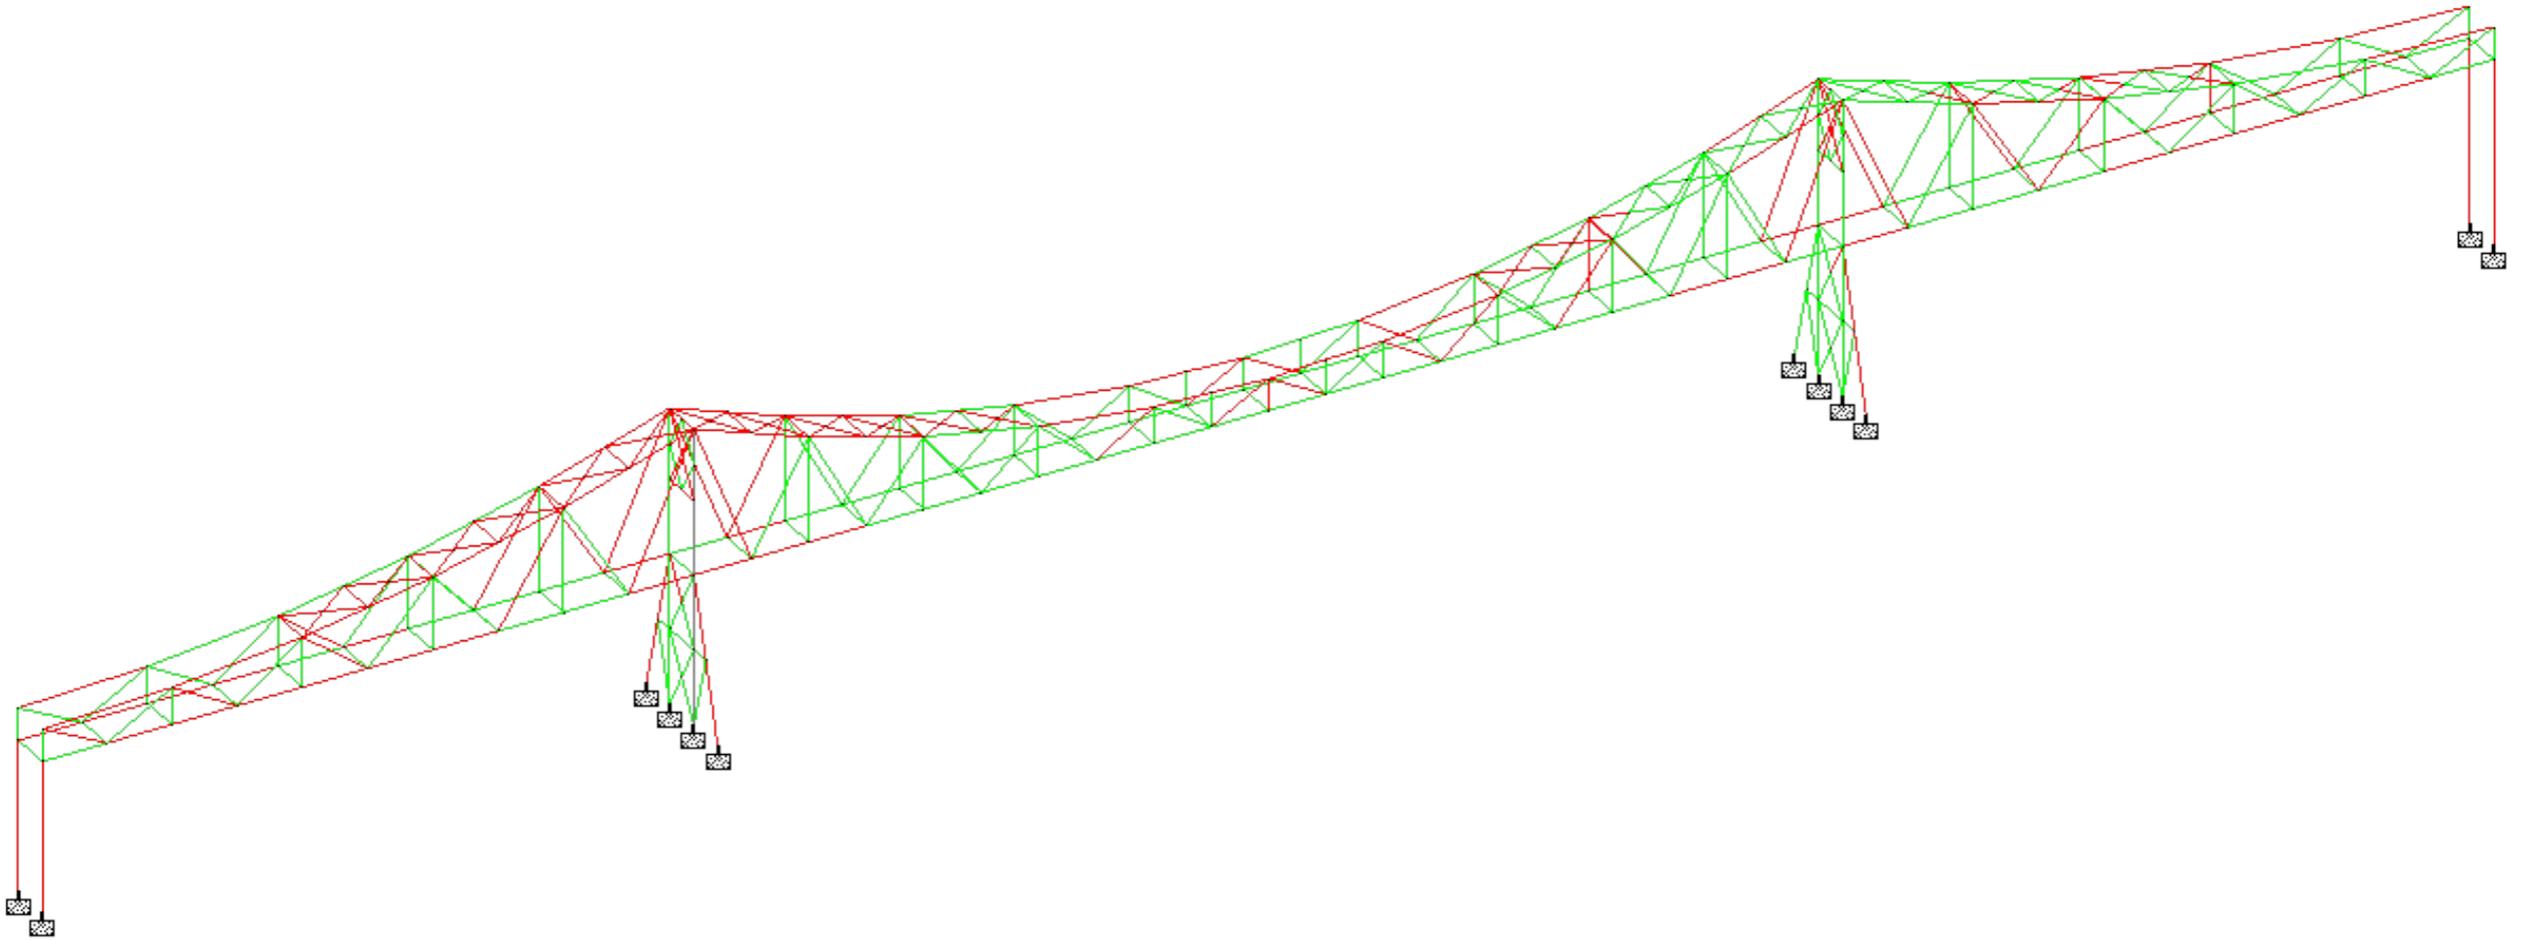
Truss Members without Capacity

Rating Factor	Number of Members
Greater than 1.0	159
0.90-0.99	35
0.76-0.89	36
0.41-0.74	20
