Phase 1 Environmental Site Assessment with visual asbestos survey

2420 W. Grand Street

Date of Report: July 7, 2009

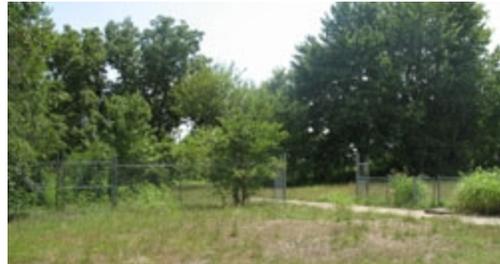
The subject property has been a small engine repair since approximately 1987. Numerous containers including three 55-gallon drums of engine oil and other lubricant containers, metal debris and cans, 1-gallon paint cans, and lawn equipment such as mowers, weed eaters, and chain saws were observed throughout the north portion of the Site. These items are stored in piles, were unsecured, and exposed to the elements. Aerial photographs indicated this storage has been present at the Site since at approximately 1996, when complaints to the Springfield-Greene County Health Department began. Oily staining was present on the concrete-covered areas around this equipment, on the floor of the repair shop, and interior of a cargo container utilized for storage. Overgrown vegetation prevented the inspection of soils for evidence of staining from this equipment; however, such impact likely exists based on the poor housekeeping practices currently present at the Site. Several automobiles were also present southeast of the residence and reportedly have been utilized for parts salvaging since approximately 2007. Based on this information, it is possible this use of the Site has adversely environmentally impacted the Site. This is an REC.
