Phase 1 Environmental Site Assessment

Southwest Corner S. Blackman Rd. at E. Berkeley St.

Date of Report: July 12, 2005

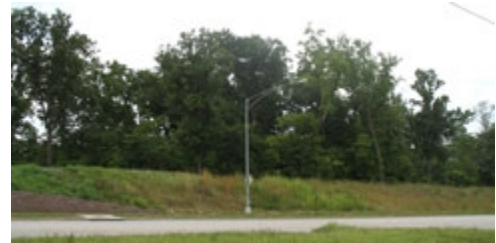
The property contains a garage structure on the southwest corner of the property. The structure is used by the Blackman Water Treatment Plant for storage purposes. The remainder of the property is undeveloped and tree covered.

No recognized environmental conditions were found. An environmental concern was identified in regards to the asphalt roofing materials on the garage structure. These roofing components should be considered suspect asbestos-containing materials. Sampling should be conducted to determine if the roofing materials contain asbestos. If demolition or renovation is planned, then a licensed abatement contractor should be contacted to properly remove and dispose of any asbestos-containing materials. If asbestos-containing materials are identified and are to remain in place, an Operations & Maintenance plan should be developed and implemented for the facility.
