City of Springfield
Water Pollution Control Section
Pollution Complaint/Report Form

Responsible Party Information:
Name PACE FURNITURE REFINISHING
Address 2816 E. DIVISION
Phone 865-2322

Investigation Results

PACS FURNITURE REFINISHING
7/29/92

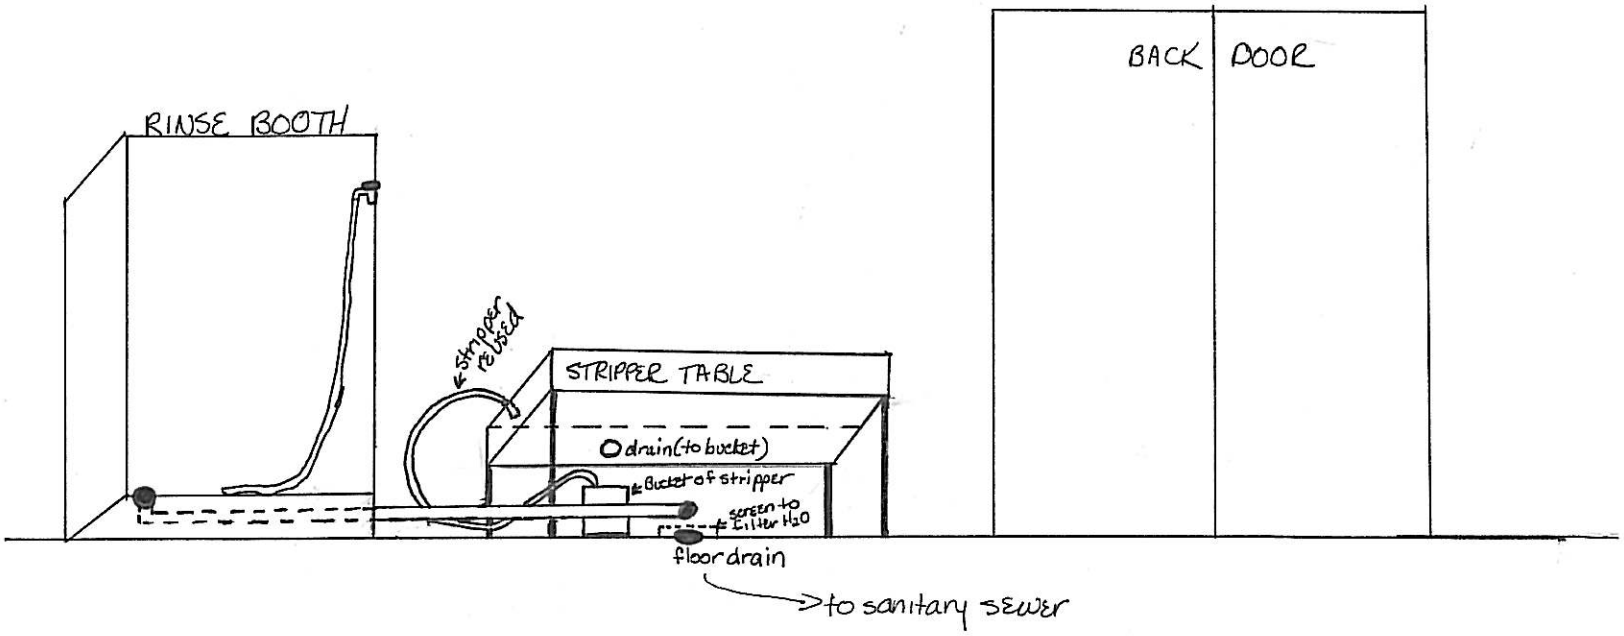
I WENT TO PACE FURNITURE REFINISHING ABOUT 2:15 IN THE AFTERNOON ON JULY 29, 1992. I DROVE AROUND THE BACK OF THE BUILDING. I SAW NO EVIDENCE OF DUMPING ON LOT (THE GRASS WASN'T DEAD). THERE WAS A FAINT STAIN ON THE ASPHALT BEHIND THE BACK DOOR, BUT IT DIDN'T LOOK FRESH. I TALKED TO MR. PACE AND LOOKED AT THE FURNITURE REFINISHING PROCESS (SEE DIAGRAM). MR. PACE COLLECTS ALL THE USED STRIPPER IN A BUCKET AND THEN REUSES IT BY PUMPING IT OUT OF THE BUCKET ONTO THE STRIPPER TABLE. HE SAID HE NEVER WASHES STRIPPER OUT OF THE BACK DOOR, IT IS TOO EXPENSIVE. HE TOLD ME THAT HE OCCASIONALLY SWEEPS THE FLOOR AND WASHES IT. HE DRAINS THIS WATER OUT OF THE BACK DOOR. HE SAID HE ALSO HAS TO SQUEEGEE OFF THE FLOOR WHEN THE RAIN BLOWS IN THE BACK DOOR. THIS IS THE ONLY WATER THAT EVER GOES OUT ON THE LOT. I DID MENTION STORMWATER REGULATIONS AND TOLD HIM IT MIGHT LIMIT WHAT COULD BE WASHED OUT ON HIS LOT IN THE FUTURE.

MR. PACE'S RINSE BOOTH WATER GOES TO A FLOOR DRAIN. HE SAID THE PIPE THAT DRAINS IT OCCASIONALLY GETS CLOGGED & HE HAS TO PULL IT APART & CLEAN IT.
