Memo

To: Cedars Restaurant
From: Bob Corson
Date: July 12, 2001
Subject: Inspection of grease trap

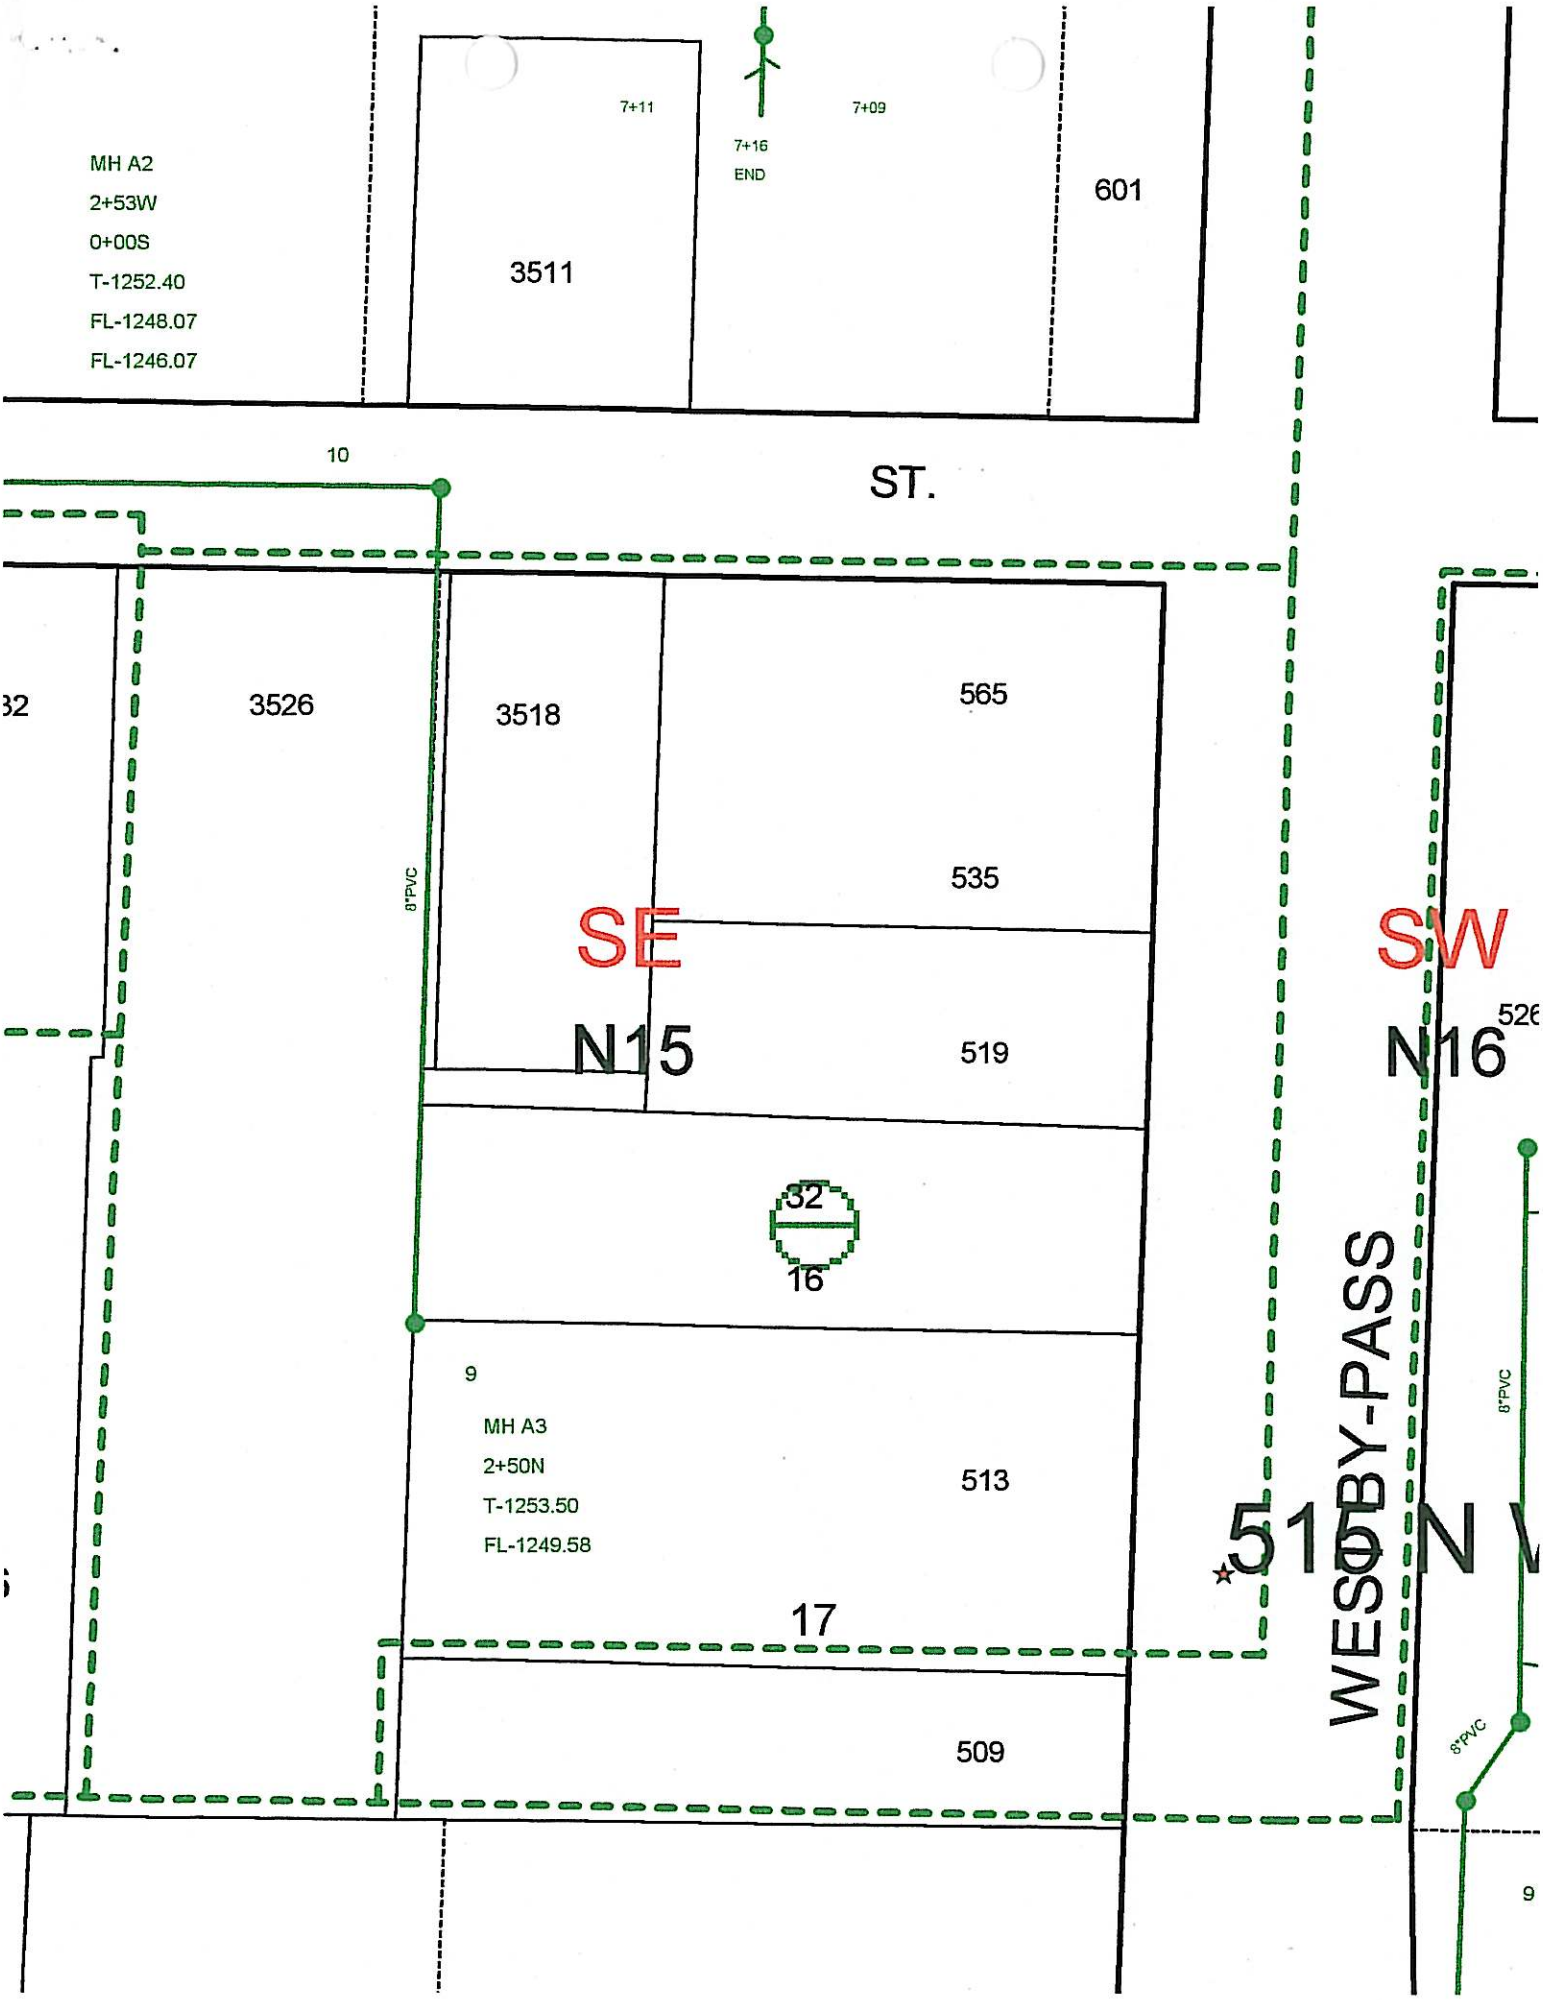
515 N West By Pass

The restaurant is connected to the City sewer between manholes 9 and 10 on Map N 15 S E.
