COUNCIL BILL NO.  2016- 063

AN ORDINANCE

This Blight Report for 616 South Market Ave., Springfield, Missouri 65806 (the “Property”) is being submitted by WPV, LLC, a Missouri limited liability company (the “Developer”), for the purpose of demonstrating that the Property should be declared blighted pursuant to the LCRA Law. This Blight Report will demonstrate that the Property is a “blighted area” under the LCRA Law due to the predominance of (1) deterioration of site improvements; (2) insanitary and unsafe conditions; and (3) the existence of conditions which endanger life and property by fire or other causes. Because of the aforementioned conditions, the Property constitutes an economic and social liability and a menace to the public health, safety, morals, and welfare in its present condition and use.

## Property Inspection Report

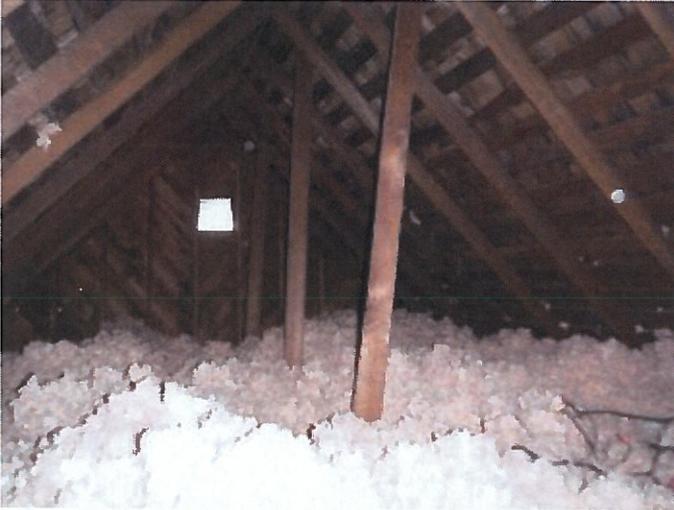
- Appears serviceable
- Entered
- Minimal ventilation provided
- Roof decking still consists of the original cedar shingles.
- Moisture stains and signs of past leakage at south side of chimney.

Partial view in middle of attic looking west
