Springfield Land Clearance for Redevelopment Authority

4.I. **Blight Report And Redevelopment Plan For The East Cherry Townhomes Redevelopment Area, Generally Located At 1361 And 1365 East Cherry Street; Say You Can, LLC, Applicant**

Report Summary of Defects

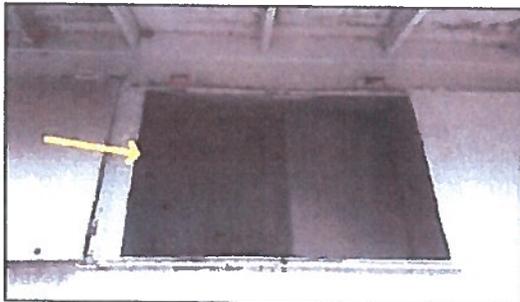
Missing shutter noted

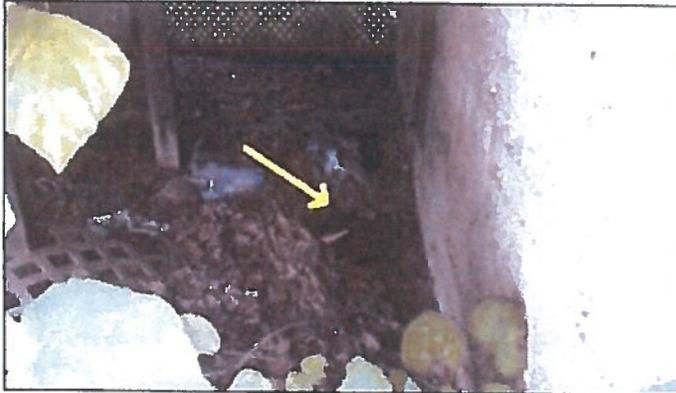
- Appears to drain fairly well.
- Overgrown landscaping noted; recommend trimming.
- Some erosion noted from water running over the guttering.
- Poor drainage noted below front porch; needs soil added.

Poor drainage below front porch

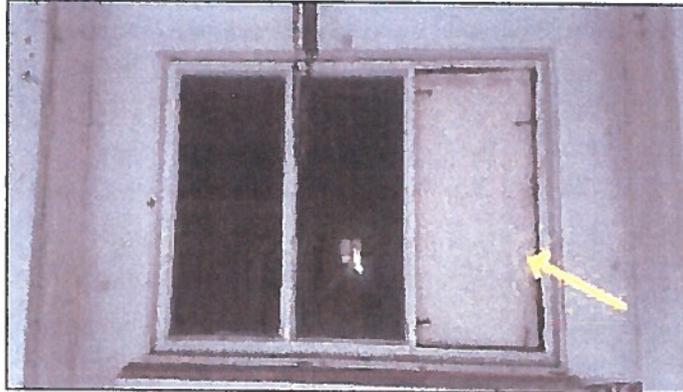
- Hardware is loose
- Weather stripping is missing
- Glass missing; needs repair.

Missing glass at front door

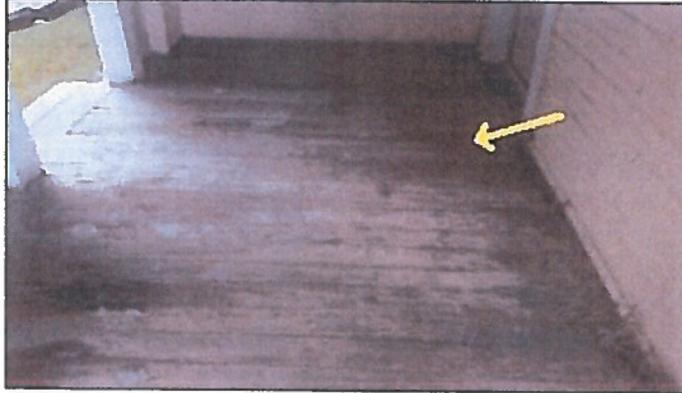
- The decks due to be sealed/painted and routine maintenance needed.

Back porch needs maintenance

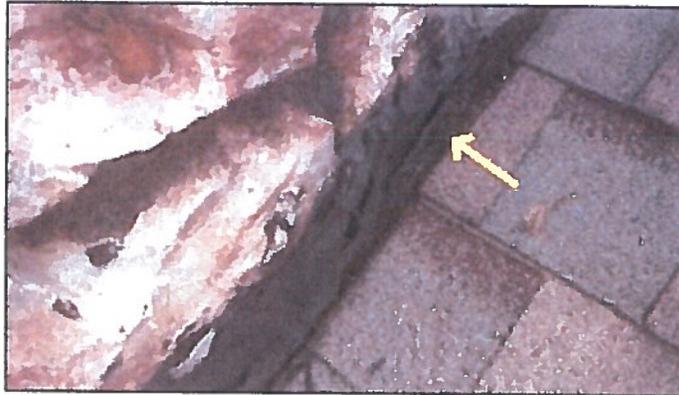
- plumbing flashings appear serviceable
- Not fully visible
- Caulk noted at electrical mast
- Heavy patching/repair observed at chimney flashing.
- Counter flashings at the chimney flashings are improper and loose; needs securing/repair.

Improper and loose flashing at front chimney

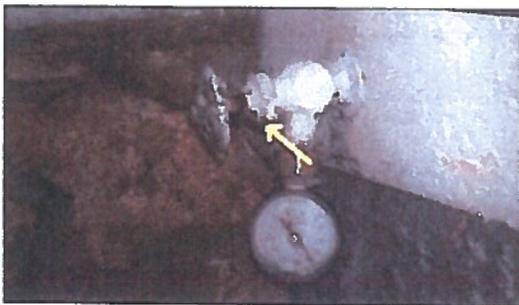
- Both hose faucets leak from the handles under pressure; need repair/replacement.

Front faucet leaks under pressure

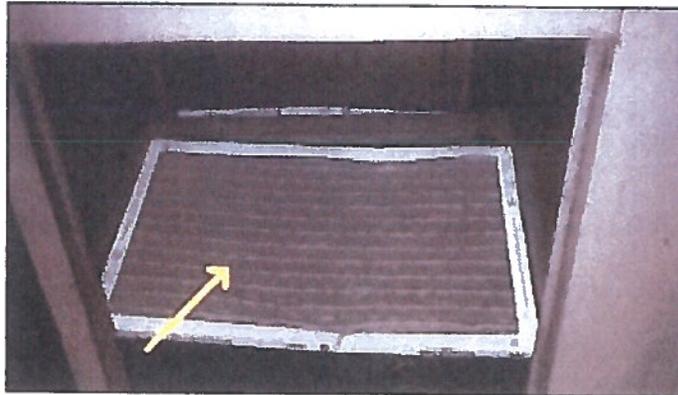
- Filters are in the blower compartment.
- Filters are dirty and in need of replacement.
- Filters are the wrong size; too short; needs replacement

Filter location

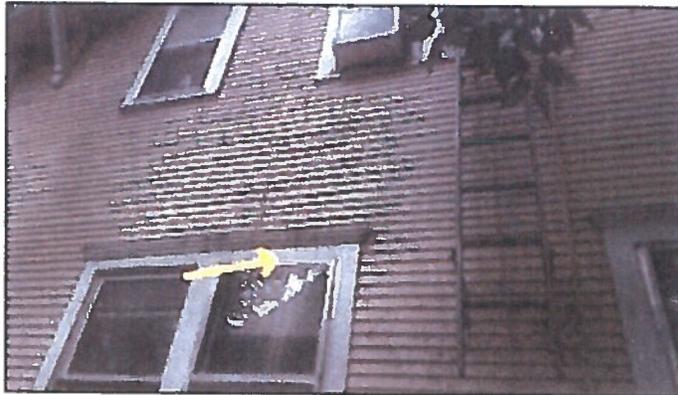
- Window units installed
- Operated normally today
- Condensation drips onto wall and windows below; recommend correction.
- AC unit at front of unit three is not functional; needs to be removed or replaced.

Condensation dripping down walls and window
